# Evaluation of Thin Polymer Overlays for Bridge Decks

Habib Tabatabai  
Konstantin Sobolev  
Al Ghorbanpoor  
Azam Nabizadeh  
Chin-Wei Lee  
Matthias Lind

University of Wisconsin-Milwaukee

WisDOT ID no. 0092-12-06

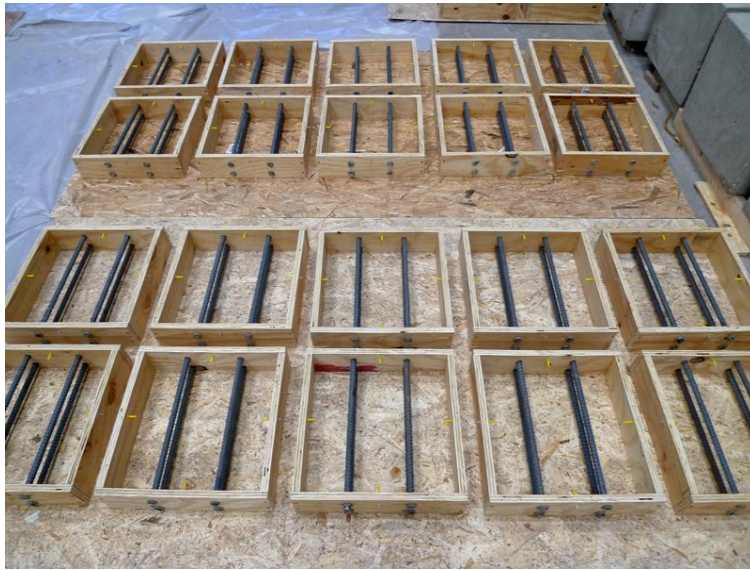
Figure 2. Concrete specimen preparation.

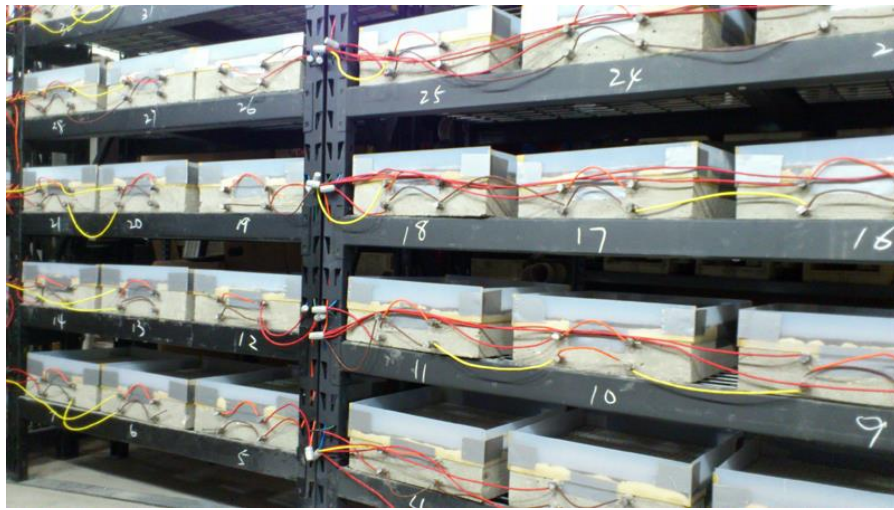
Figure 3. Group B and C specimens undergoing initial chloride/accelerated corrosion exposure.

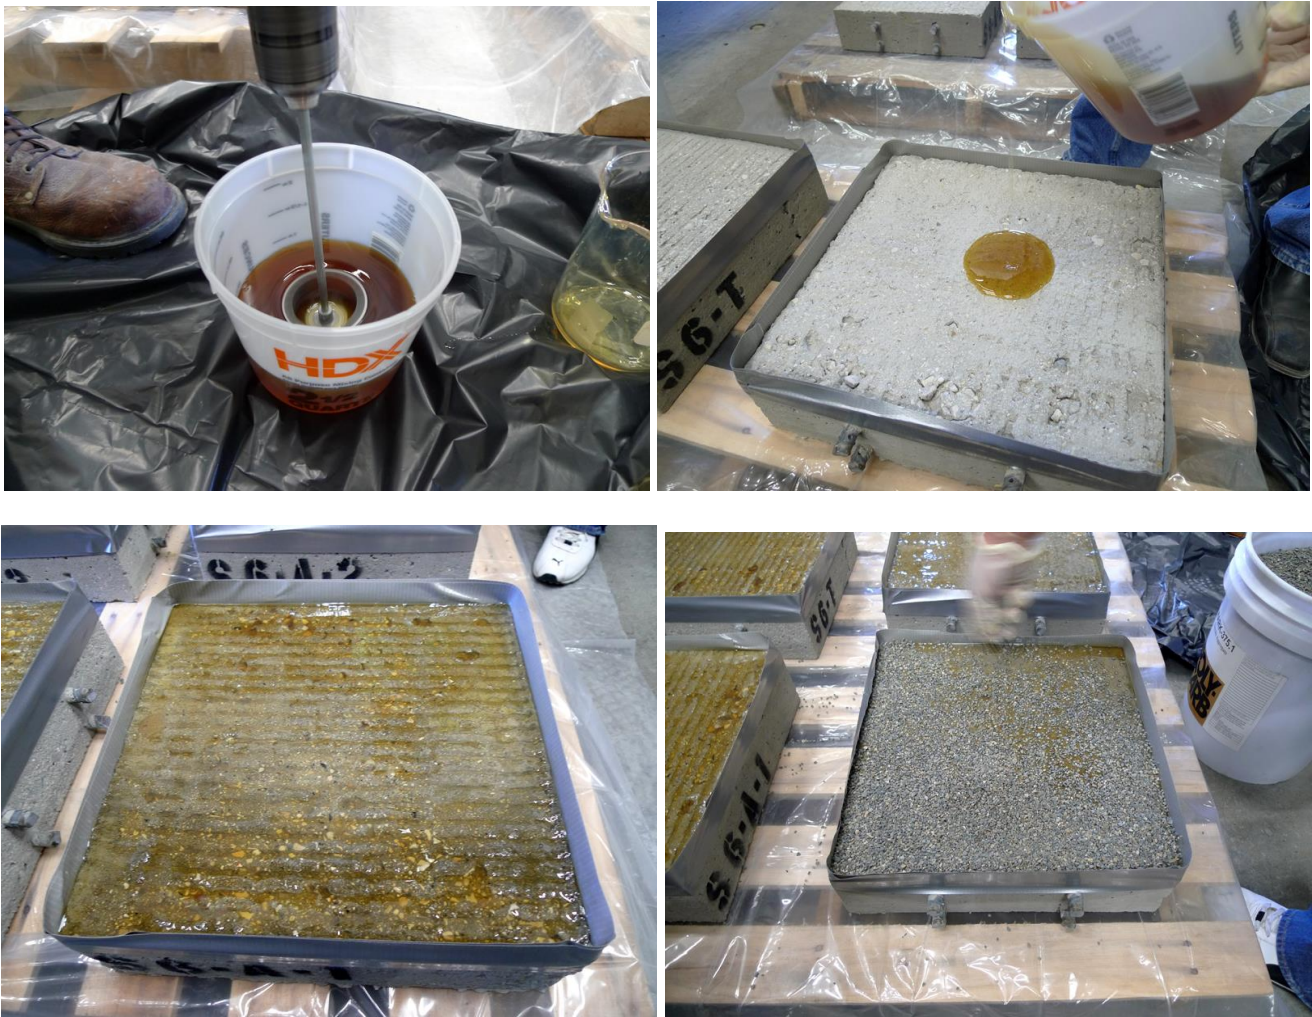
Figure 4. Placement of thin polymer overlay on test specimen.

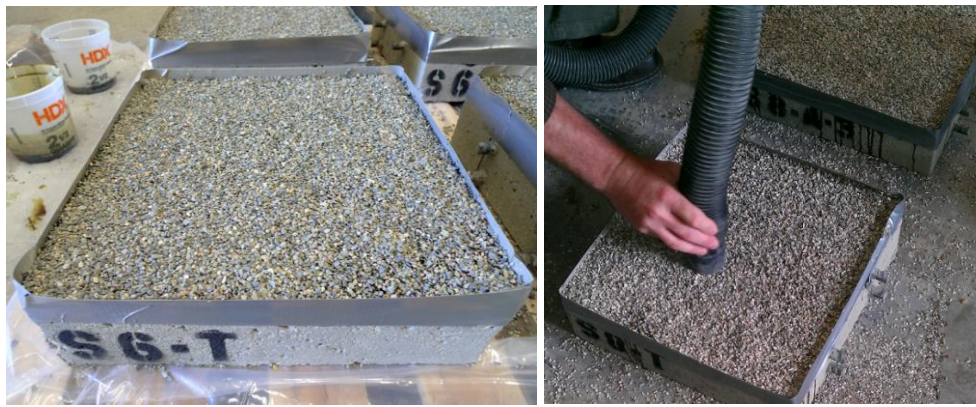
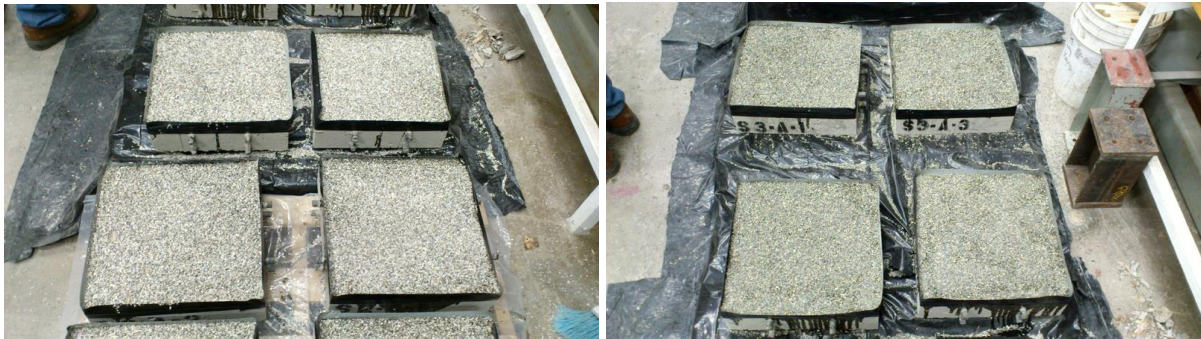
Figure 5. Multi-lift overlay placements.

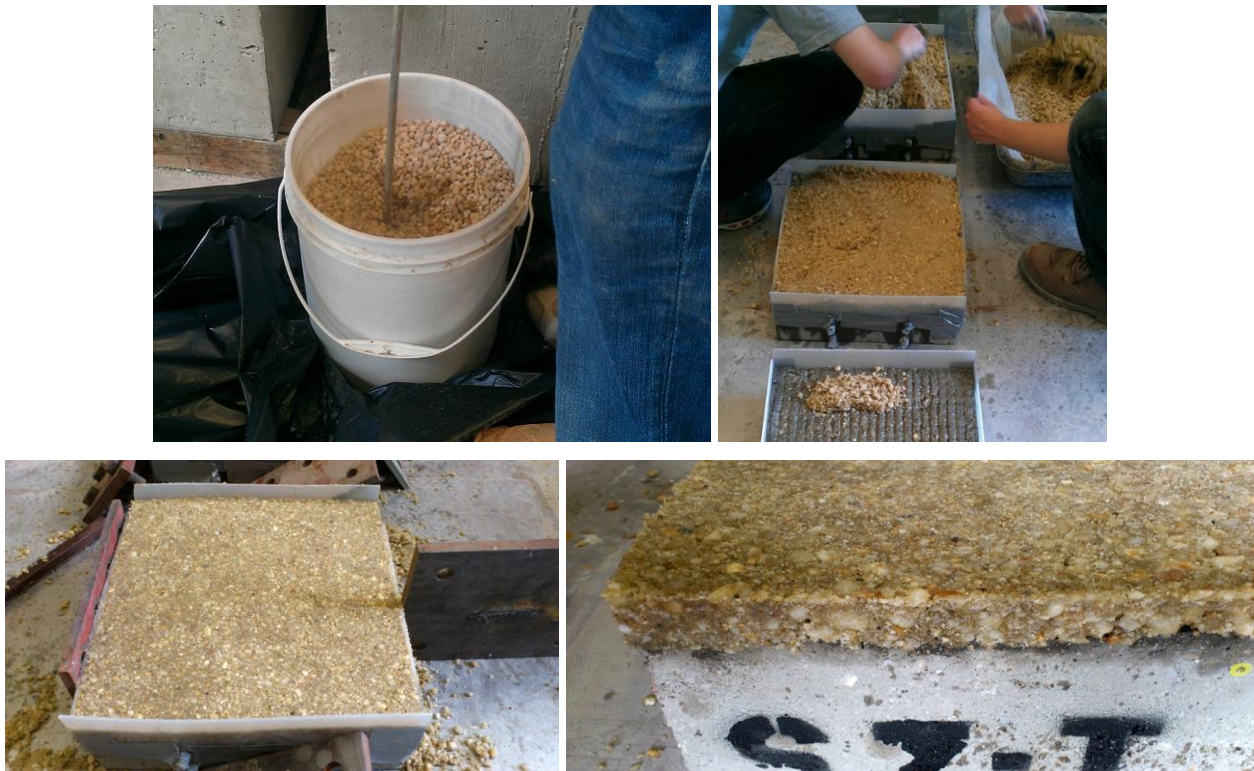
Figure 6. Pre-mixed polyester overlay system (S7) placement.

In the case of pre-mixed polyester system (S7), aggregates supplied by the manufacturer were mixed with the polymer before placement on the surface. A primer was first applied on the concrete surface. The overall thickness of this overlay was on the order of  $\frac{3}{4}$  in. The surface was finished smooth. Figure 6 shows placement of the S7 overlays.

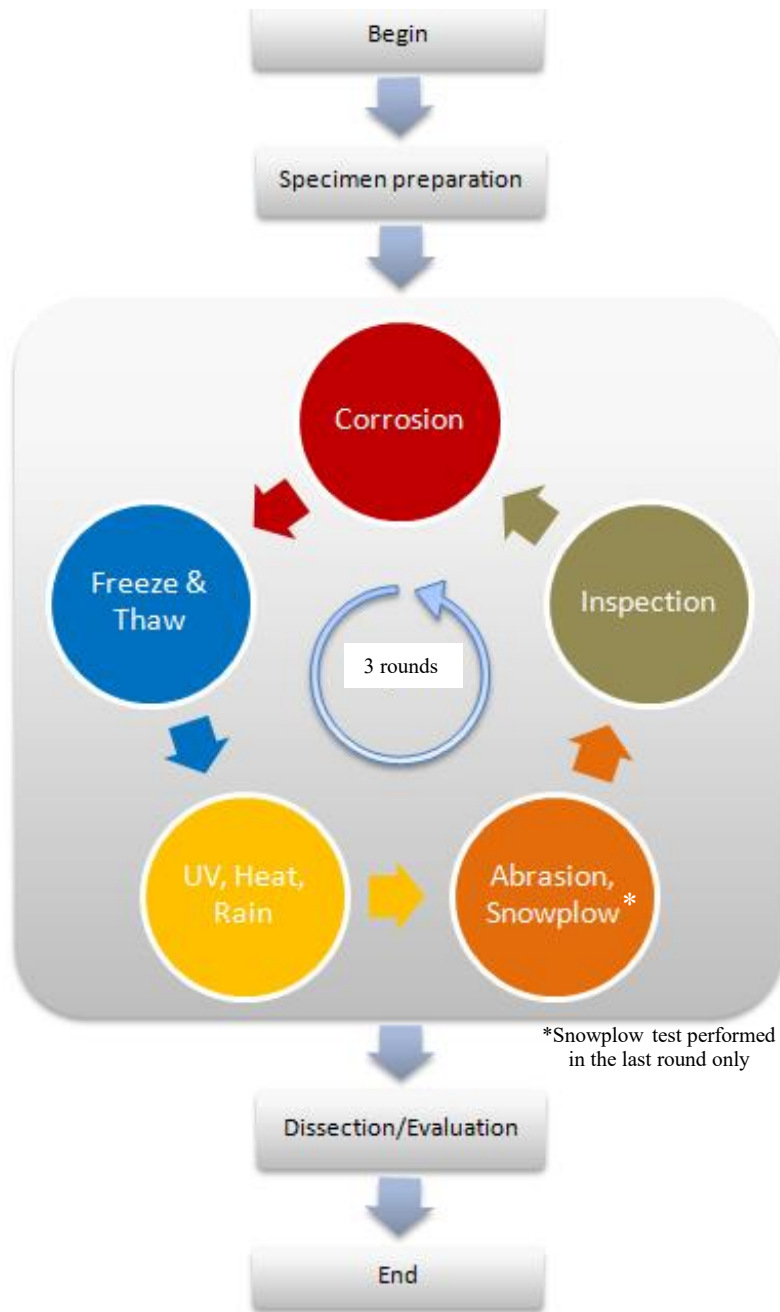
Figure 7. Test exposure cycles.

Each specimen was subjected to a sequential series of exposures/tests as shown in Figure 7. After the application of overlays, all specimens were subjected to three rounds of testing/exposure involving accelerated corrosion, freeze-thaw cycles, heat/UV/rain cycles, and wear testing (repetitive tire passage), and a “snow plow” test at the end of round 3 testing. Details of each test component are described below.

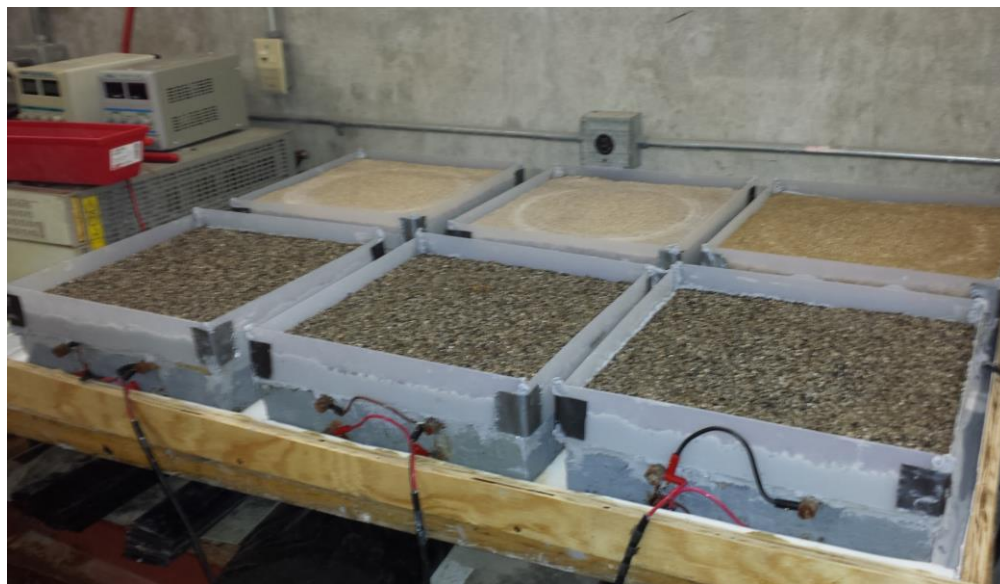
Figure 8. Accelerated corrosion setup.

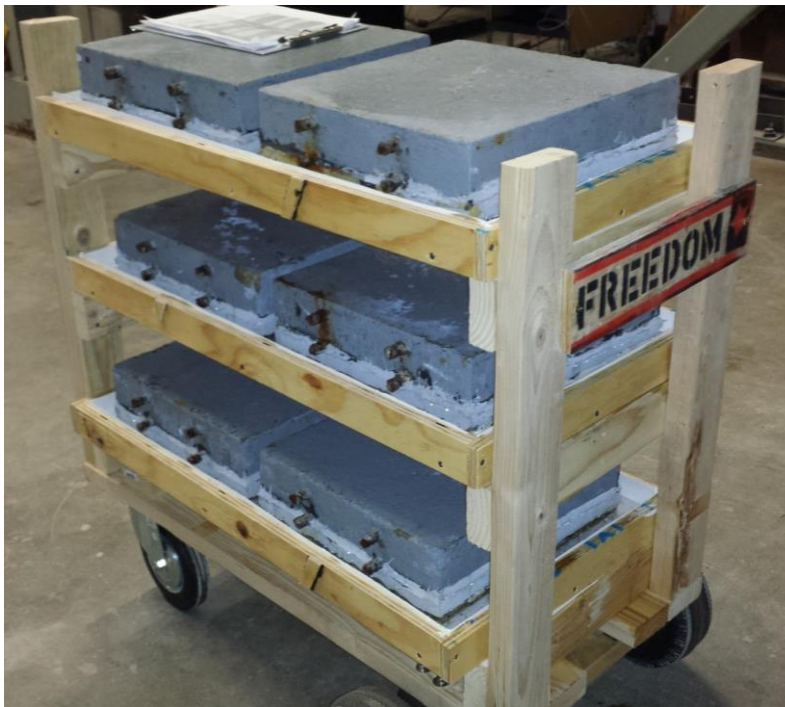
Figure 11. One of the three carts used for manual FT testing.

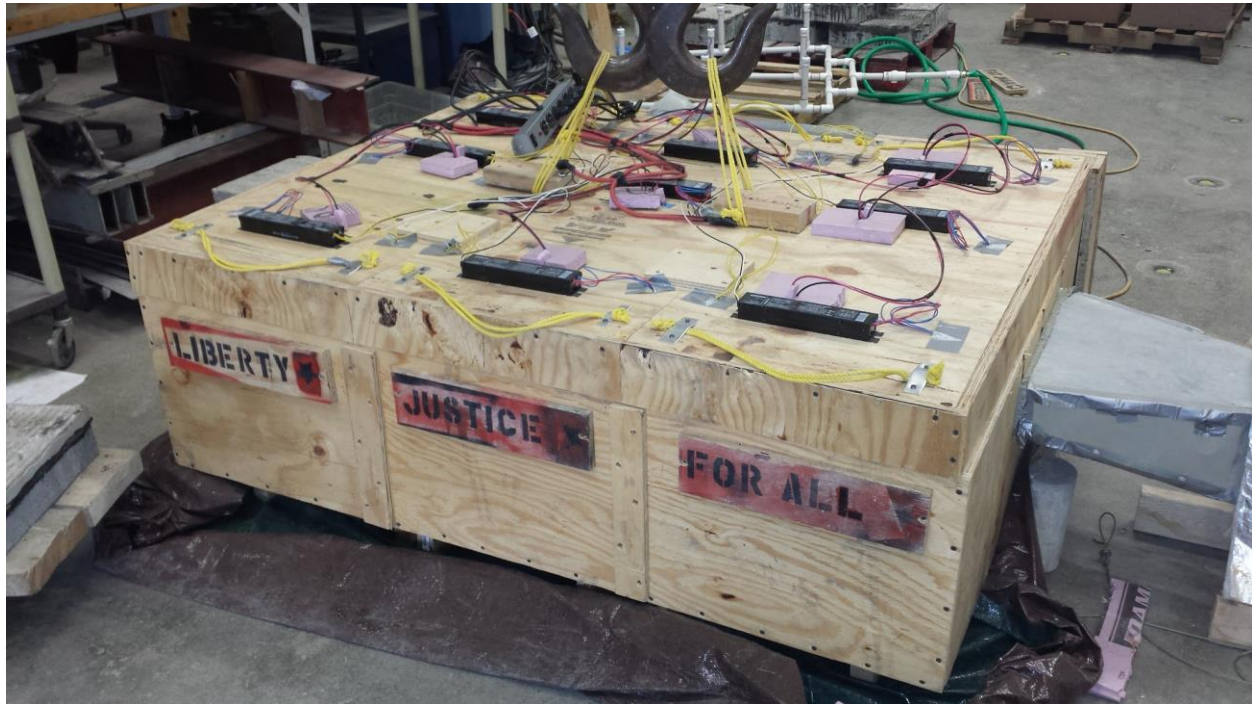
Figure 14. Manual HURA test box.

UV light bulb (the same type as those used in the automated system). In addition to the heat lamps, an electric heater also provided general heating for the inside of the box through a side access duct. The top surfaces of the specimens (overlays) were cooled by a system of pipes that sprayed each specimen individually with tap water to rapidly cool the surface of the overlay.

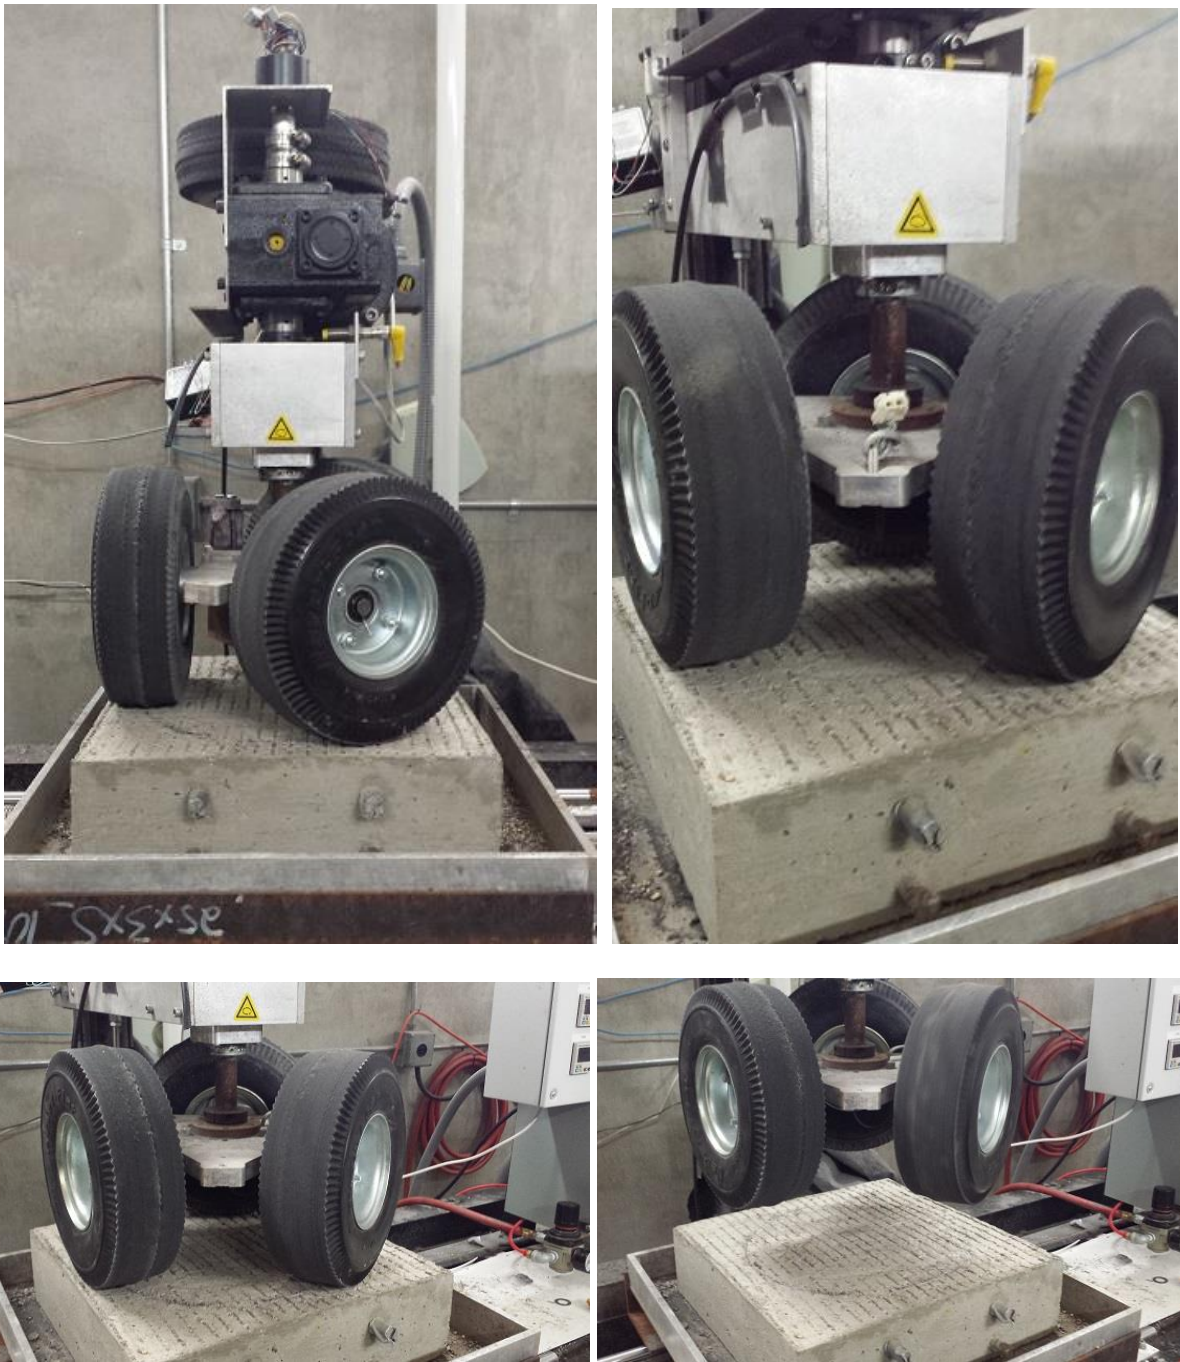
Figure 17. UWM-designed wear test device.

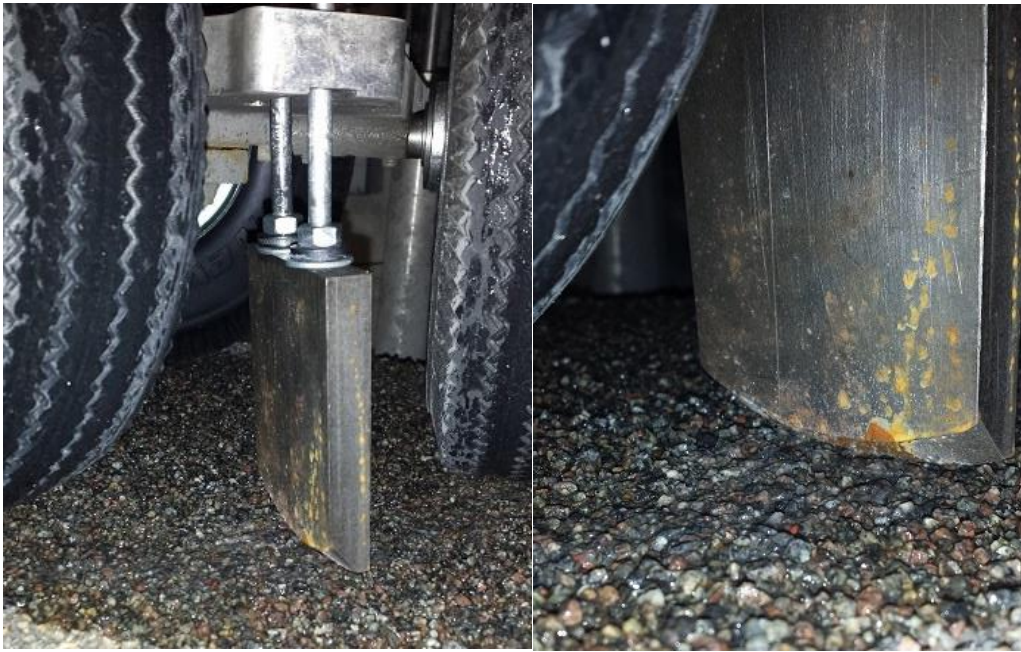
Figure 19. "Snow plow" assembly installed between two tires.

To simulate snow plow damage on the overlay system, a steel “snow plow” test assembly was designed. Figure 18 shows the dimensions and layout of the snow plow assembly. The total weight of this assembly was 5.0 lb. For all specimens, the snow plow test was performed at the conclusion of the Round 3 wear tests (before the last friction test). The “snow plow” assembly was attached to the wear test assembly (at the triangular aluminum plate where tires are attached) between two tires (Figures 18 and 19). The tip of

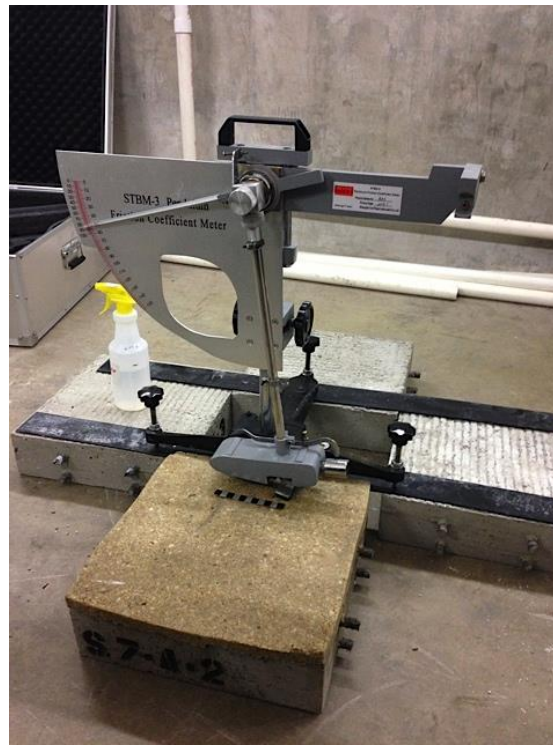
Figure 20. British Pendulum Tester used on specimens prior to exposure tests.

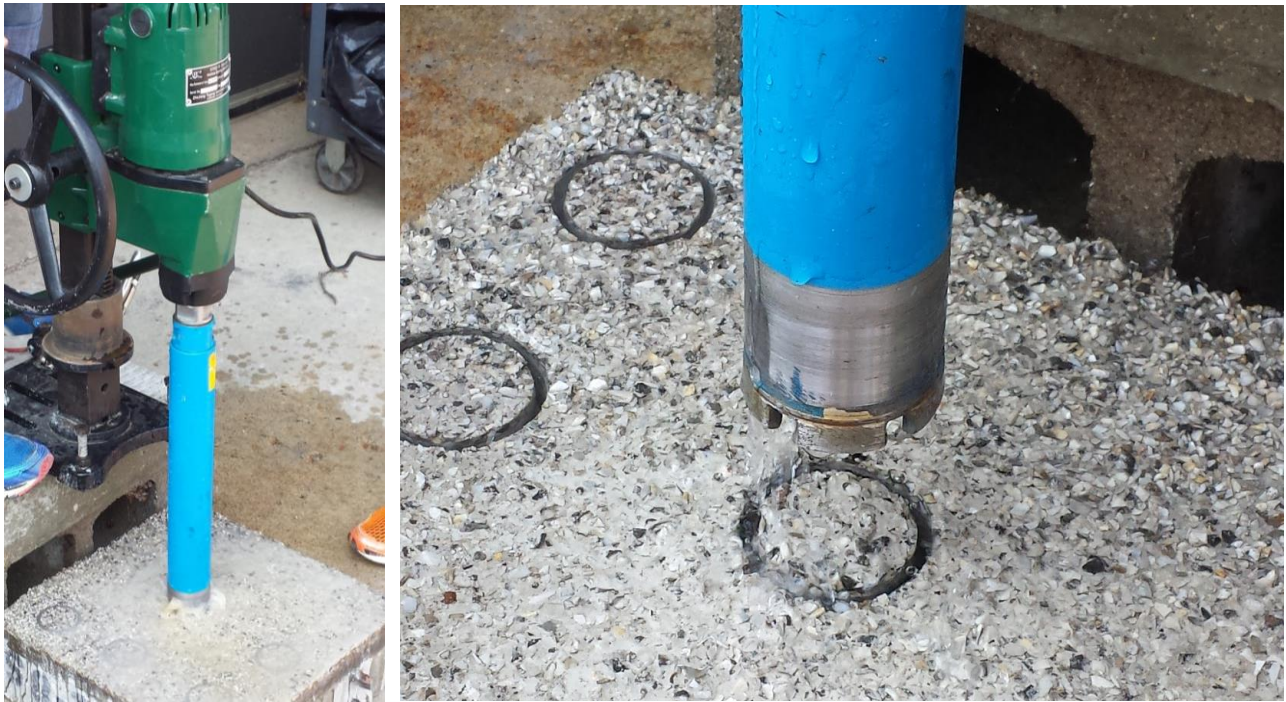
Figure 23. Coring drill setup.

- The coring apparatus was secured on a flat solid base for the drilling operation.
- The specimen to be cored was placed on the ground next to the base of the coring machine. A cardboard template was used to mark the drilling locations on the surface of the specimen.
- The coring machine was placed over one of the three holes on the template.
- A continuous water supply was provided for the cooling of the bit during drilling.
- The coring rig was turned on and lowered to the surface.
- Coring was done at a pace of about  $\frac{1}{4}$  in every minute. Coring was done to a depth of approximately 1  $\frac{1}{2}$  in. from the surface.
- This process was repeated for the second and third cuts.

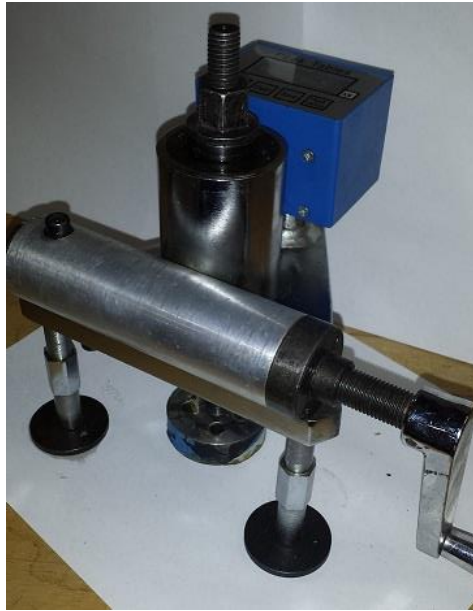
Figure 25. Pull-out test device.

A digital pull-out test machine was used to measure the pull-out strength. A metal disc was attached (using epoxy adhesive) to the top surface of the cored section (Figure 25). The 2-in steel discs were custom-made with a machined 11-mm threaded portion in the center for better bond to the pull-out apparatus. Four ¼” diameter holes were drilled through the thickness of the disc to allow pouring of additional epoxy into the interface zone.

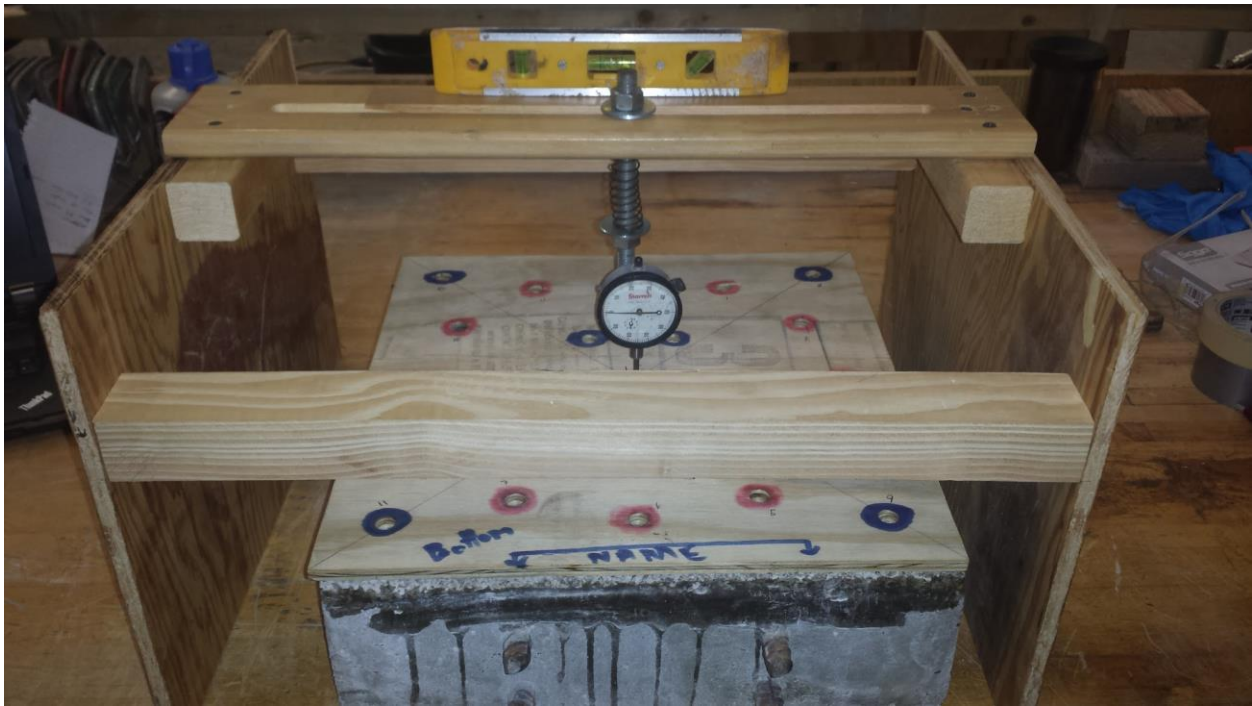
Figure 26. Measurement of the depth of surface groove (rut) through a dial gage at measurement points defined using a wooden template.

Once all the exposure tests were completed, the surface profile of the specimen was measured to assess the relative depth of the groove (rut) created as a result of the wear test and the “snow plow” passage. This measurement was performed at the end of Round 3 tests. This was accomplished by taking measurements at preset locations along the surface of each specimen. A wooden template with pre-drilled holes was used to have consistent measurement points between specimens. Twelve measurement points were spread outside of the tire track, and twelve points were located along the centerline of the tire track. At each point, the depth was measured with respect to a central baseline. The two highest and the two lowest measured values in each group were removed from analyses to eliminate localized extreme values. The averages and standard deviations of the remaining eight data point were calculated. The average depth within the center of the tire track or groove (rutted area) was subtracted from the average depth of the surrounding areas.

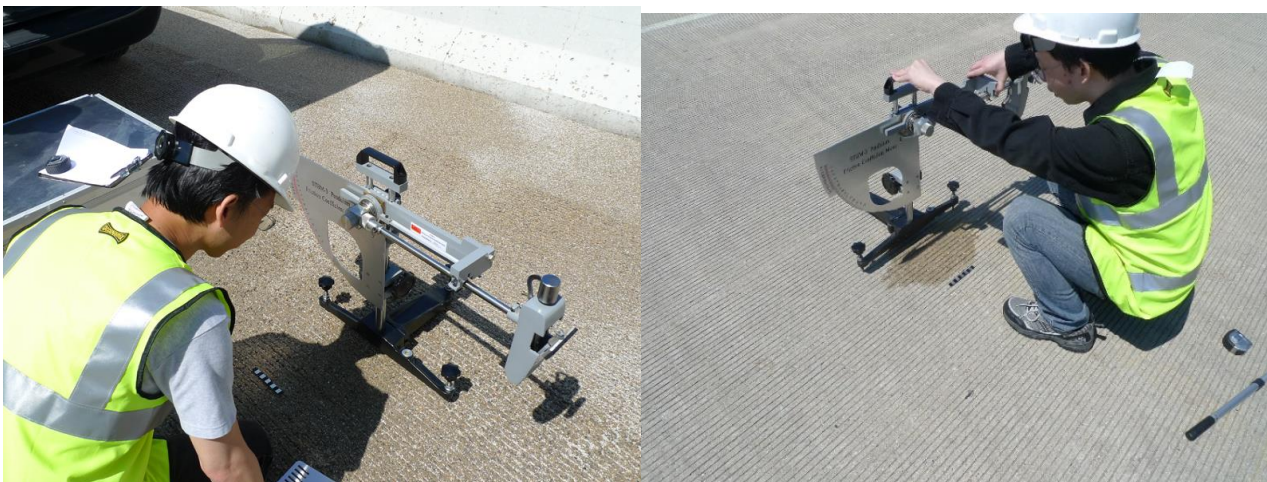
Figure 29. Friction testing using BPT.

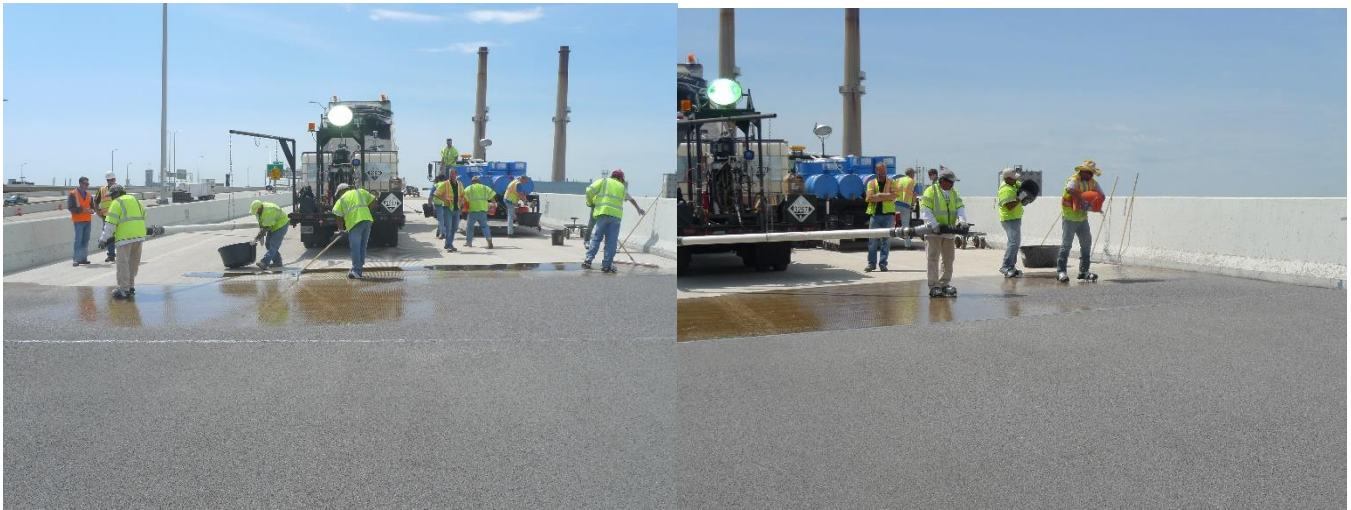
Figure 30. Placement of resin and aggregate on a 2-lift overlay system.

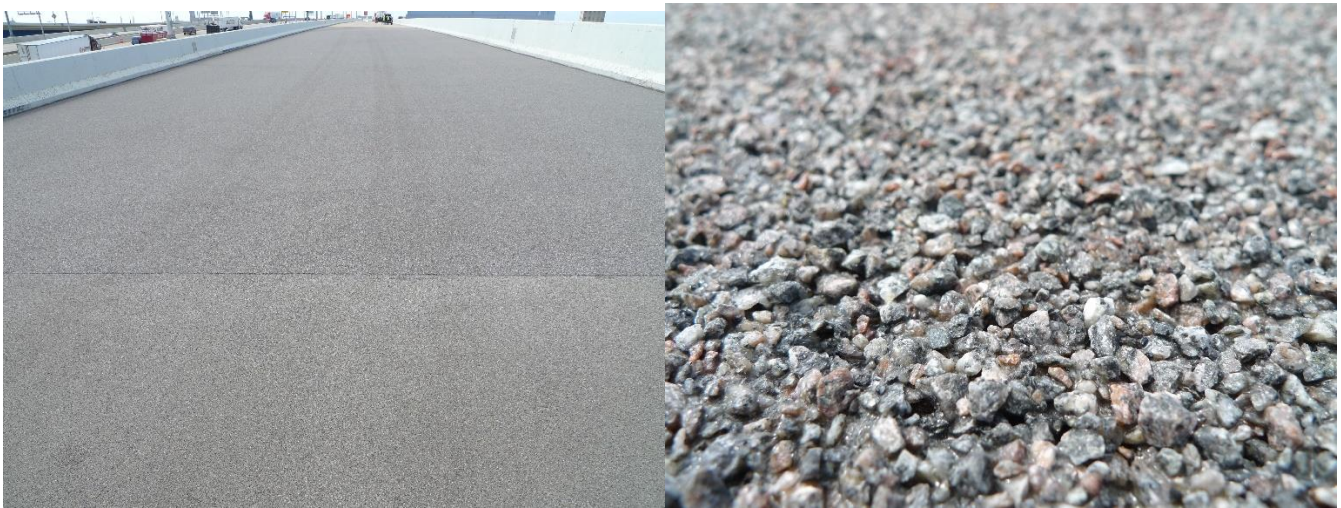
Figure 31. Marquette Interchange ramp after placement of four different thin polymer overlay systems (A through D).

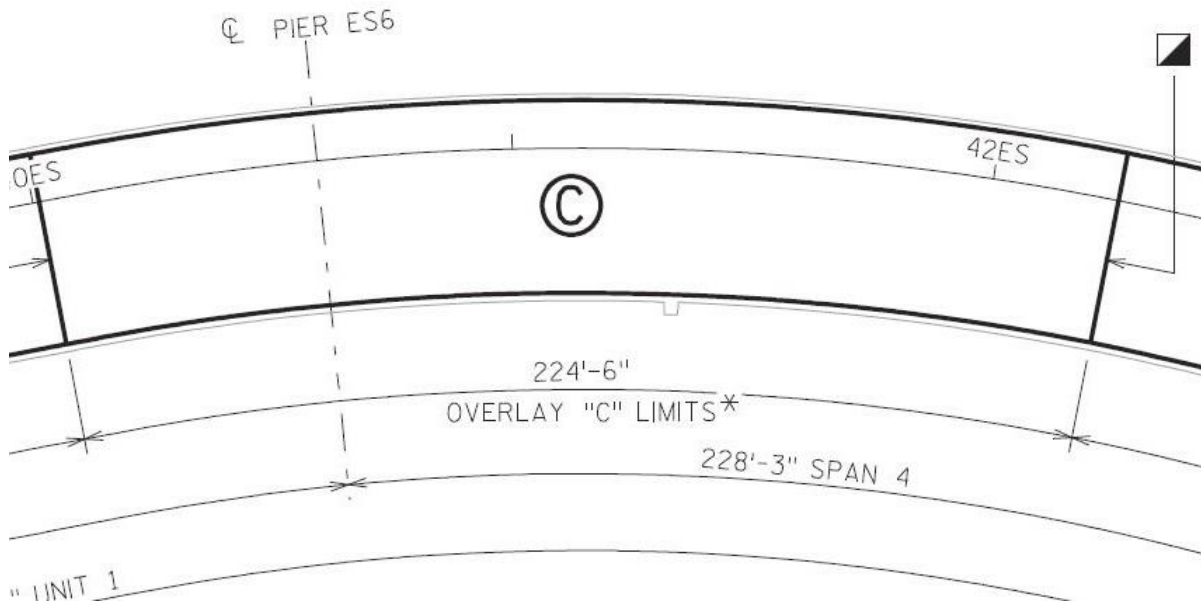
Figure 35. Section C drawing (from WisDOT).

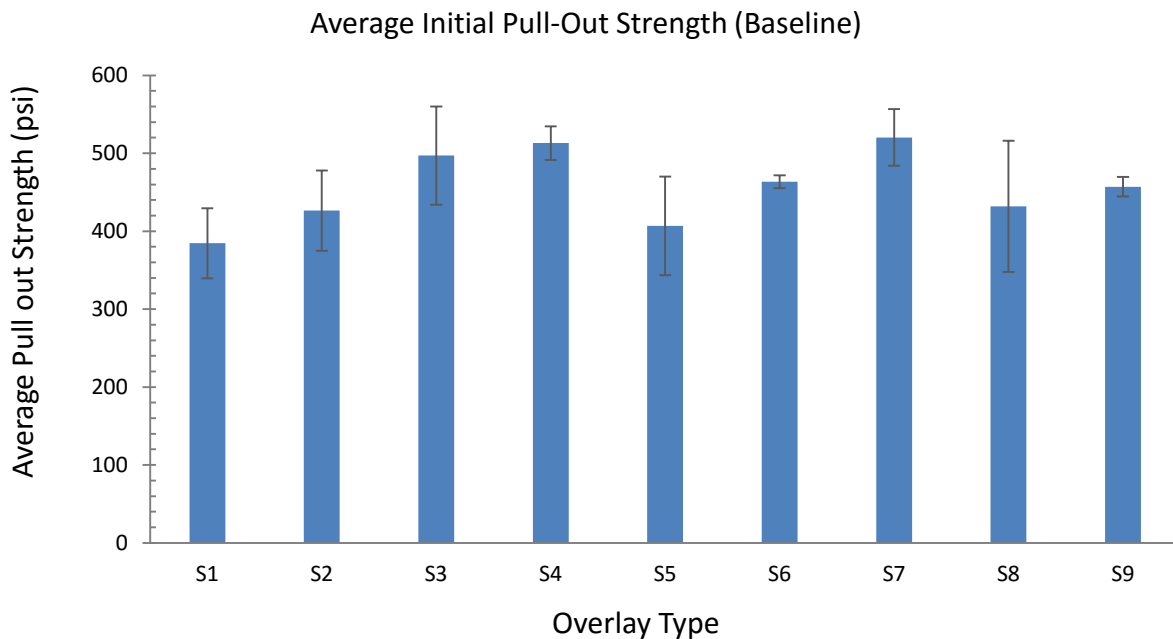
Figure 37. Average initial pull-out strength (baseline).

Overlay Type	Average Pull-out Strength (psi)	St. dev. (psi)
S1	384.6	45.0
S2	426.4	51.5
S3	497.1	63.0
S4	513.1	21.6
S5	406.8	63.1
S6	463.6	8.1
S7	520.2	36.4
S8	431.8	84.1
S9	457.2	12.4

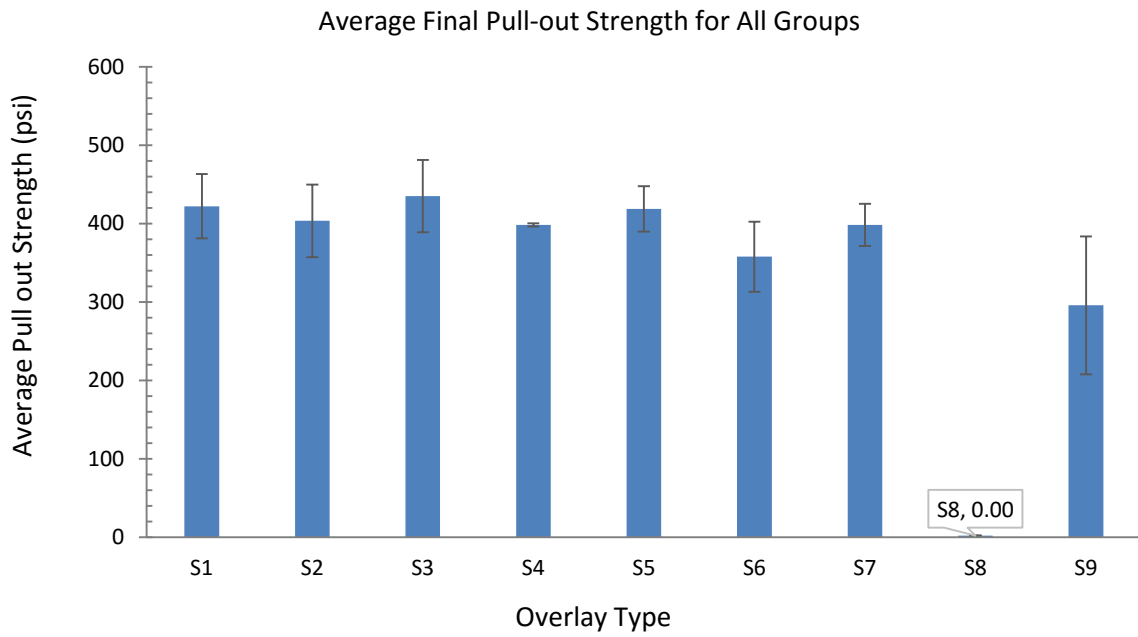
Figure 38. Average final pull-out strength of all groups.

Specimen	Avg. Pull-out Strength (Psi)	St. dev. (psi)	Specimen	Avg. Pull-out Strength (Psi)	St. dev. (psi)	Specimen	Avg. Pull-out Strength (Psi)	St. dev. (psi)
S1-A	387.1	45.0	S1-B	467.5	57.9	S1-C	411.8	73.0
S2-A	403.8	50.0	S2-B	449.7	92.6	S2-C	356.7	33.2
S3-A	458.6	52.2	S3-B	381.7	73.8	S3-C	464.6	106.9
S4-A	396.0	99.9	S4-B	398.7	37.0	S4-C	400.2	62.8
S5-A	397.4	91.4	S5-B	407.3	66.4	S5-C	451.8	92.8
S6-A	308.3	179.1	S6-B	395.0	22.2	S6-C	369.8	71.3
S7-A	380.0	52.1	S7-B	429.0	84.1	S7-C	385.7	50.8
S8-A*	0.0	0.0	S8-B*	0.0	0.0	S8-C*	0.0	0.0
S9-A	195.2	50.0	S9-B	359.6	37.9	S9-C	332.1	34.3

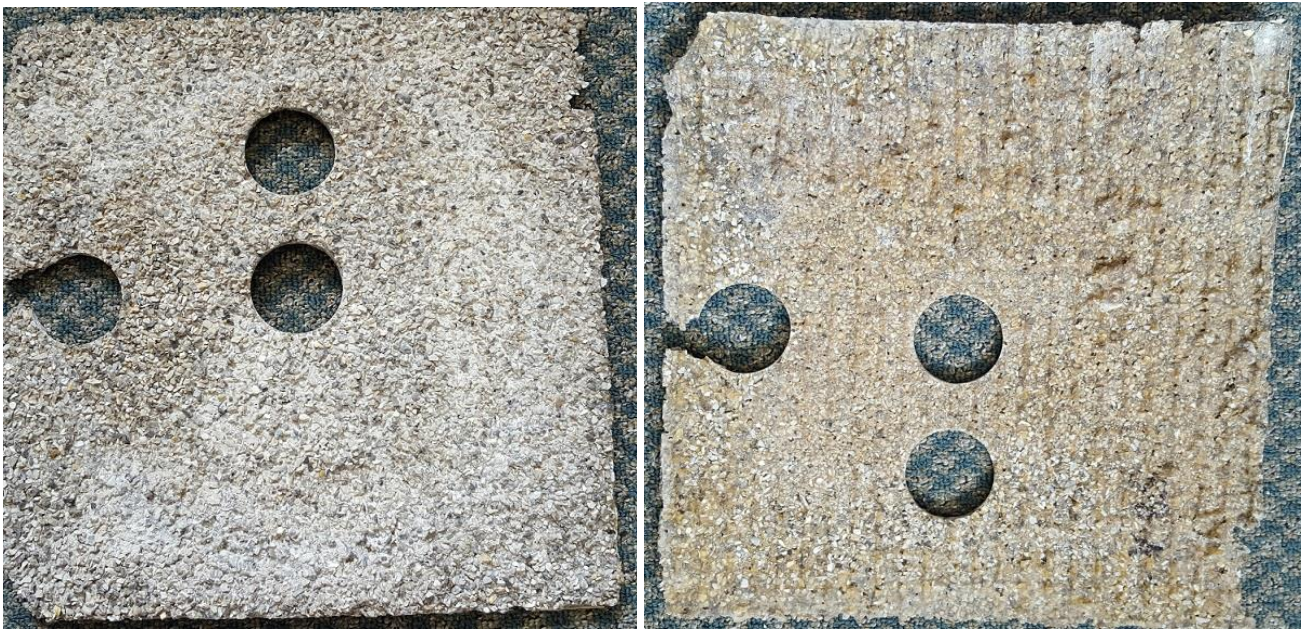
Figure 39. Pictures of delaminated overlay from a S8 specimen: top surface (left), bottom surface (right).

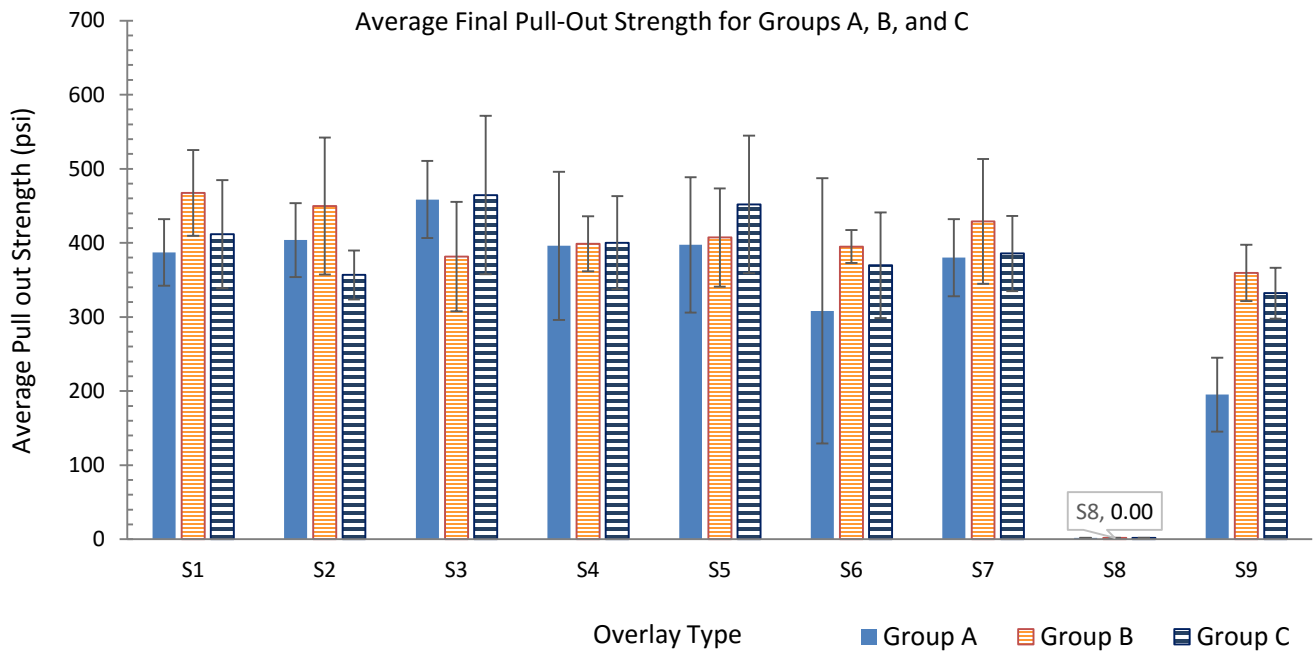
Figure 40. Average final pull-out strength for groups A, B, and C.

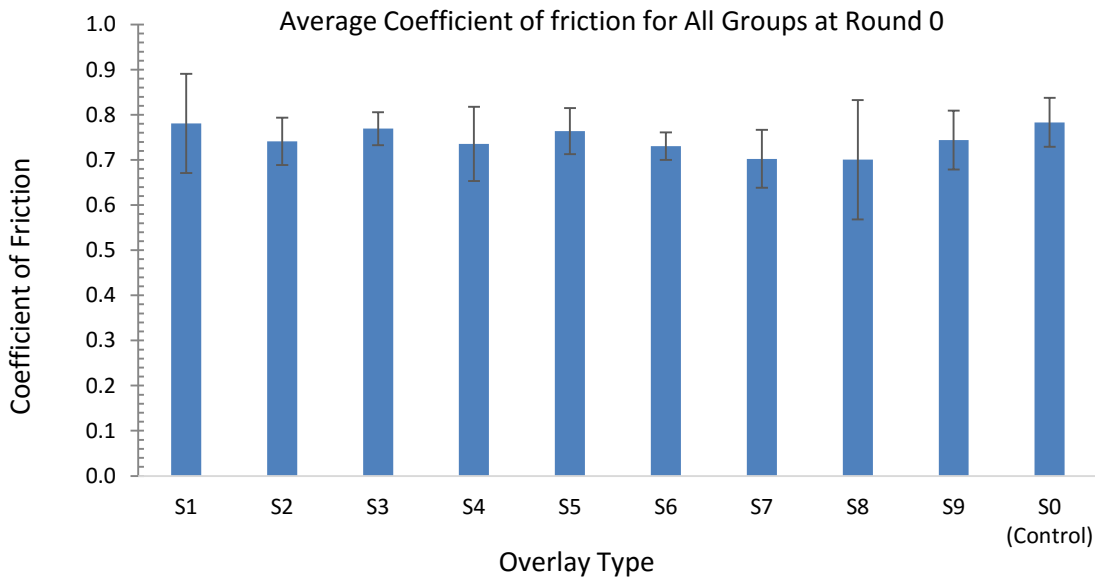
Figure 41. Initial average coefficients of friction for all groups at Round 0.

Specimen	Coefficient of Friction	St. Dev.
S1	0.781	0.102
S2	0.741	0.052
S3	0.769	0.132
S4	0.736	0.082
S5	0.764	0.051
S6	0.730	0.030
S7	0.703	0.064
S8	0.701	0.132
S9	0.744	0.065
S0	0.783	0.054

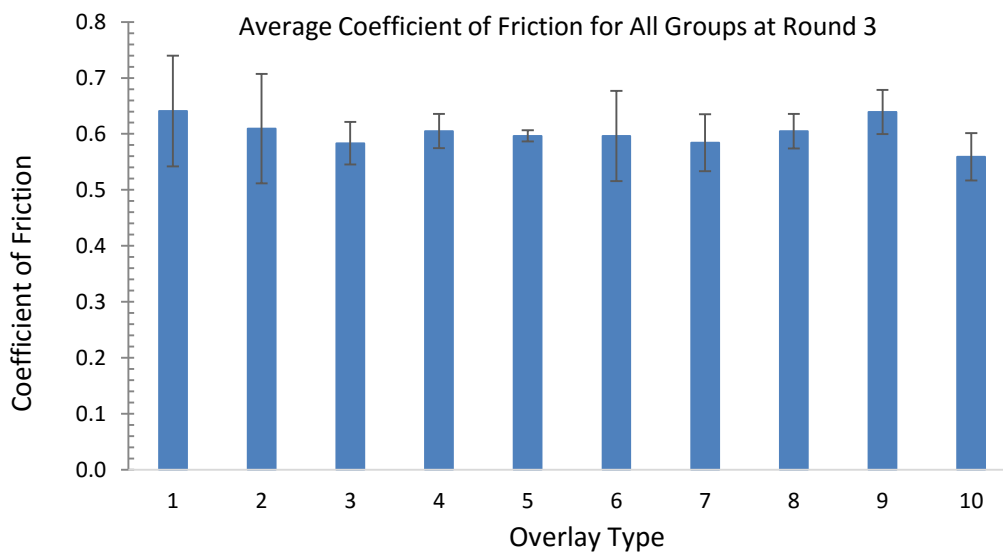
Figure 42. Average coefficient of friction for all groups at round 3.

Specimen	Coefficient of Friction	St. Dev.	Specimen	Coefficient of Friction	St. Dev.	Specimen	Coefficient of Friction	St. Dev.
S1-A	0.753	0.087	S1-B	0.604	0.057	S1-C	0.566	0.075
S2-A	0.684	0.098	S2-B	0.499	0.059	S2-C	0.646	0.061
S3-A	0.624	0.111	S3-B	0.550	0.052	S3-C	0.576	0.060
S4-A	0.637	0.087	S4-B	0.577	0.061	S4-C	0.601	0.055
S5-A	0.605	0.045	S5-B	0.586	0.046	S5-C	0.598	0.073
S6-A	0.674	0.056	S6-B	0.513	0.057	S6-C	0.601	0.055
S7-A	0.610	0.047	S7-B	0.526	0.059	S7-C	0.617	0.057
S8-A	0.632	0.046	S8-B	0.571	0.050	S8-C	0.611	0.069
S9-A	0.666	0.085	S9-B	0.658	0.071	S9-C	0.594	0.055
S0-A	0.559	0.042

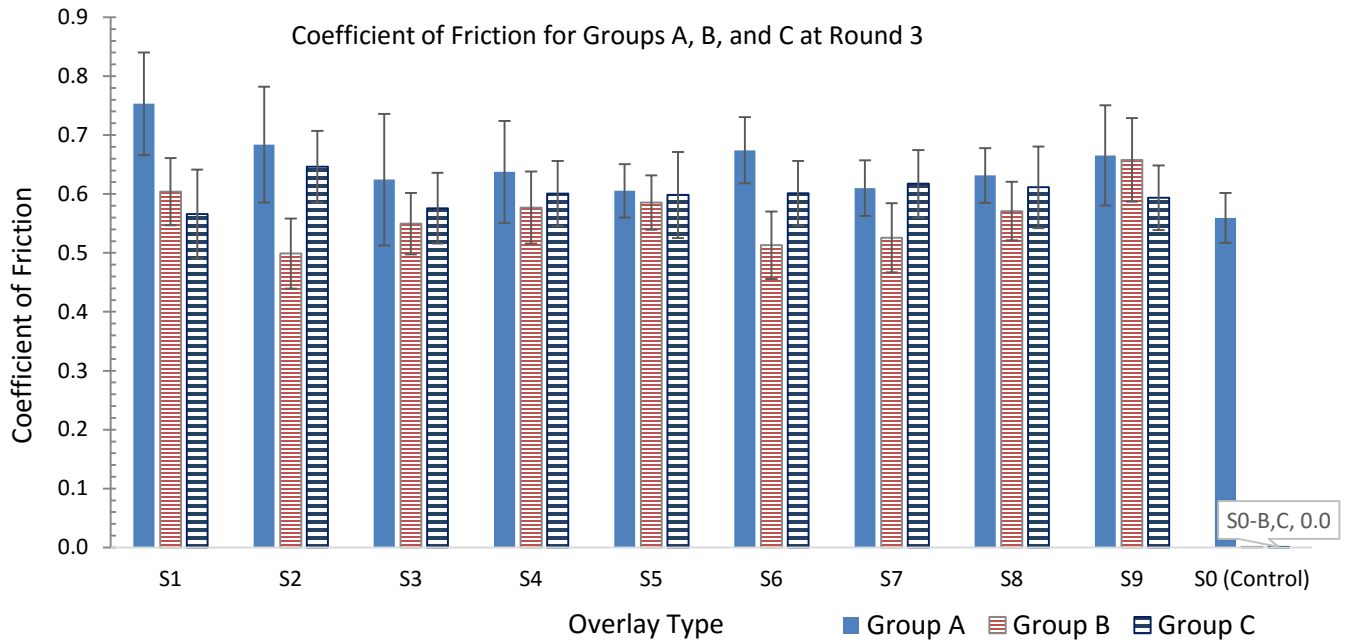
Figure 43. Coefficient of friction for groups A, B, and Cat Round 3.

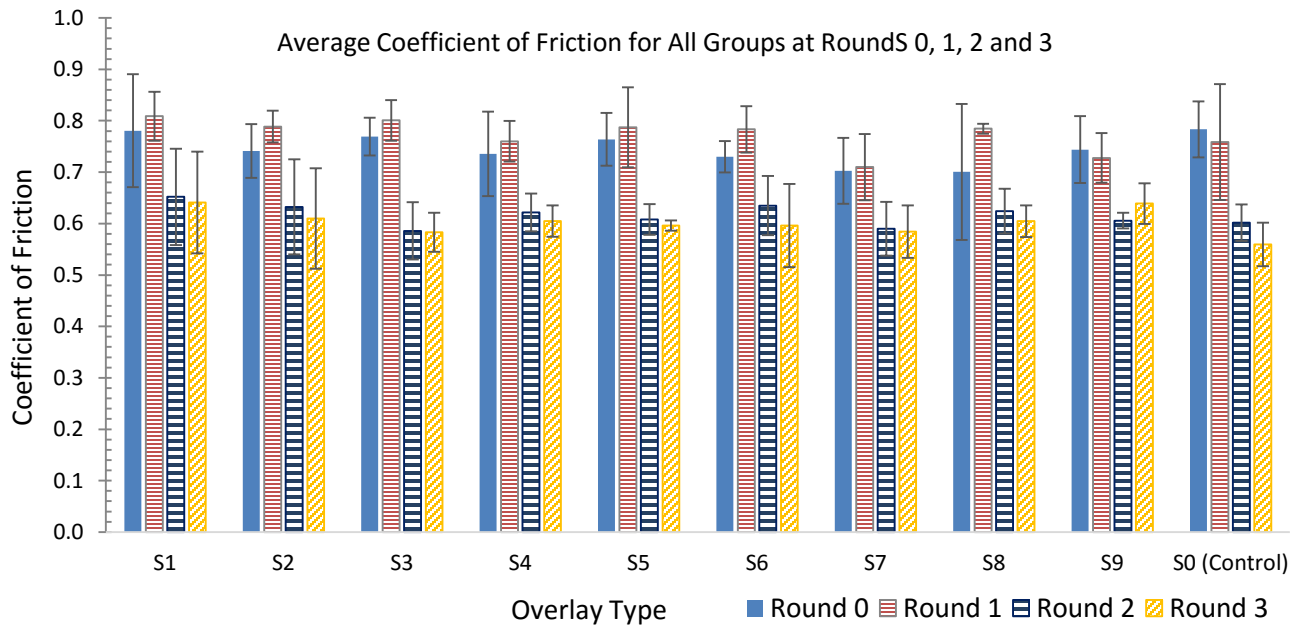
Figure 44. Average coefficient of friction for all groups at round 0, 1, 2, and 3.

Actual Average Coefficient of Friction											
Round #	Tire Passes	S1	S2	S3	S4	S5	S6	S7	S8	S9	S0
Round 0	0	0.781	0.741	0.769	0.736	0.764	0.730	0.703	0.701	0.744	0.783
Round 1	33000	0.809	0.789	0.801	0.760	0.787	0.783	0.710	0.785	0.728	0.759
Round 2	66000	0.652	0.632	0.586	0.622	0.608	0.635	0.590	0.624	0.606	0.602
Round 3	99000	0.641	0.610	0.583	0.605	0.596	0.596	0.584	0.605	0.639	0.559
