# Evaluation of Thin Polymer Overlays for Bridge Decks

Habib Tabatabai  
Konstantin Sobolev  
Al Ghorbanpoor  
Azam Nabizadeh  
Chin-Wei Lee  
Matthias Lind

University of Wisconsin-Milwaukee

WisDOT ID no. 0092-12-06

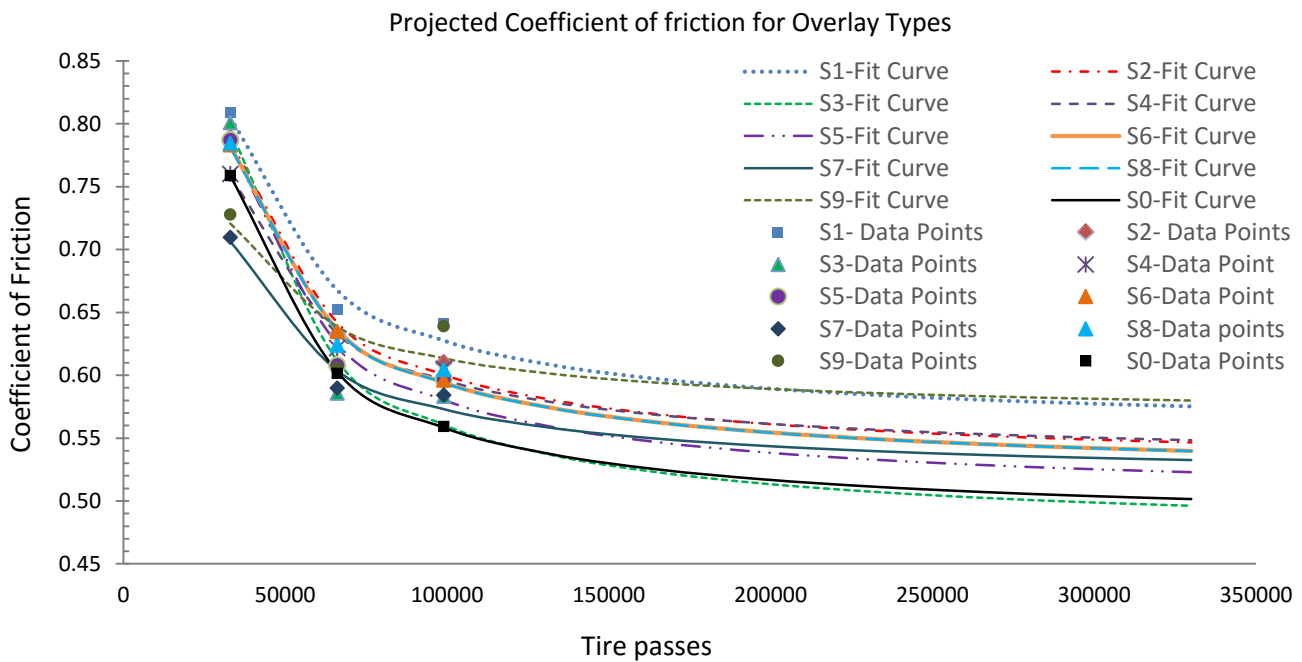
Figure 45. Projected coefficients of friction for various overlay types.

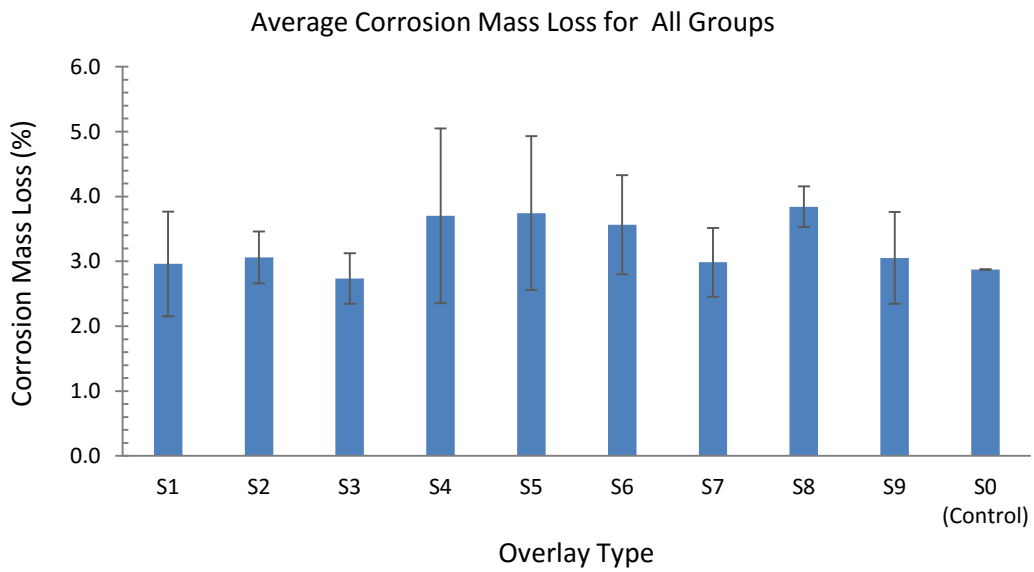
Figure 46. Average corrosion mass loss for all groups.

Average % Change for all Specimens Groups		
Specimen	All. Groups	St. Dev. %
S1	-2.96	0.81
S2	-3.06	0.40
S3	-2.74	0.39
S4	-3.70	1.35
S5	-3.74	1.19
S6	-3.56	0.77
S7	-2.99	0.53
S8	-3.84	0.31
S9	-3.05	0.71
S0 (Control)	-2.87	0.00

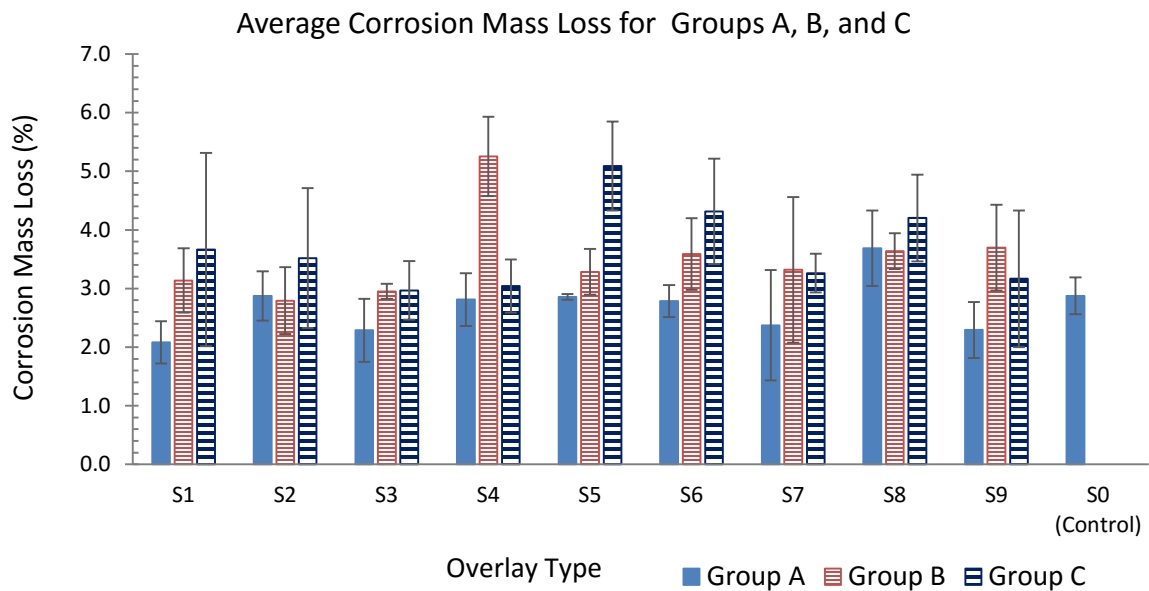
Figure 47. Average corrosion mass loss for Groups A, B, and C.

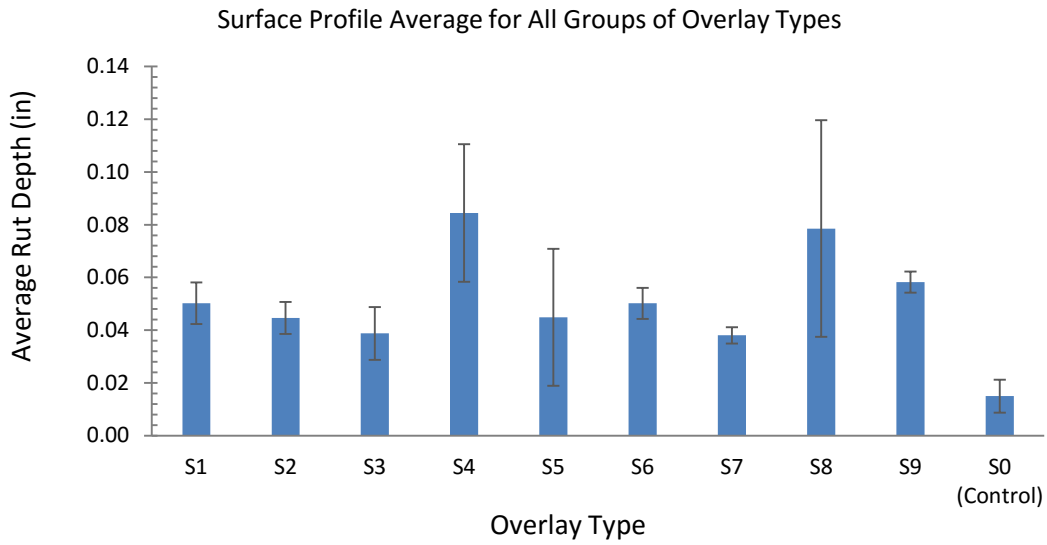
Figure 48. Surface profile average for all groups of overlay types.

<b>Surface profile Average for All Groups</b>		
Specimen	Total Avg. Rut Depth (in)	St. Dev. (in)
<b>S1</b>	0.050	0.008
<b>S2</b>	0.045	0.006
<b>S3</b>	0.039	0.010
<b>S4</b>	0.084	0.026
<b>S5</b>	0.045	0.026
<b>S6</b>	0.050	0.006
<b>S7</b>	0.038	0.003
<b>S8</b>	0.079	0.041
<b>S9</b>	0.058	0.004
<b>S0 (Control)</b>	0.015	0.006

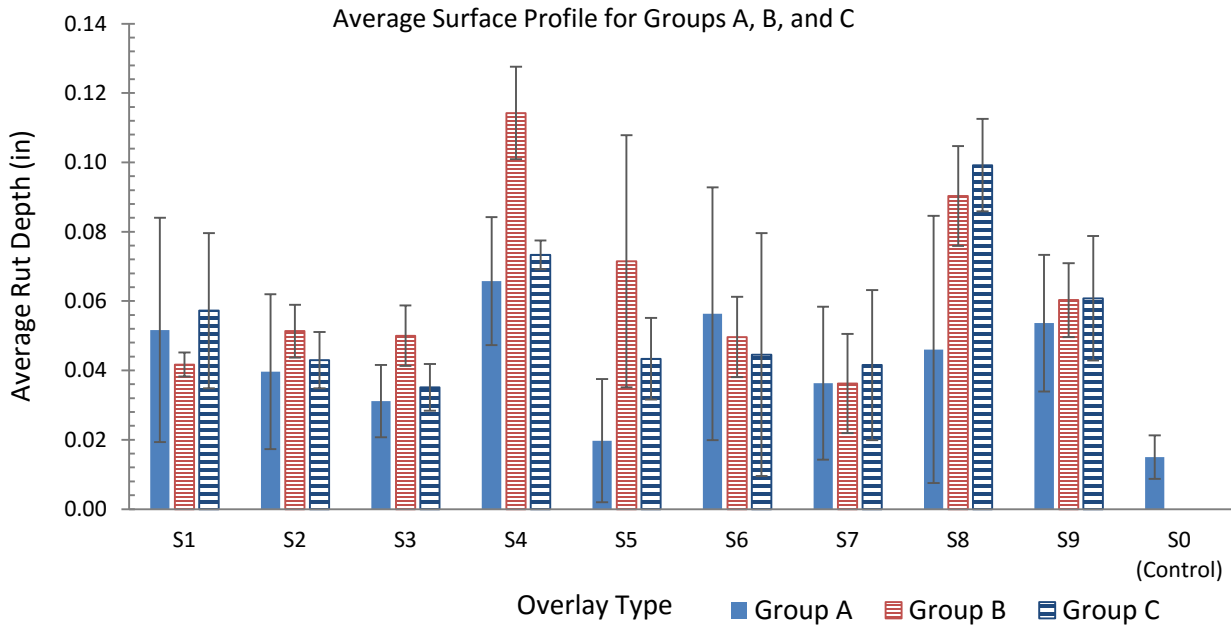
Figure 49. Average surface profile for groups A, B, and C.

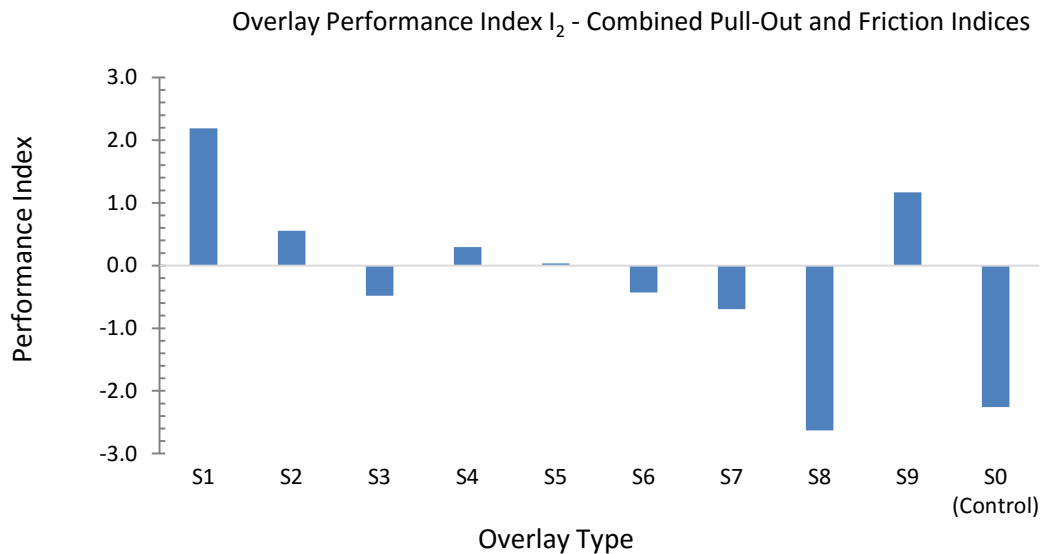
Figure 52. Overlay Performance Index ( $I_2$ ) - Including pull-out strength, and friction indices.

Combined Index $I_2$	
Specimen	Index
S1	2.2
S2	0.6
S3	-0.5
S4	0.3
S5	0.0
S6	-0.4
S7	-0.7
S8	-2.6
S9	1.2
S0 (Control)	-2.3

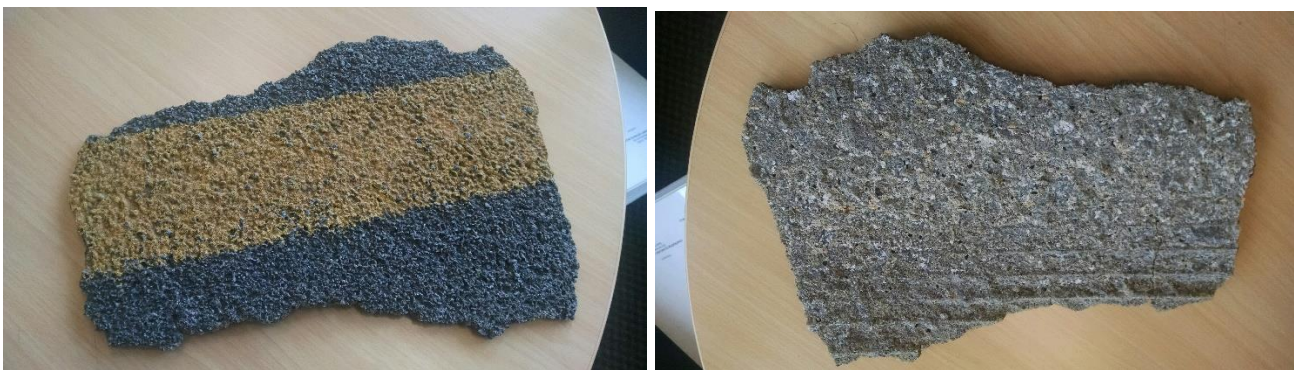
Figure 53. Delaminated multi-lift polyester overlay (from the Marquette Interchange ramp).
