# **Behavior and Design of Cast-in-Place Anchors under Simulated Seismic Loading**

## **Final Report (Volume III)**

### **Headed Anchors in Plastic Hinge Zone of Reinforced Concrete Members**

**July 2013**

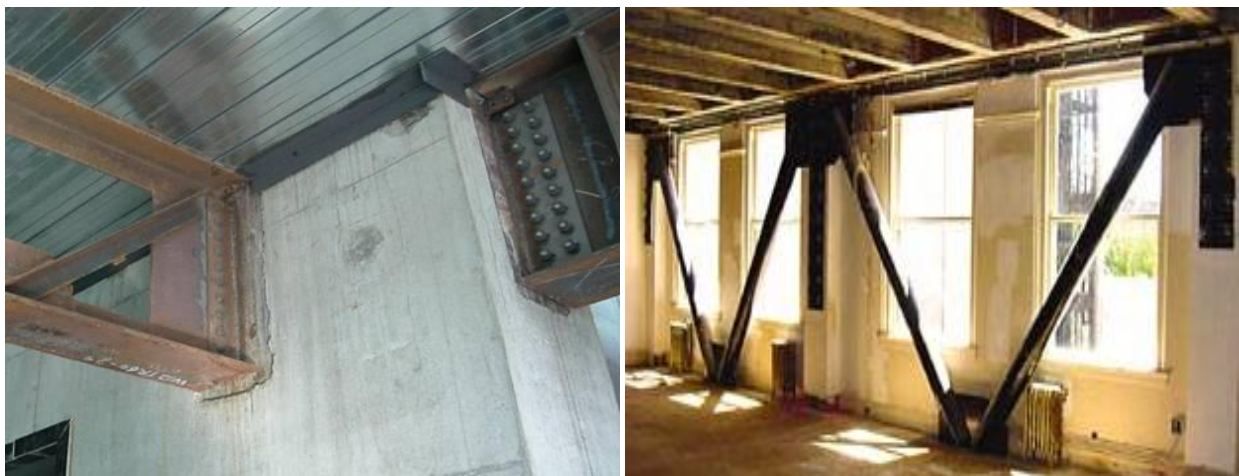
**Figure 1.1: Anchors installed in typical plastic hinge zones**

Anchor connections are often time needed in the regions as shown in Figure 1.1, in which steel girders are connected to the concrete wall or braces are connected to beams and columns. On the other hand, the current building codes (e.g., Appendix D of ACI 318-11) and design guidelines [fib, 2008] are based on experimental tests of anchors cast/post-installed in concrete that experiences controlled minor damage (i.e., crack opening up to around 0.04 in.) [Eligehausen et al., 2006; Pallarés and Hajjar, 2009a, 2009b]. Therefore, engineers are left with no guidance when designing the embedded connections in concrete walls, where substantial concrete damage is expected, as the Appendix D of ACI 318-11 states, “The provisions of Appendix D do not apply to the design of anchors in plastic hinge zones of concrete structures under seismic loads.”

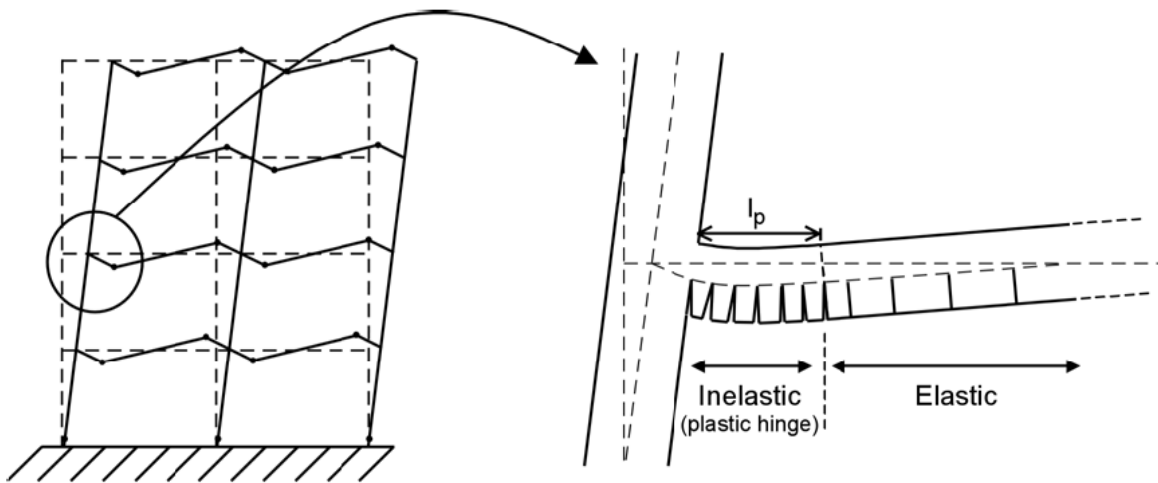
**Figure 1.2: Plastic hinge zones (Hoehler, 2006)**

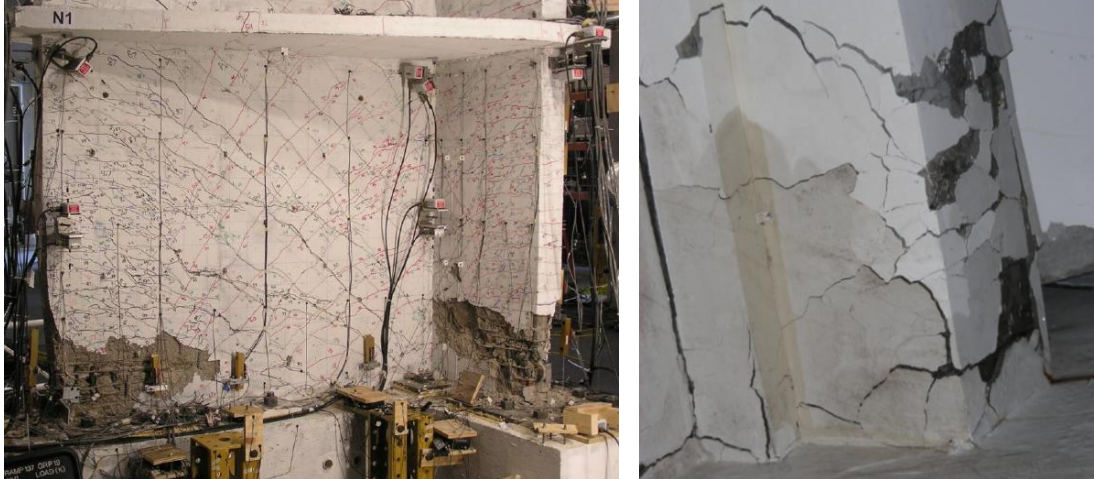
**Figure 1.3: Expected damage in plastic hinge zones of reinforced concrete elements**

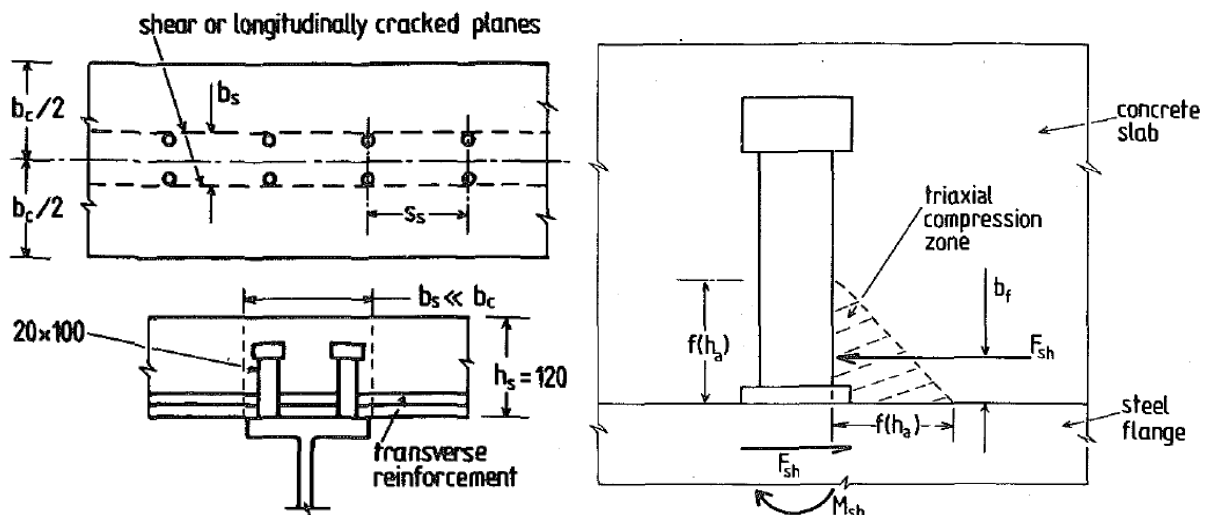
**Figure 2.1: Failure mechanism of shear studs in concrete with longitudinal cracks (Oehlers and Park, 1992)**

and the height affected the overall shear capacity of the studs (see Figure 2.1). Note that these observations are similar to those obtained in Phase II tests of the NEES-Anchor project.

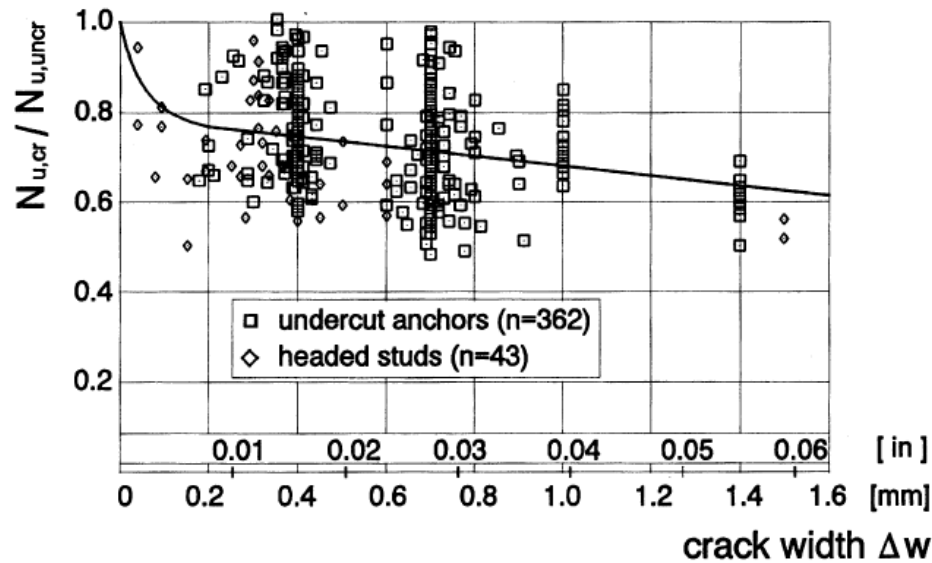
**Figure 2.3: Typical load-displacement curves of headed studs in uncracked and cracked reinforced concrete (concrete cone failure)**

finite element analysis was not able to explain the further capacity reduction when the crack is wider as shown in Figure 2.3.

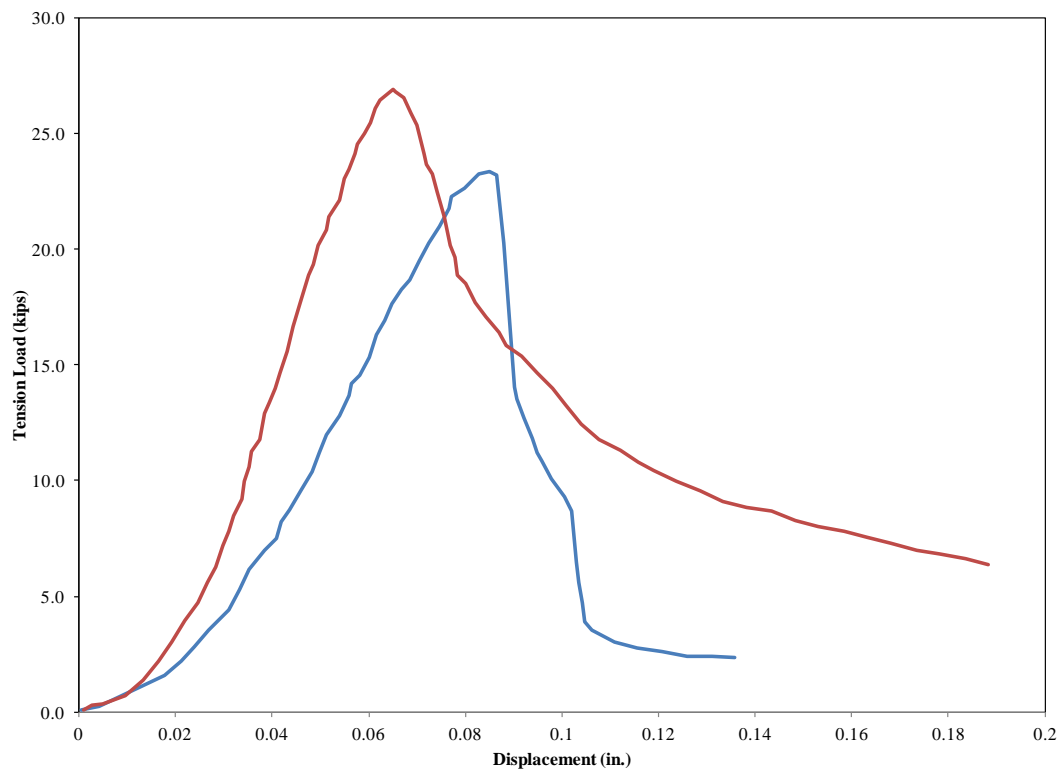
**Figure 2.4: Typical load-displacement curves of headed anchors in uncracked and cracked concrete (concrete cone failure)**

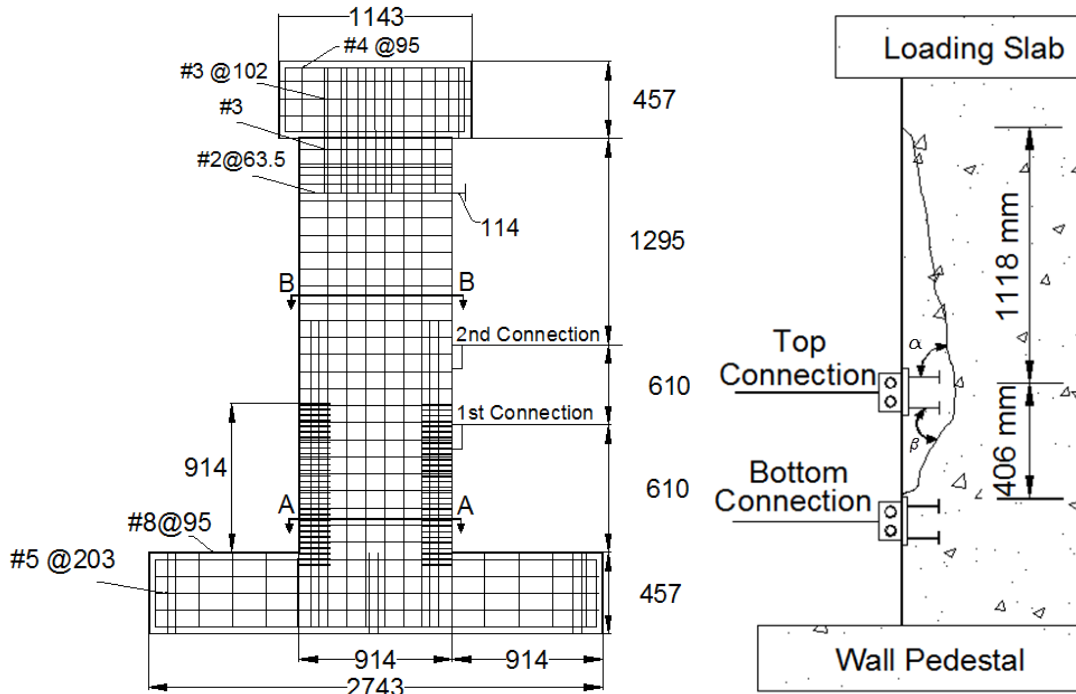
**Figure 2.7: Specimen design and failure modes of anchor connections in RC walls (Shahrooz et al. 2004)**

The plastic hinge zone formed during the test of specimen 1 (a rectangular wall) and the rebar yielding and cracking extended near 6 ft above the foundation. This is roughly two times the section height, which is similar to the code-specified plastic hinge zone in the commentary of provision D3.3.2 (ACI 318-11). Meanwhile the lateral loads applied through the anchor connection in addition to the shear at the wall top as illustrated in Figure 2.8 changed the damage pattern of the wall such that the majority of concrete crushing occurred below the lower connection at 2 ft above the foundation. The bottom connection, which was subjected to cyclic tension, developed ductile behavior despite the damage in concrete around the connection. This may have been attributed to the dense grid of reinforcement at the wall boundary elements as shown in Figure 2.7. The top connection, on the other hand failed by concrete breakout though the concrete developed less damage compared with the bottom connection. Note that the breakout cracks started behind the heads of the studs. This may have been due to the fact the amount of the horizontal reinforcement (6 No. 2 bars) behind the anchor connection was not sufficient such that forced applied to the wall through the anchor connections failed to be further transferred to the rest of the wall.

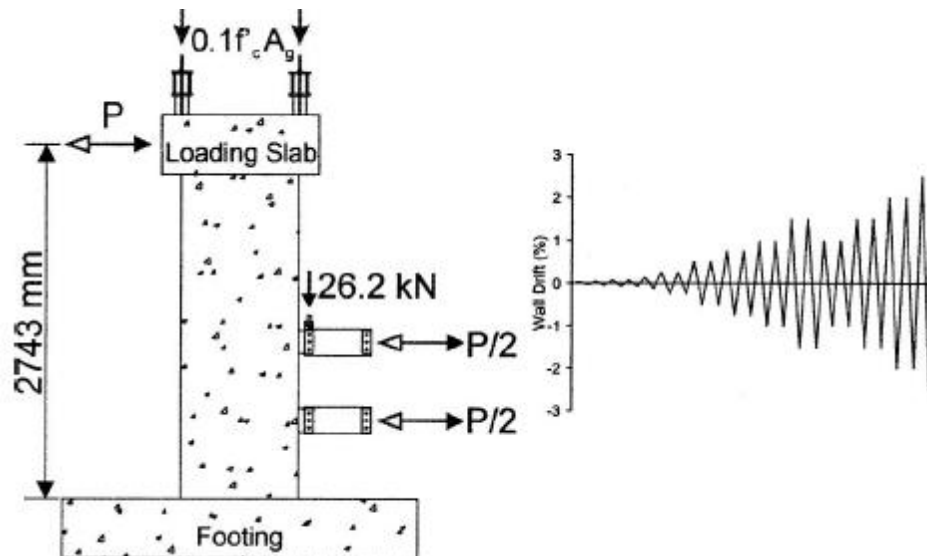
**Figure 2.8: Loading protocol for the anchor connections in RC walls (Shahrooz et al. 2004)**

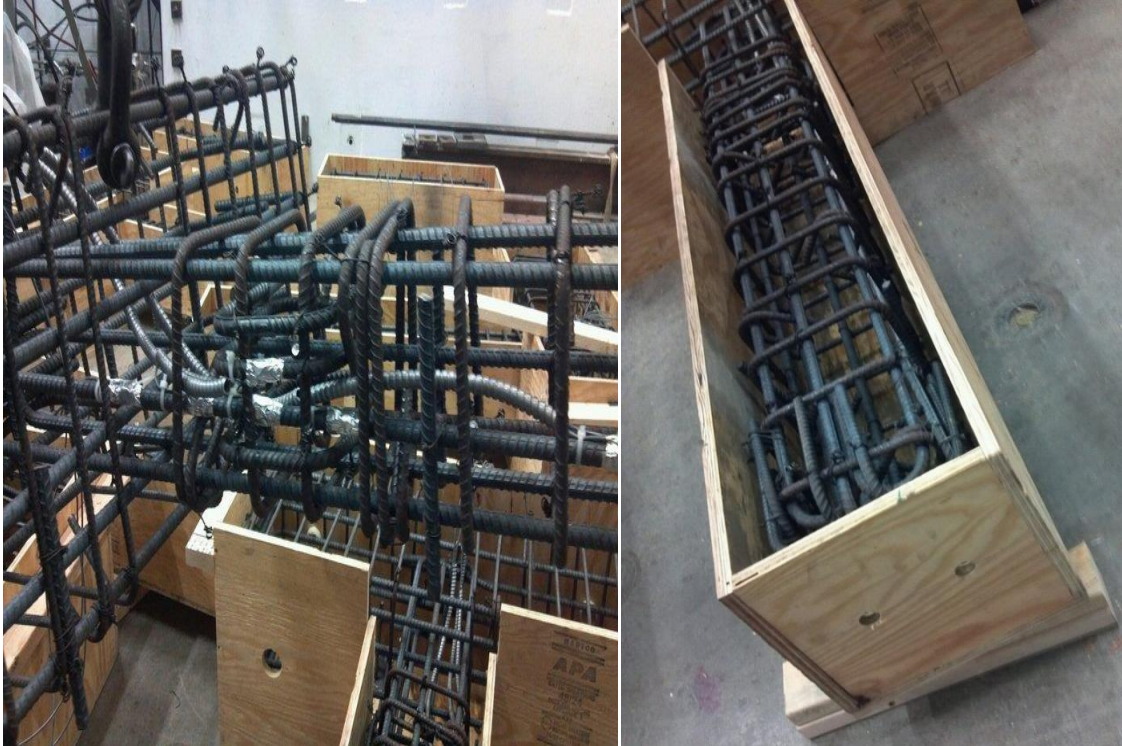
**Figure 3.4: Reinforcing steel cage of Phase V specimens**

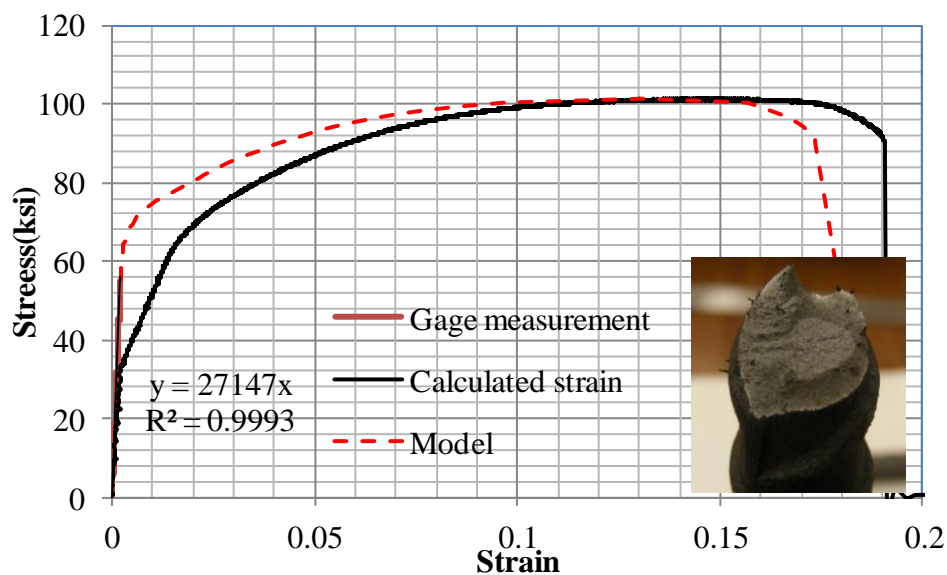
**Figure 3.5: Stress-strain behavior of No. 5 steel reinforcing bars**

The No. 5 reinforcing steel with a nominal yield strength of 60 ksi were used as longitudinal reinforcement. Full-size bars were tested with a gauge length of 8 in. following ASTM A370. The tests were conducted under monotonic displacement control using a MTS loading frame with a 100-kip capacity. Two strain gauges were used in addition to the bar elongation to measure the bar deformation. The obtained stress-strain curves are shown in Figure 3.5.

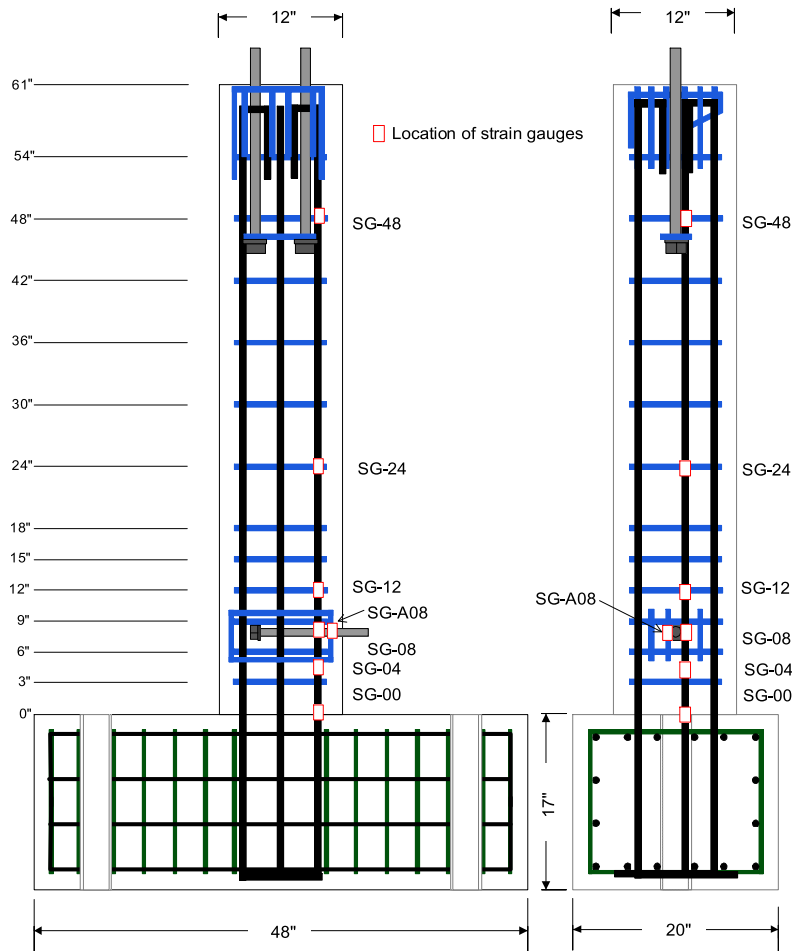
**Figure 3.10: Strain gage locations in Phase V tests**

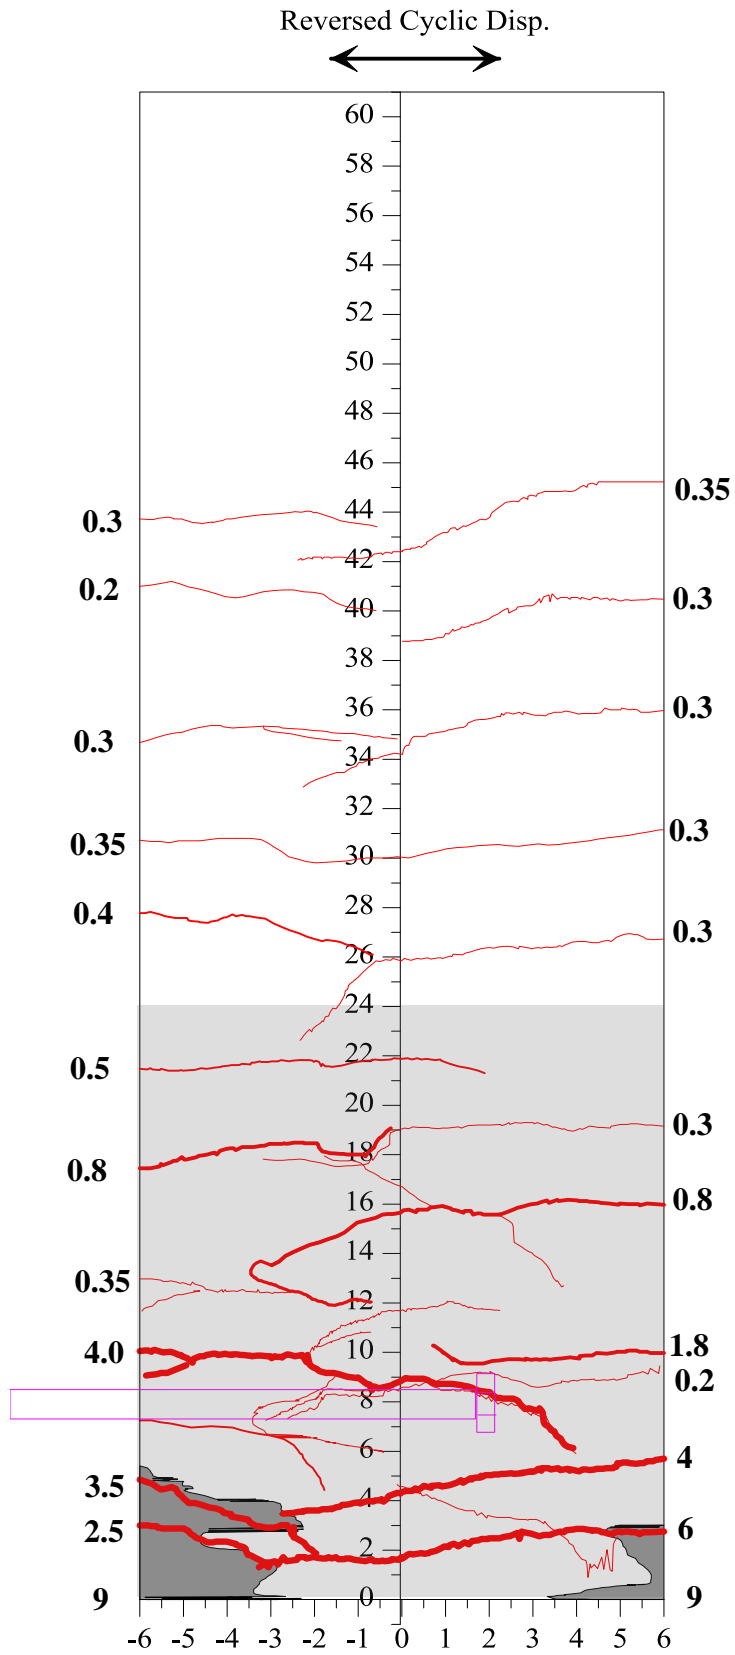
Figure 4.1: Crack patterns and measured crack widths in T2 after  $\pm 4.9$  in loading cycles

Further damage in the plastic hinge zone as well as concrete cover spalling was observed at both sides of the column, when the column was subjected to the group of displacement at 4.9 in. The crack widths are shown in Figure 4.1 after all loading steps are complete for the column. By plotting the crack pattern and crack width developed after the loading cycles 4.9 in., the variation of the crack width from bottom to top through the height of the column was observed as crack cycling proceeded. The crack width at the base rose up to 9.0 mm at both north and south sides. A couple of other major cracks are observed within the plastic hinge zone. However, it was believed that the crack did not pass through the core concrete around the anchor head. The cracks are distributed evenly and the largest crack width was 0.4 mm outside the plastic hinge zone. .

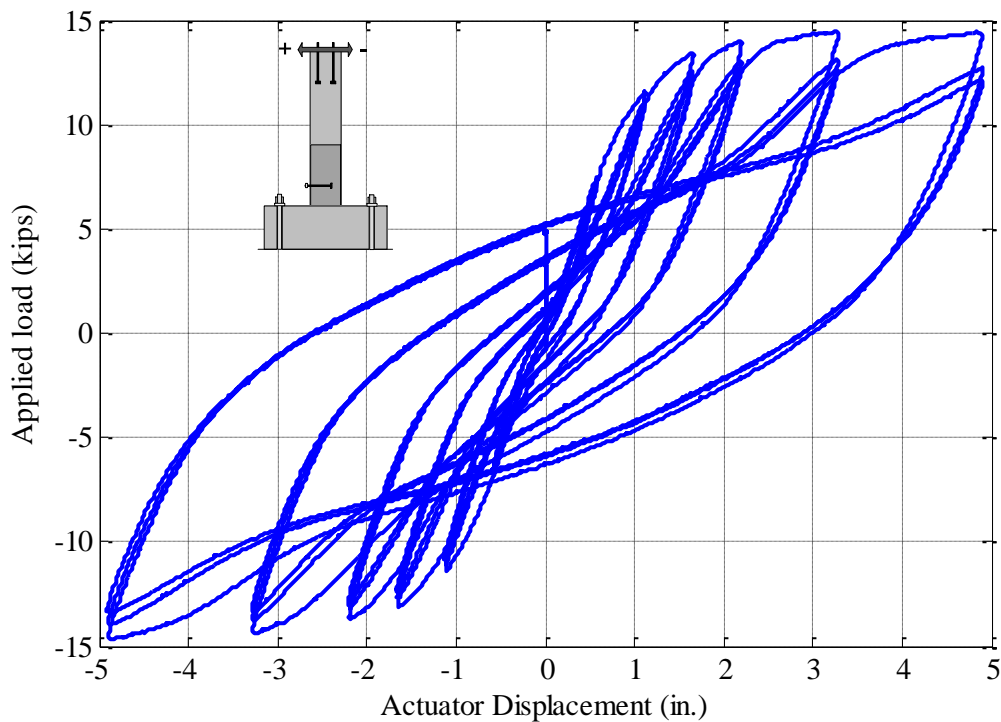
**Figure 4.2: Load vs. actuator displacement curves of column T2**

The cyclic behavior of column T2 is shown in Figures 4.2 and 4.3. The column had a typical hysteretic behavior, similar to others in the literature. The load vs. actuator displacement curves indicated that the actuator was able to follow the predefined loading history. However, the reaction frame was not rigidly tied with the specimen; therefore the actuator displacements were somewhat different from the true column displacement measured using a string pot. The true column behavior indicates a 0.8 in. difference between the two displacement measurements. This difference may have been attributed to 1) the specimen was not rigidly fixed with the reaction frame; 2) the reaction frame allowed additional movement; 3) the oversized holes on the loading plate allowed 1/8 in. difference.

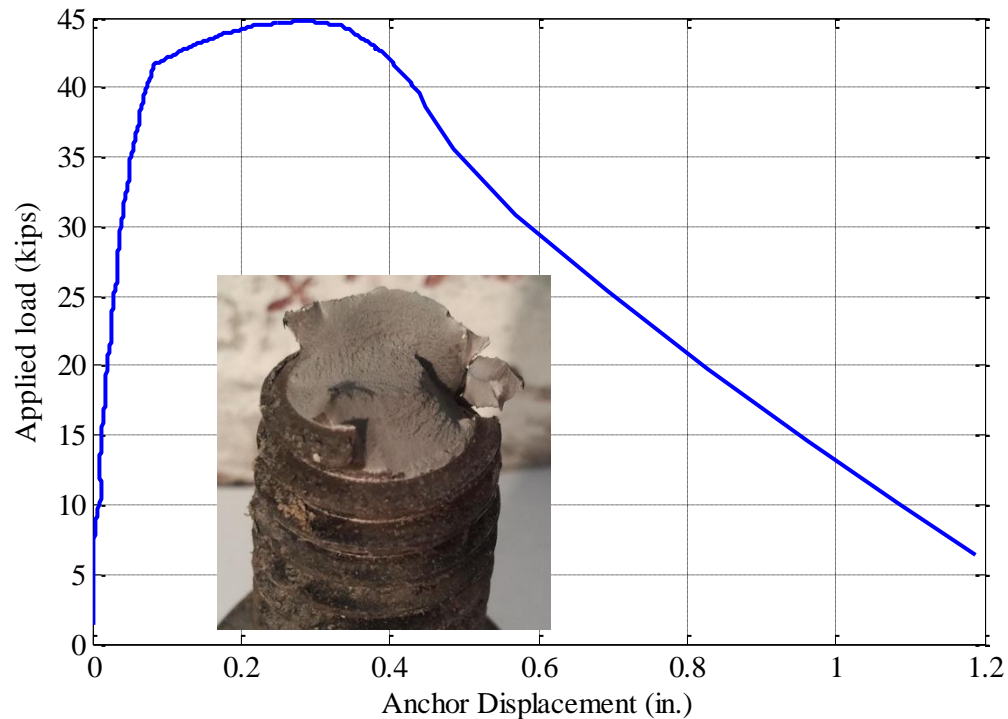
**Figure 4.6: Load vs. displacement of anchor in tension (T2) after cyclic loading**

Concrete within the plastic hinge zones was extensively cracked as shown in Figure 4.7 before the anchor was subjected to tensile loading. These existing cracks before anchor loading changed the development of a breakout cracks: instead of a concrete breakout cone as usual in un-reinforcement concrete, the crack surfaced out to the side faces due to a limited side edge distance as shown in Figure 4.7. The inclined cracks were soon arrested by a flexural crack in the column outside the local confined concrete as shown in Figure 4.8. The flexural crack, which was likely through the entire column section, became the weakest link in the loading resisting system. The concrete column attempted to shift out when the anchor load was at its peak. The dry friction provided higher capacity than the anchor fracture in tension as shown in Chapter 3; therefore the failure mode was anchor bolt fracture as indicated by the load vs. displacement curve in Figure 4.6.

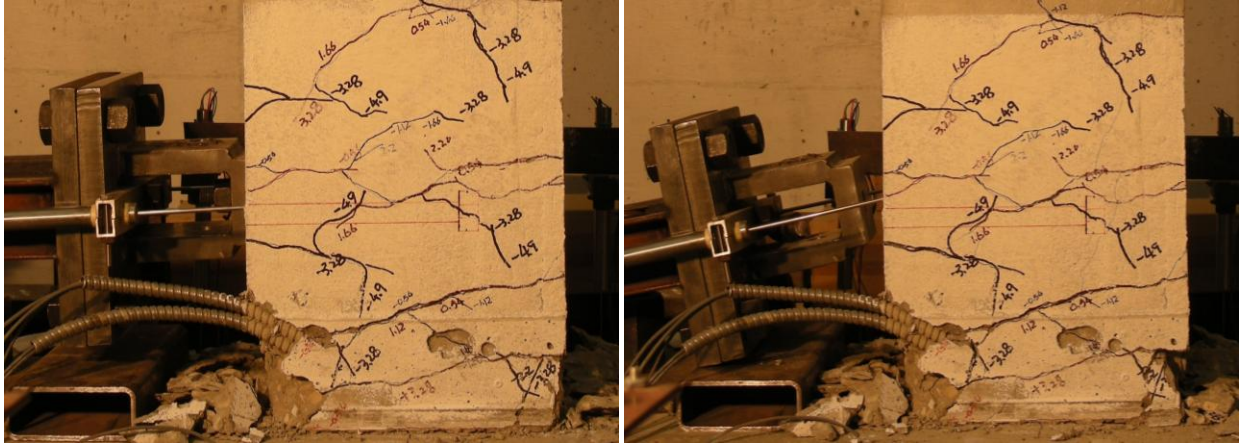
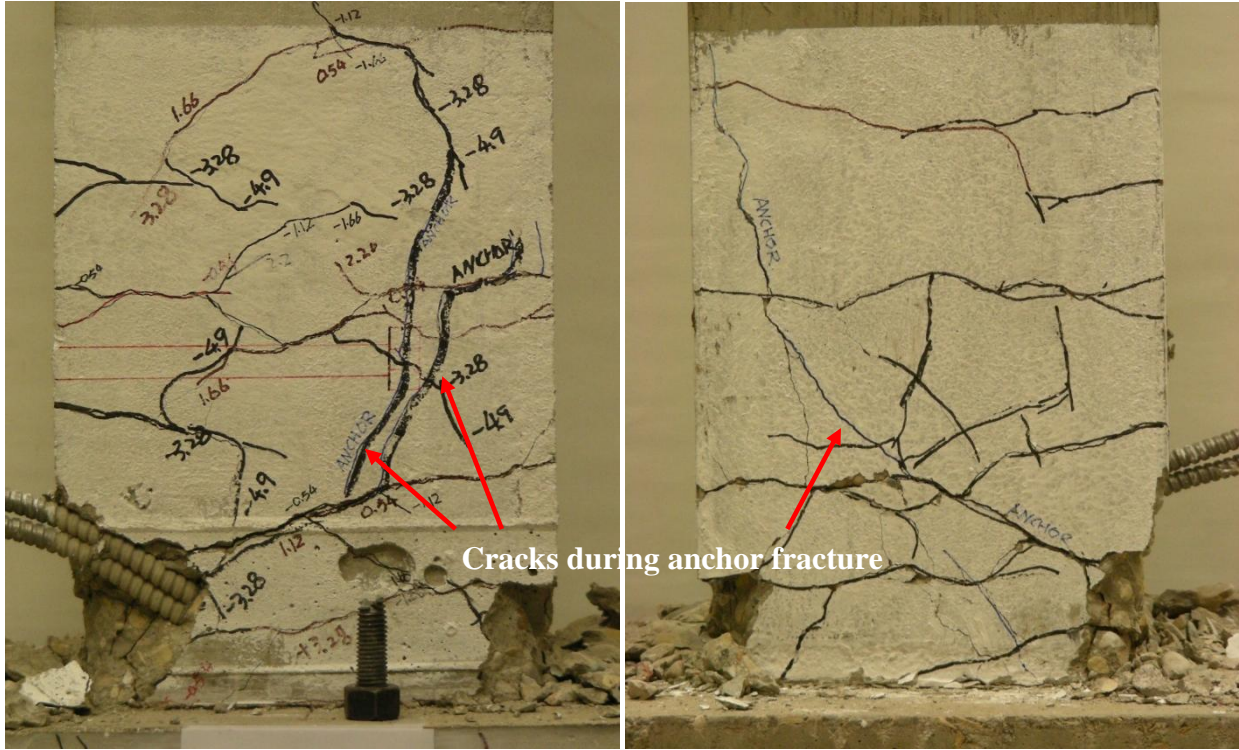
Figure 4.7: Comparison of concrete cracking patterns

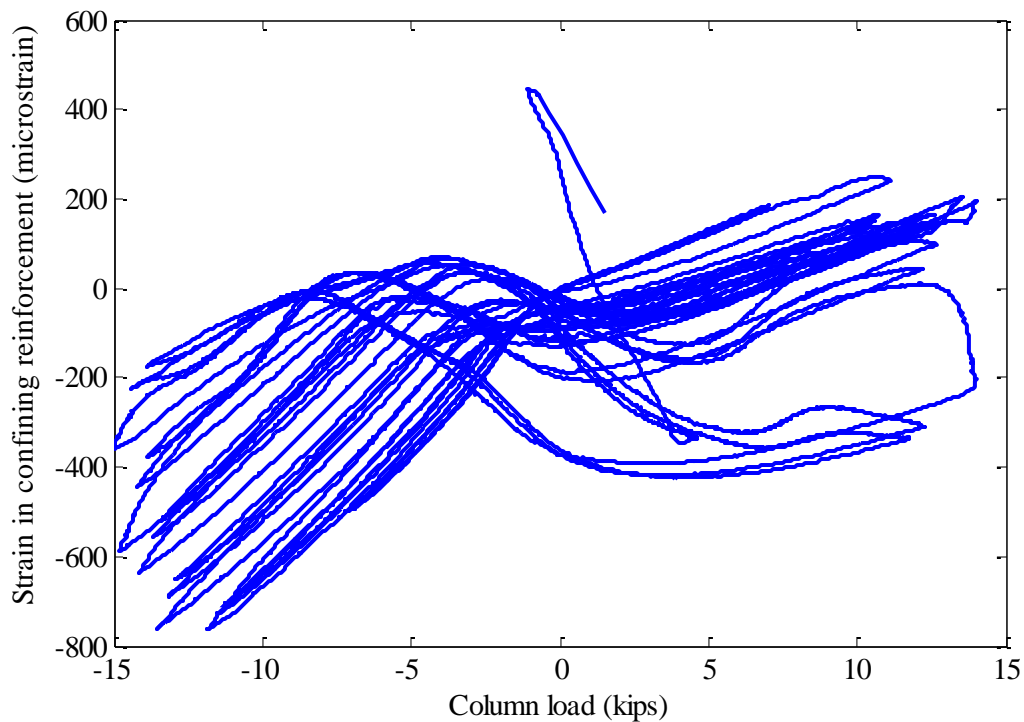
**Figure 4.9: Strain in the confining reinforcement (T2)**

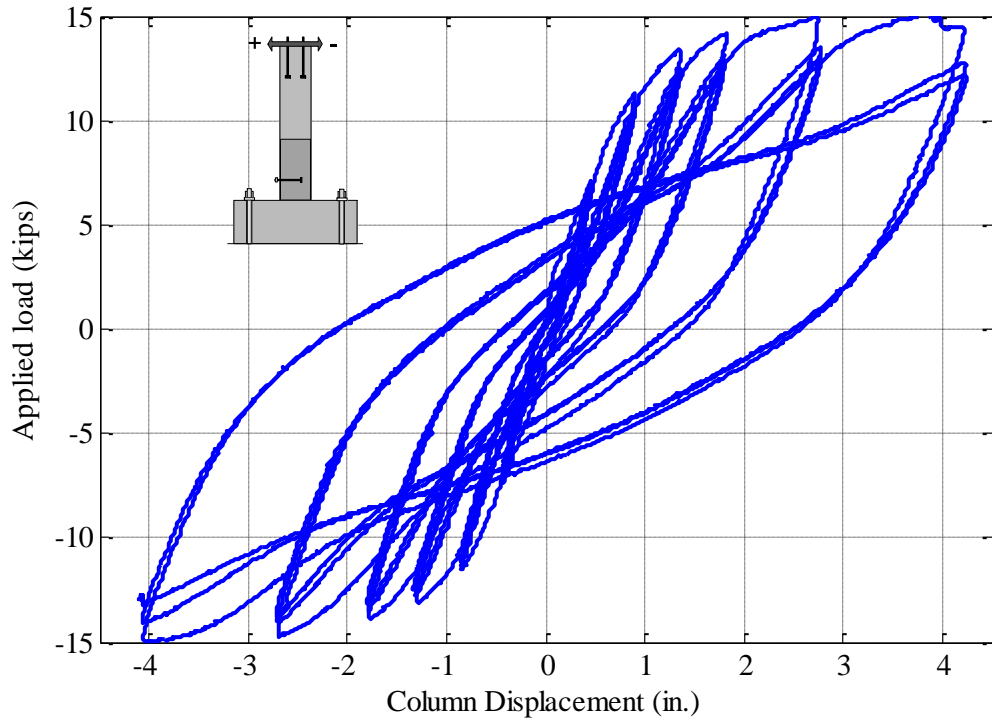
**Figure 4.10: Load vs. column displacement of the column T3**

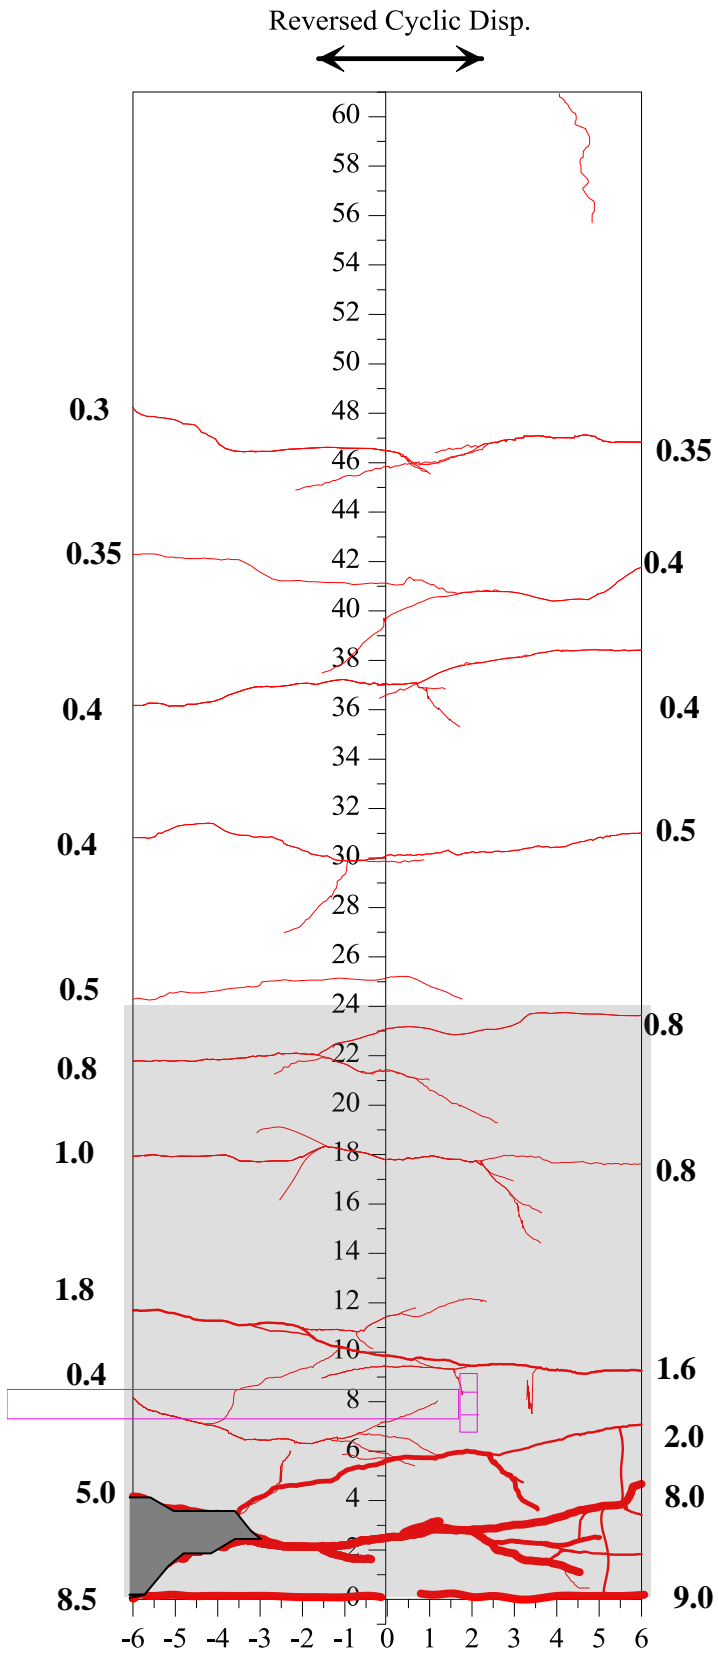
Figure 4.12: Crack patterns in Column T3 and measured crack widths after cyclic loading

Comparison of the crack growth and crack density under various cyclic loading levels was plotted in Figure A.14. Most cracks concentrated in the plastic hinge zone at the end of the last cyclic loading. The crack width at the base opened up to 9 mm while the major crack below the embedded anchor had a width of about 8 mm, as shown in Figure 4.12.

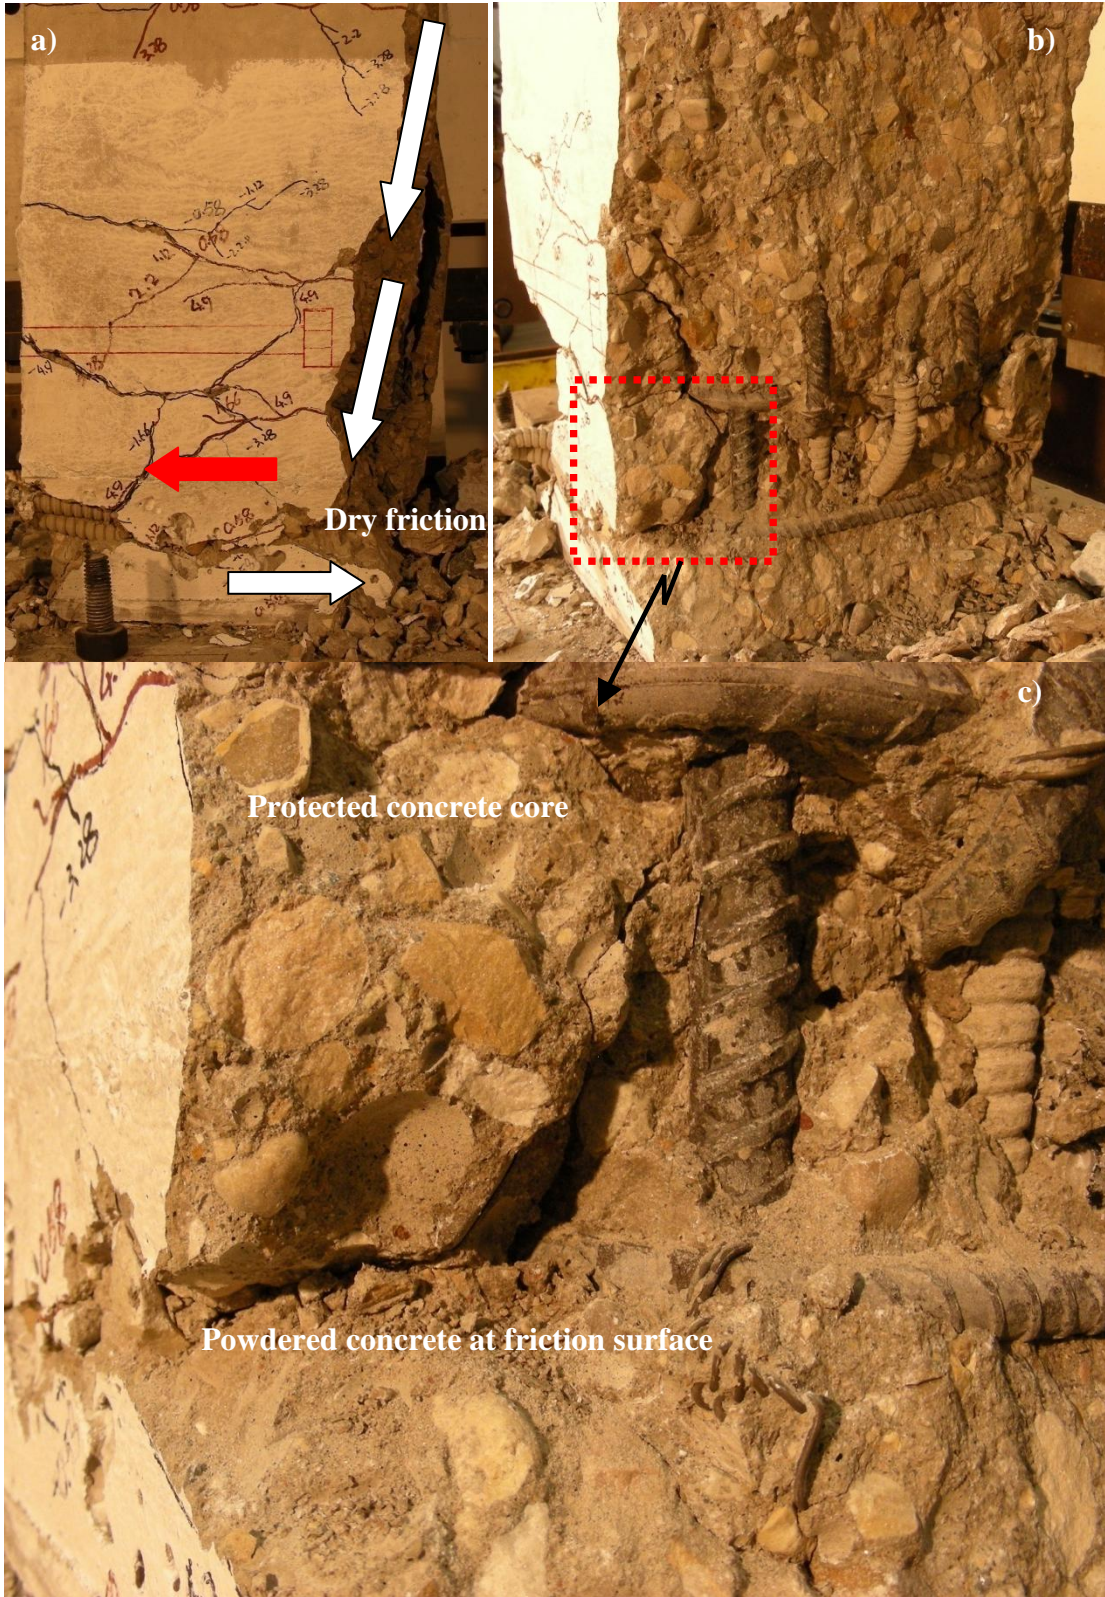
**Figure 4.15: Evidence of final failure and load transfer path (T3)**

At 44-kip targeted load, the actuator did not reach the 44 kips, instead, it went unloading at about 43.6 kips. The actuator displacement increased notably, indicating that the anchor steel was yielded, as shown in Figure 4.13. The third cycle of loading showed that the anchor was able to achieve 43.9 kips. In this group of loading, the displacement increase (from actuator reading) was higher than the last two groups. Monotonic tension was applied after the cyclic loading. The anchor bolt was able to carry a tension load of 43.99 kips, which is slightly smaller than the capacity of the anchor subjected to monotonic loading. The similar behavior indicated that the concrete core was well protected by anchor reinforcement, as shown Figure 4.15c.

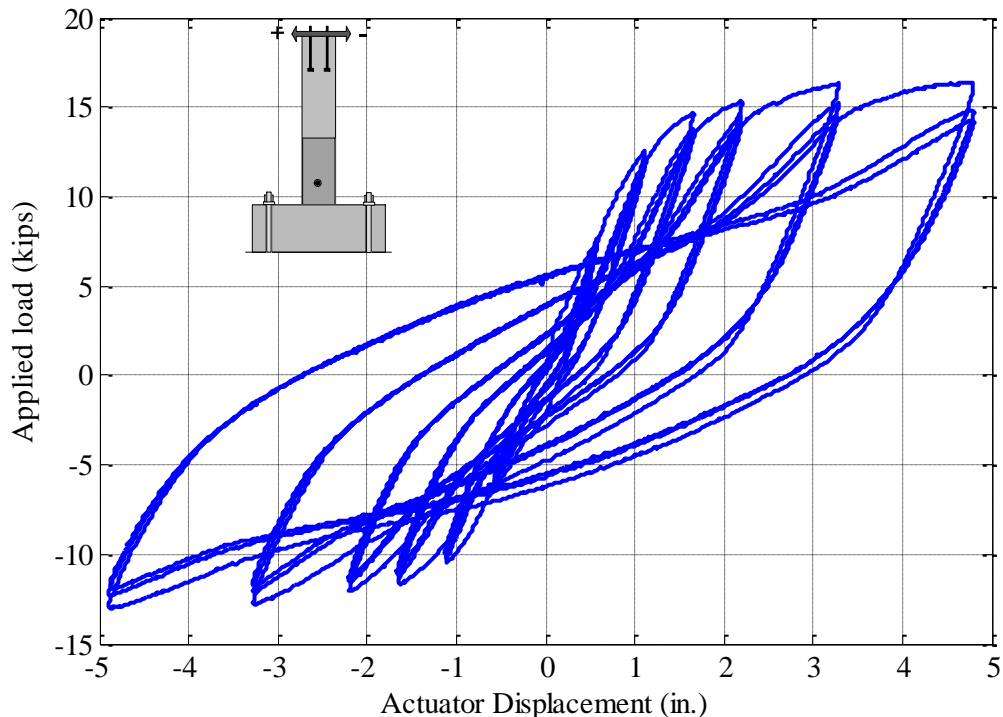
**Figure 4.16: Load vs. actuator displacement for Specimen S1**

This was the first shear test. The column was subjected to cyclic loading before the two single anchors were loaded in monotonic shear. The column behavior is shown below: the load vs. actuator displacement curves in Figure 4.16 and the load vs. column displacement curves in Figure 4.17. The column had a initial offset (3/4 in. away from the actuators), therefore the load vs. displacement curves are not symmetric and the maximum displacement was  $\pm 4.8$  in.

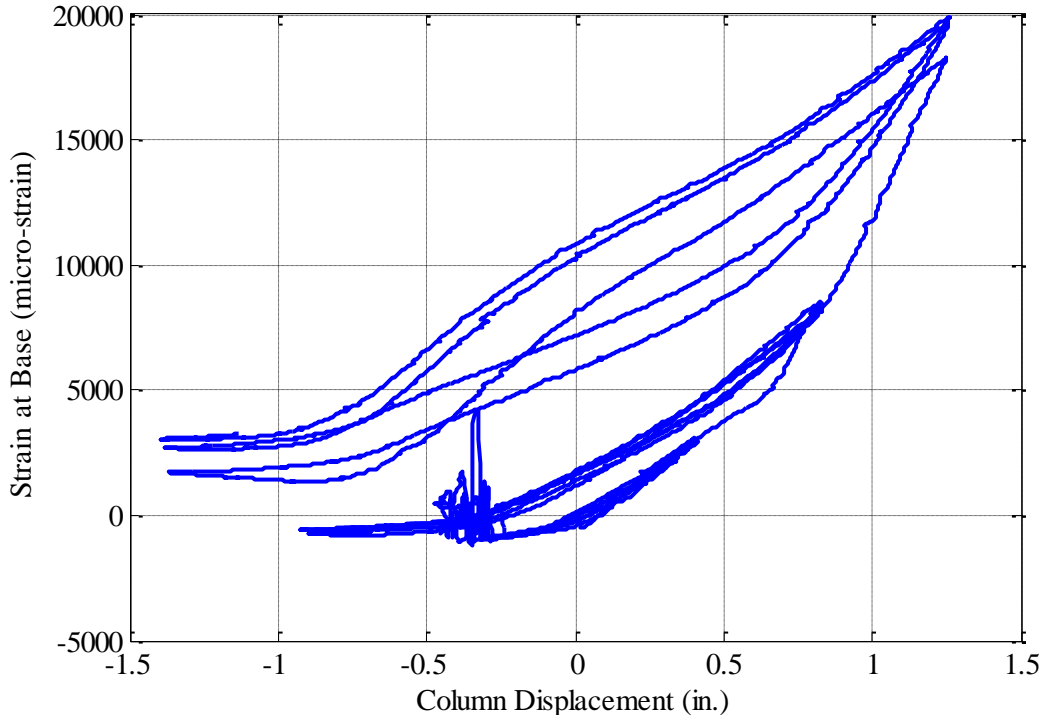
**Figure 4.18: Strain development at column base in Specimen S1**

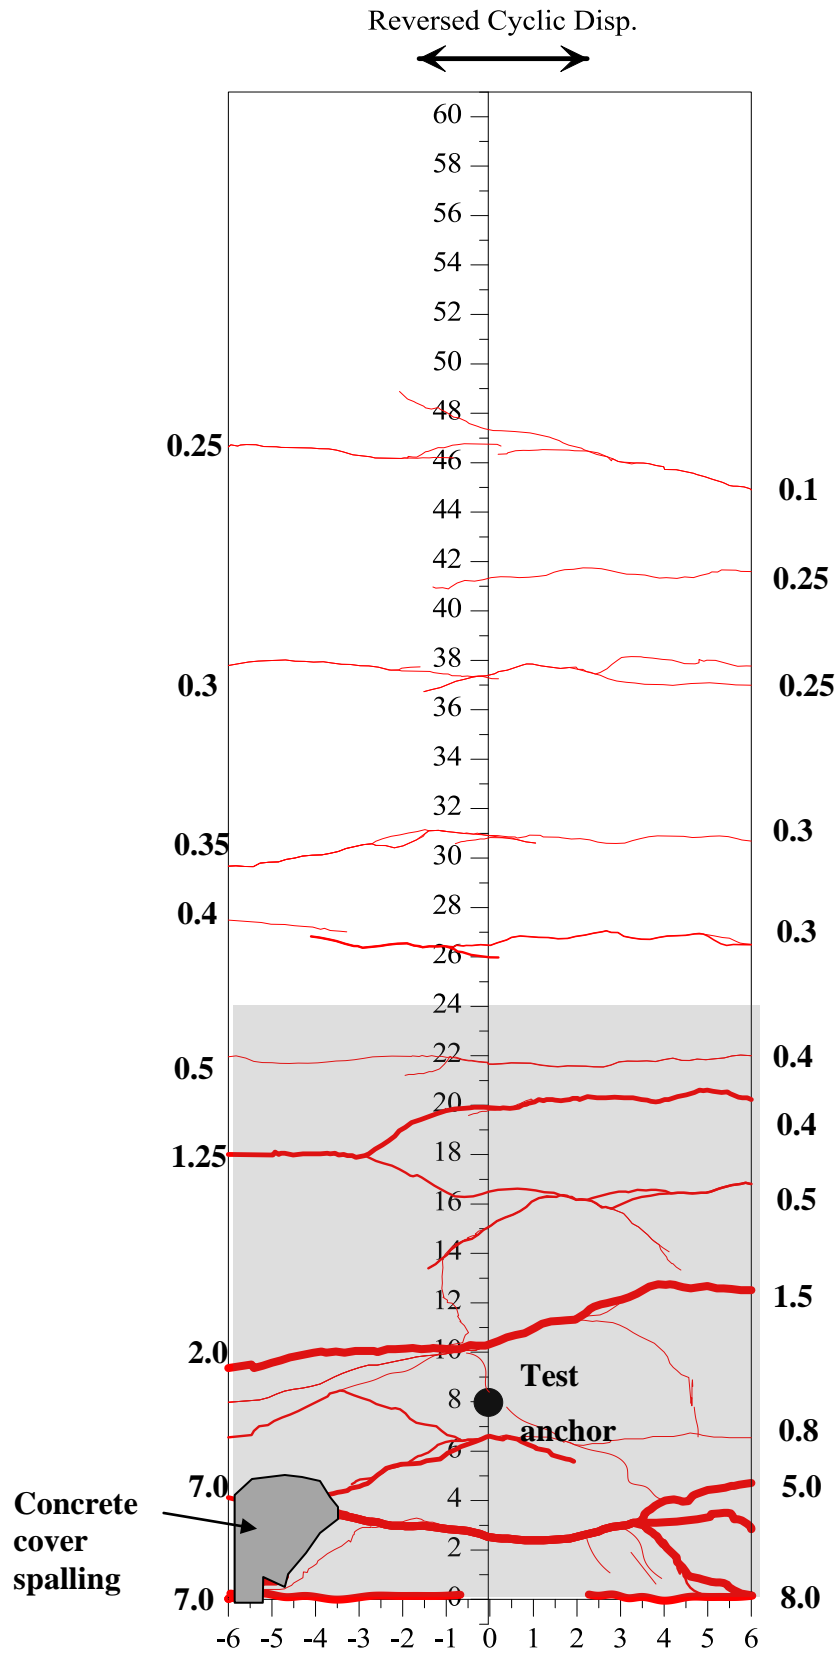
Figure 4.20: Crack patterns and measured crack widths after  $\pm 4.8$  in loading (S1)

Comparison of the crack growth and crack density under various cyclic loading levels was plotted in Figure A.21. The flexural cracks firstly developed at the base and within the plastic hinge zone. Small flexural cracks were then observed at higher location with the increase of the loading level. The cracks widened and propagated upon further loading, in particular, at the plastic hinge zone. Most cracks concentrated in the plastic hinge zone at the end of the last cyclic loading. The crack width at the base opened up to 8 mm while the major crack at 4 in. above the base had a width of about 7 mm, as shown in Figure 4.20. Outside the plastic hinge zone, the flexural cracks were evenly distributed and the maximum crack width, measured at the surface of concrete, was 0.4 mm.

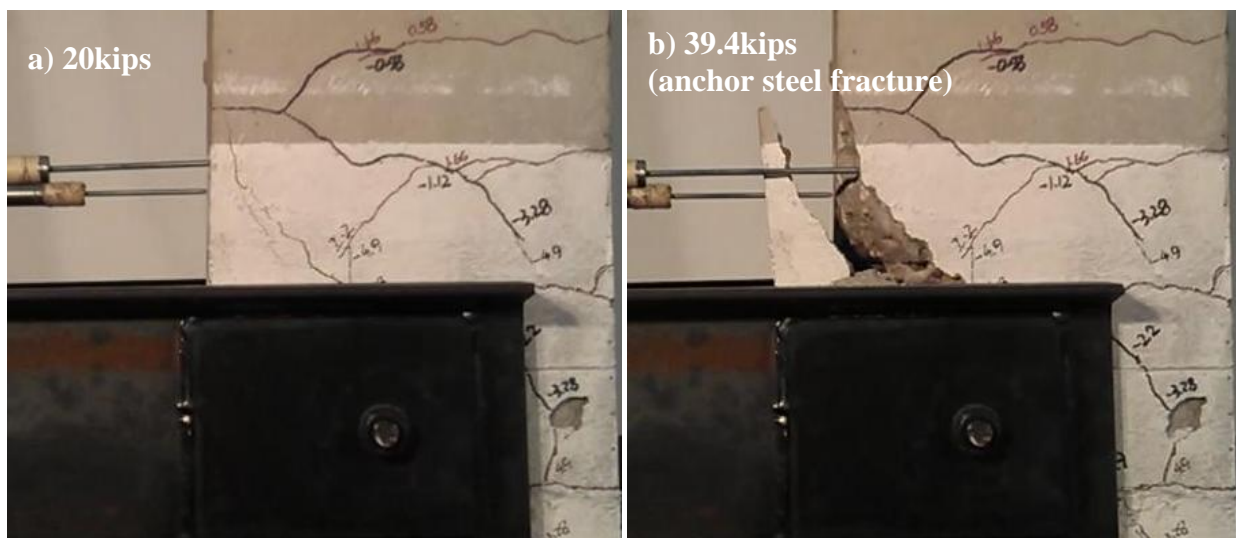
**Figure 4.22: Crack pattern during the process of anchor loading (S1)**

The observation of the crack growth and crack propagation near the anchors was not available because of the loading plate. The observation of concrete (cover) breakout cracks was only available after they extended outside of the load plate, as shown in Figure 4.22.

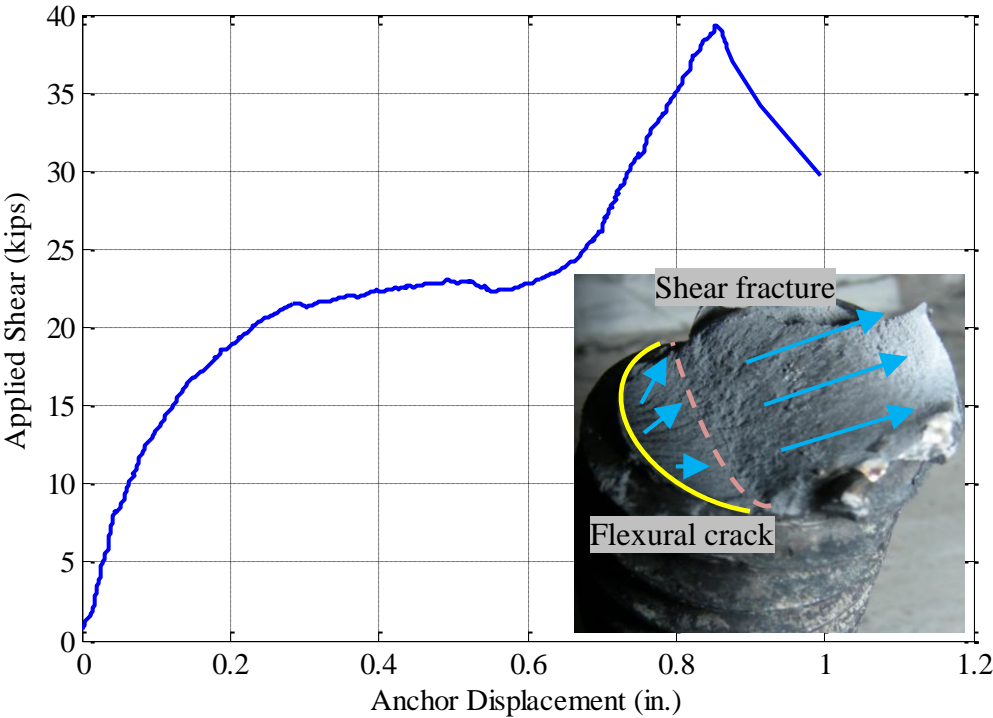
**Figure 4.23: Behavior of two single anchors in monotonic shear (S1)**

The behavior of the two single anchors subjected to monotonic shear is shown in Figure 4.23. The plot contains the combine behavior from the two single anchors. The anchors behaved elastically till about 7.5 kips, beyond which the slope reduced significantly, indicating the first cracks and crush of concrete in front of the anchors. The concrete breakout crack showed up at east surface of the column, when the anchors were loaded at 20 kips, as shown in Figure 4.22a. An after-test inspection indicated that the concrete cover on the east side was pushed out starting from an existing vertical cracks, and then the cover cracks bent out at an angle about 35 degree, as shown in Figure 4.24a. At the same time, the concrete cover cracks were arrested by the existing flexural cracks and the cracked concrete pieces were not significantly crushed, as shown in Figure 4.24b. This created a higher stiffness for the west anchor. The west anchor might have been subjected to a larger shear compared with the east side anchor, which experienced much bending deformation.
