# **Behavior and Design of Cast-in-Place Anchors under Simulated Seismic Loading**

## **Final Report (Volume III)**

### **Headed Anchors in Plastic Hinge Zone of Reinforced Concrete Members**

**July 2013**

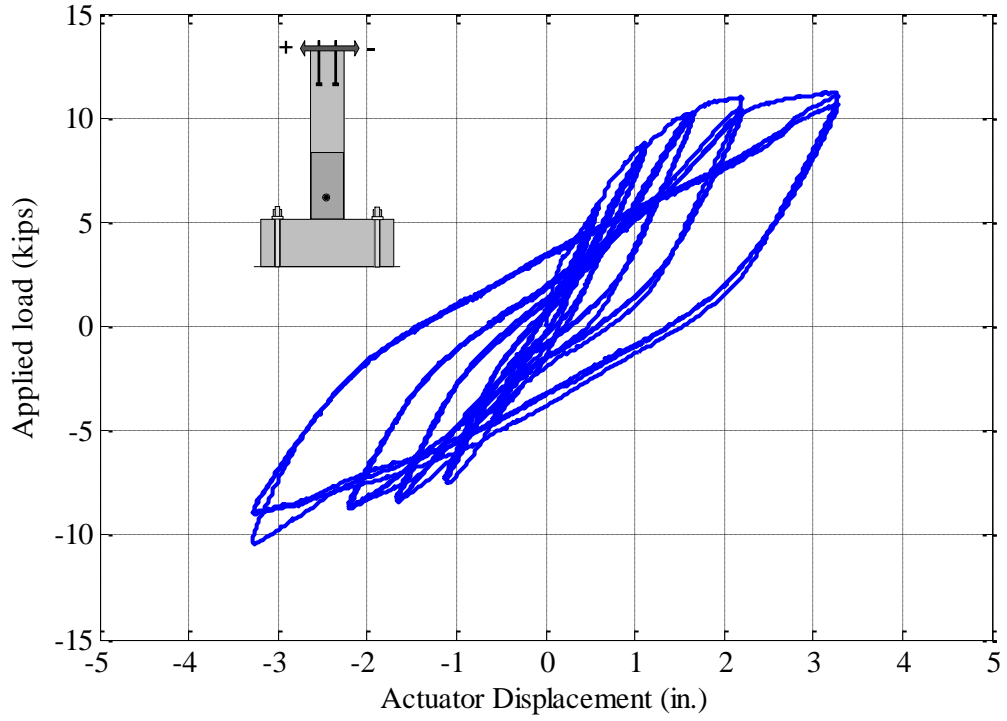
**Figure 4.25: Load vs. actuator displacement for Specimen S2**

The behavior of Column S2 is plotted in Figures 4.25 and 4.26. The values in the load vs. actuator displacement curves will be referenced in the following discussion while the load vs. column displacement shows the actual behavior. Note that the anchors were simultaneously loaded with the column, therefore, the loads detected by the top actuator were affected by the force applied to the anchors. One the other hand, because the displacements of the anchors were directly monitored using two LVDT's, the anchor behavior was deemed not affected by the column loading. The behavior of the two single anchors in shear is plotted in Figures 4.27 and 4.28. Again the values in the load vs. anchor command displacement curves will be cited in the discussion.

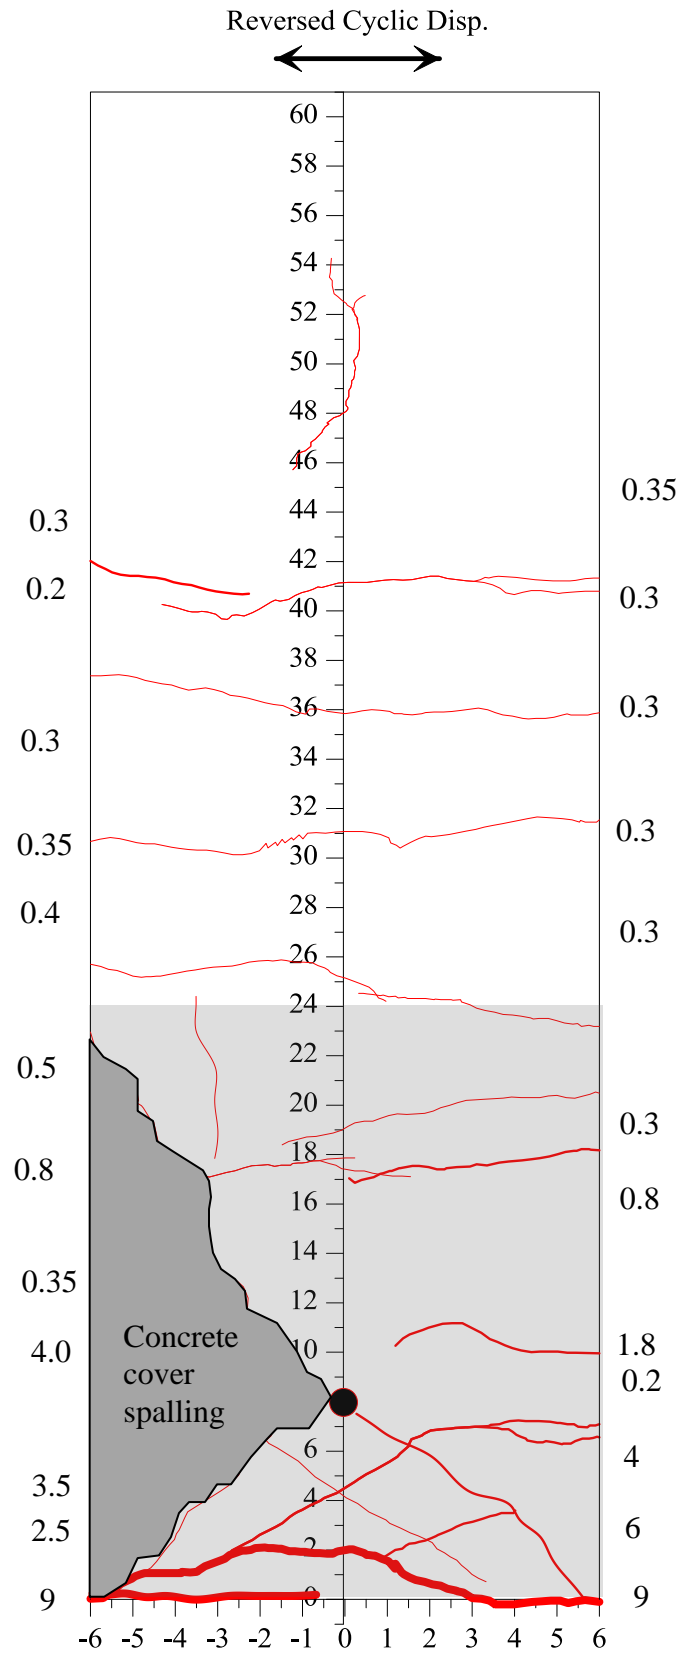
**Figure 4.29: Crack patterns of column S2 and measured crack widths**

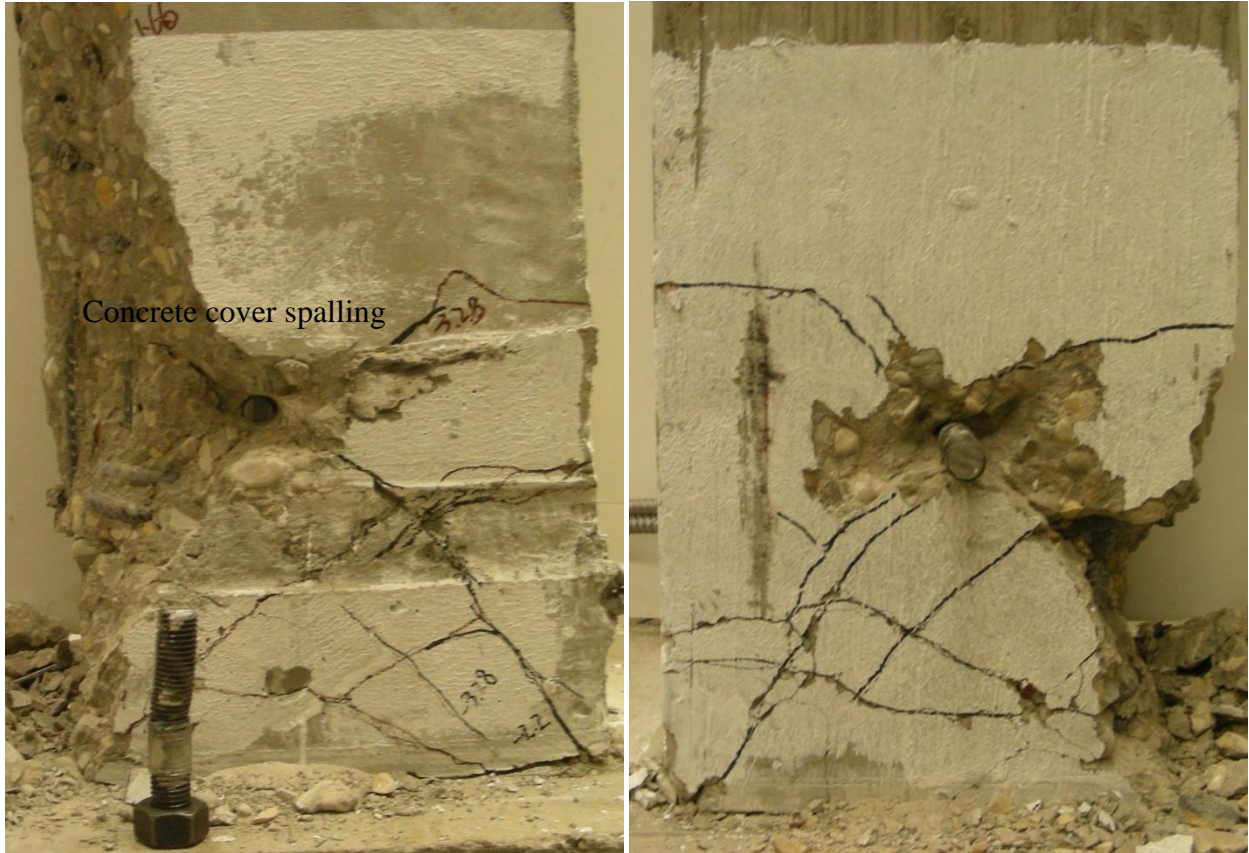
Figure 4.30: Crack pattern after anchor fracture by shear (S2)

As compared to the peak value of 39.4 kips in monotonic loading, anchor rods failed at the east side by fracture in shear under a loading of 30 kips. The other rod at the east side was also bent at the same time. Concrete breakout cone at the east side, as observed in Figure A.27, was totally pushed away during the anchor fracture toward the peak load. The well confined concrete core with the proposed anchor reinforcement allowed the embedded anchors to fully develop their capacity, even though concrete in plastic hinge zone was suffered from damaged and most. It confirmed that the anchor can be installed in the plastic hinge zone or similar situation where concrete was suffered from severe damaged if the suitable anchor reinforcement has been introduced as stated in Phase II and III.

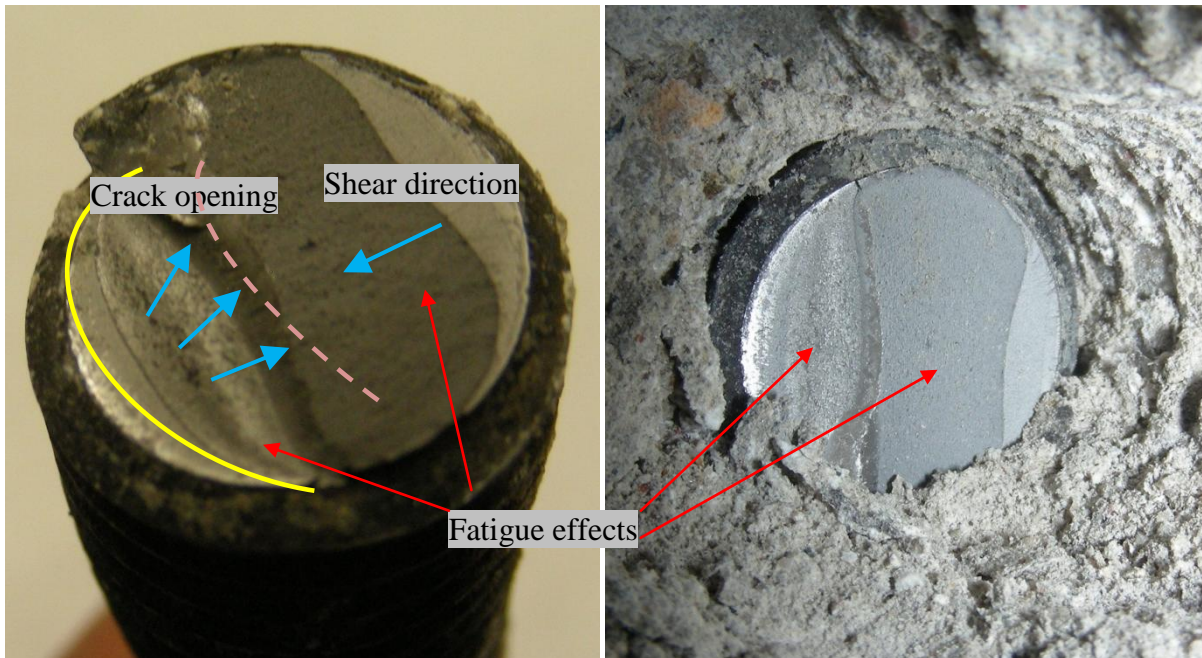
Figure 4.31: Fracture of the anchor rod in Specimen S2

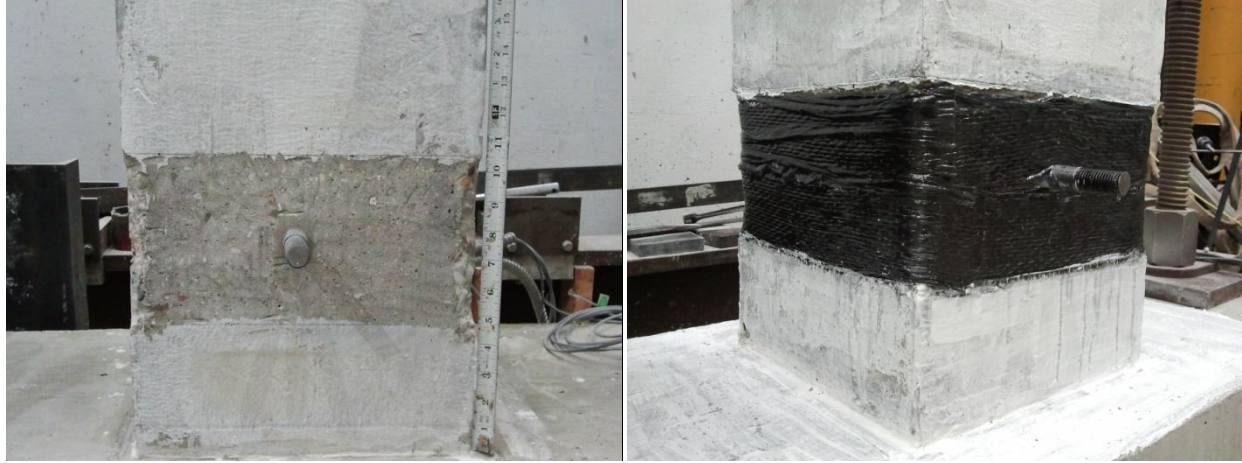
**Figure 4.32: FRP wrapping of Specimen S3**

The QuakeWrap product is developed mainly for structural strengthening. The FRP strips were wrapped around the column and overlapped by 12 in. on the North side of the column. The bond property between the concrete and the FRP strips was not known; therefore the overlapping was expect to hold the concrete cover from spalling. This test was in exploratory nature, and further studies are needed to fully develop the external reinforcement for anchor systems.

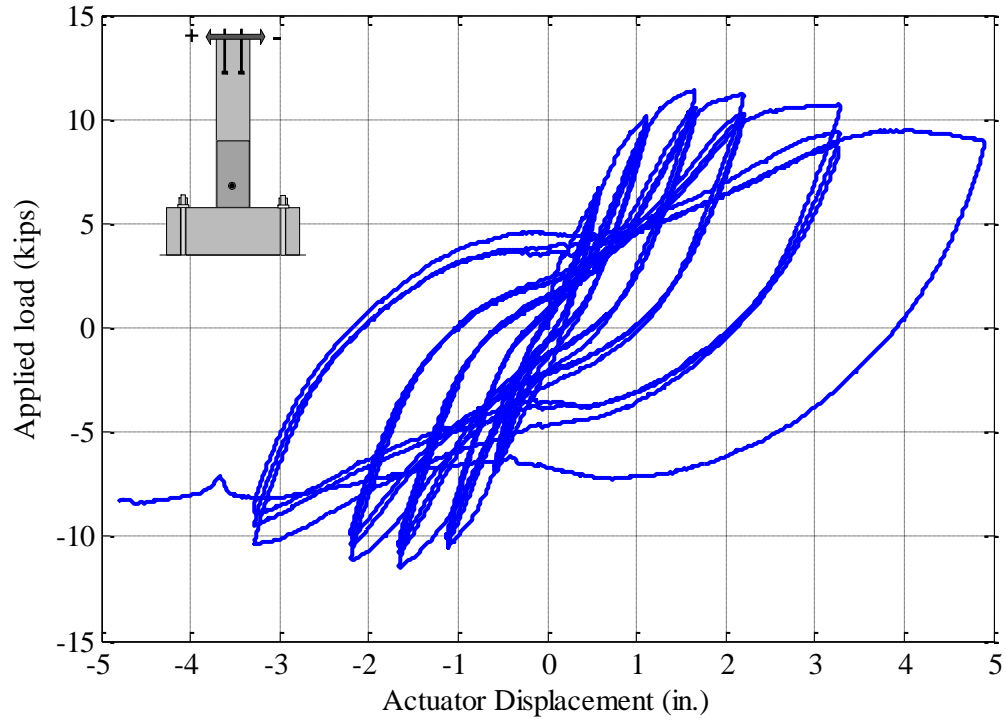
**Figure 4.33: Load vs. command displacment for Specimen S3**

With the loads from the anchors at 8 in. above the base, the peak loads captured by the top actuator were lower than the actual loading capacity, which is similar to the test of Column S2. In addition, the high load applied to the anchors actually caused apparent degrading behavior. Additional study is needed to confirm this observed behavior, especially for those structures that incorporate damping devices.

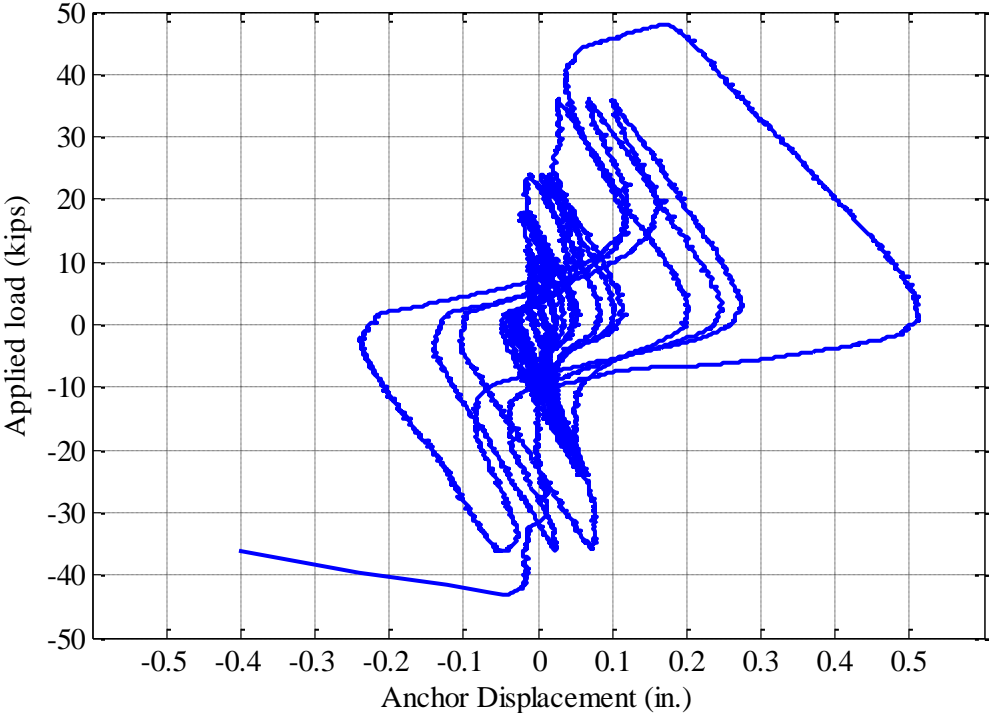
**Figure 4.35: Load vs. column displacement for Specimen S3**

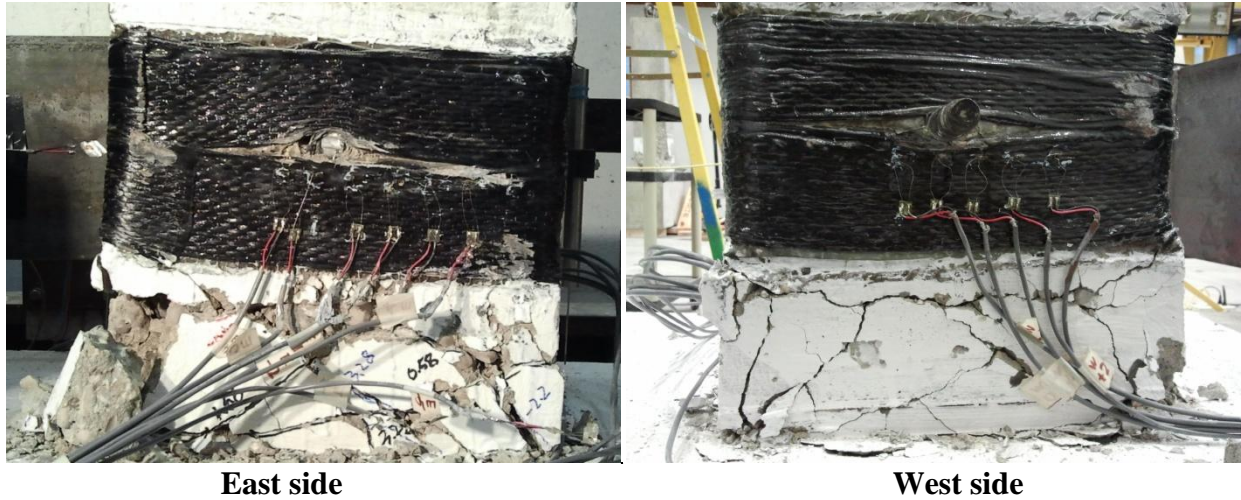
**Figure 4.36: Damaged column in Specimen S3**

In general, the anchors had an increased displacement during the second and third cycles compared with the first loading cycle. This indicated that concrete experienced damage, specifically concrete in front of the anchors crushed as shown in Figure 4.36. The anchors were able to carry 49 kips in the first cycle of 49 kips, which however had created damage to the anchor bolts. This large load likely initiated flexural cracks, which reduced the area of the anchor shafts. When the anchors were loaded in the negative direction, the reduced cross section caused fracture to the east side anchor, and shown in Figure 4.36.

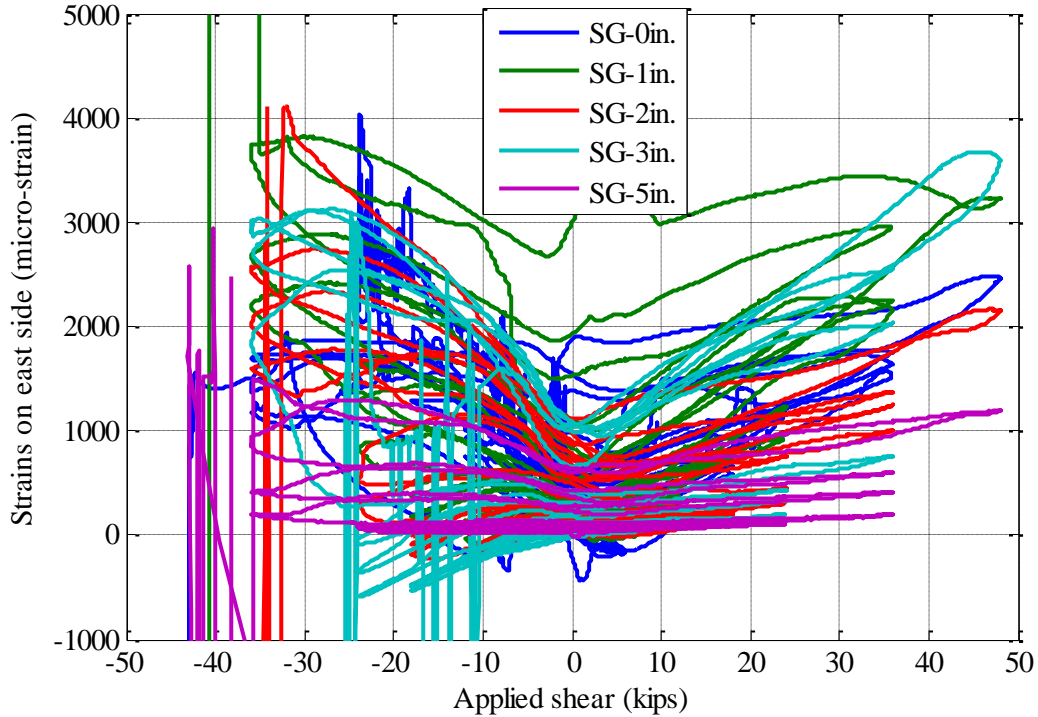
**Figure 4.37: Measured strains on east side FRP in Specimen S3**

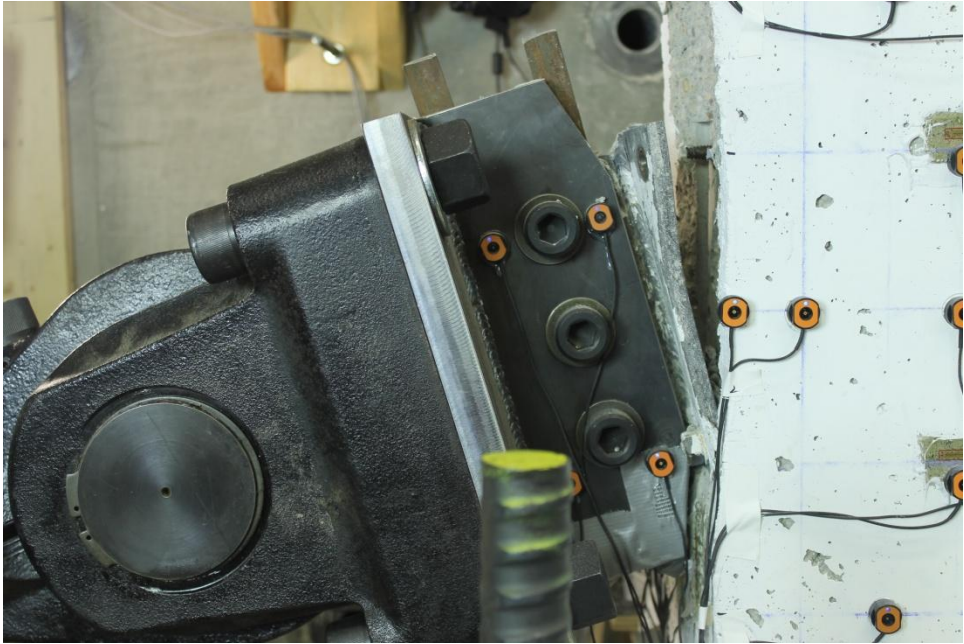
**Figure 5.11: Photo of left anchor connection at failure**

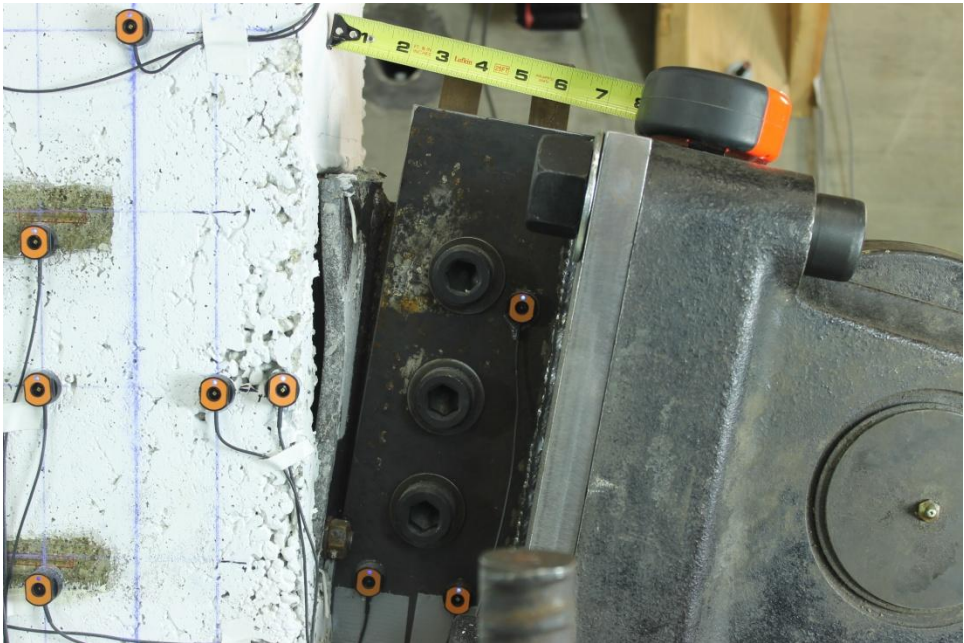
**Figure 5.12: Photo of right anchor connection at failure**

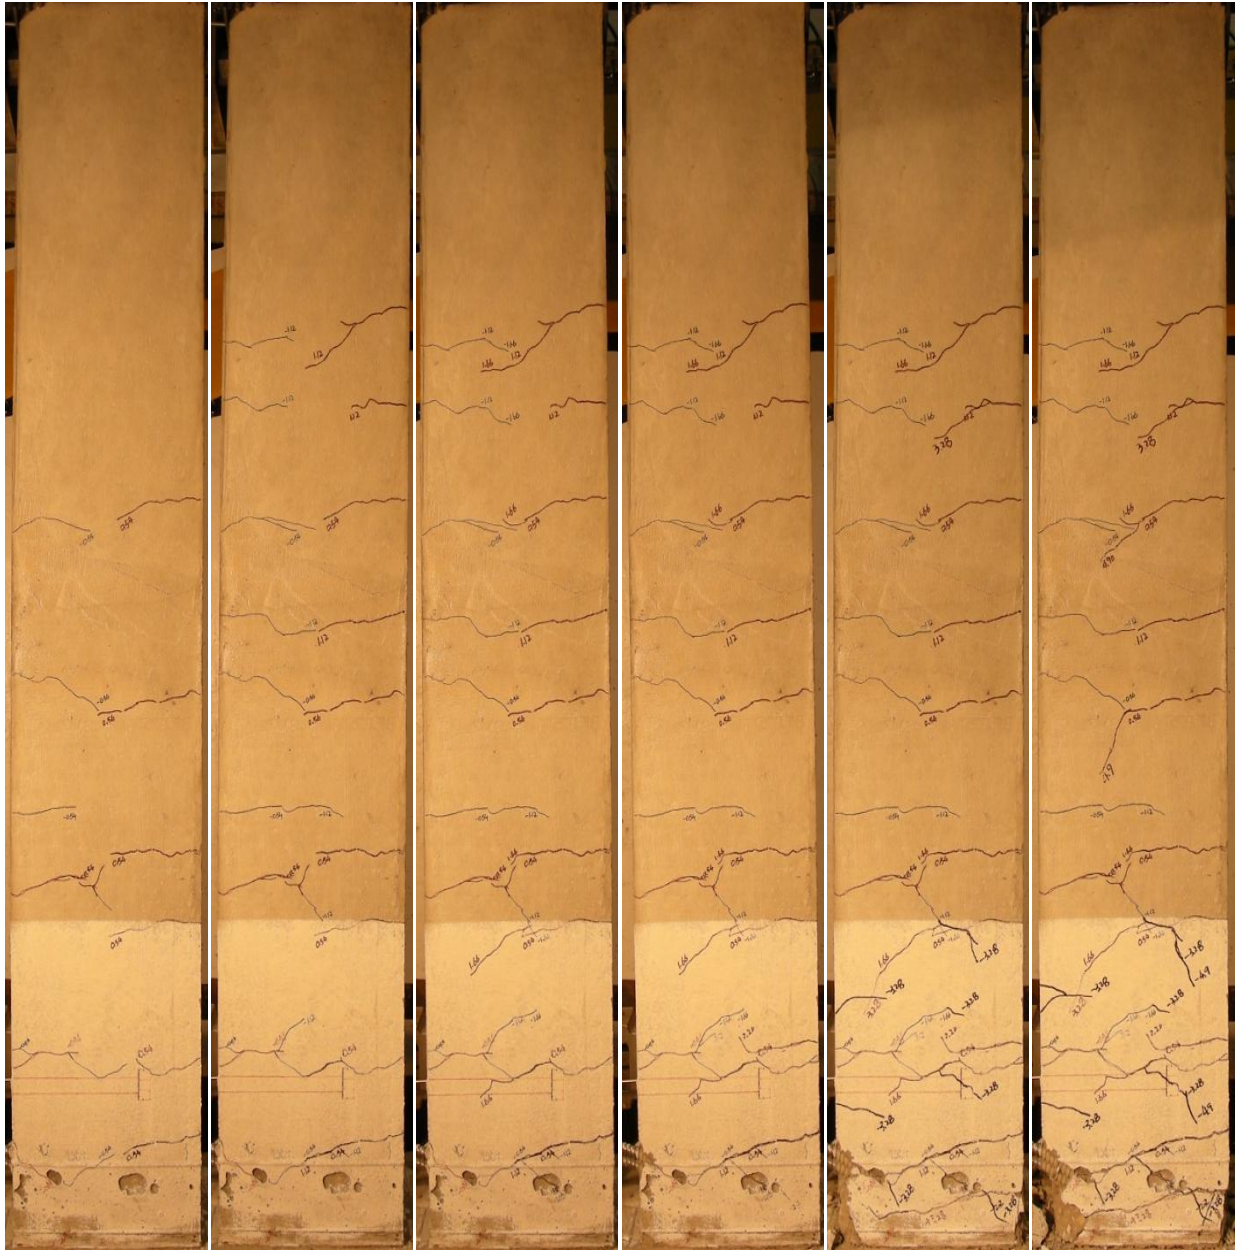
(a)  $\pm 0.58$  in. (b)  $\pm 1.12$  in. (c)  $\pm 1.66$  in. (d)  $\pm 2.20$  in. (e)  $\pm 3.28$  in. (f)  $\pm 4.9$  in.  
Figure A.7-Crack development after all loading cycles (T2)

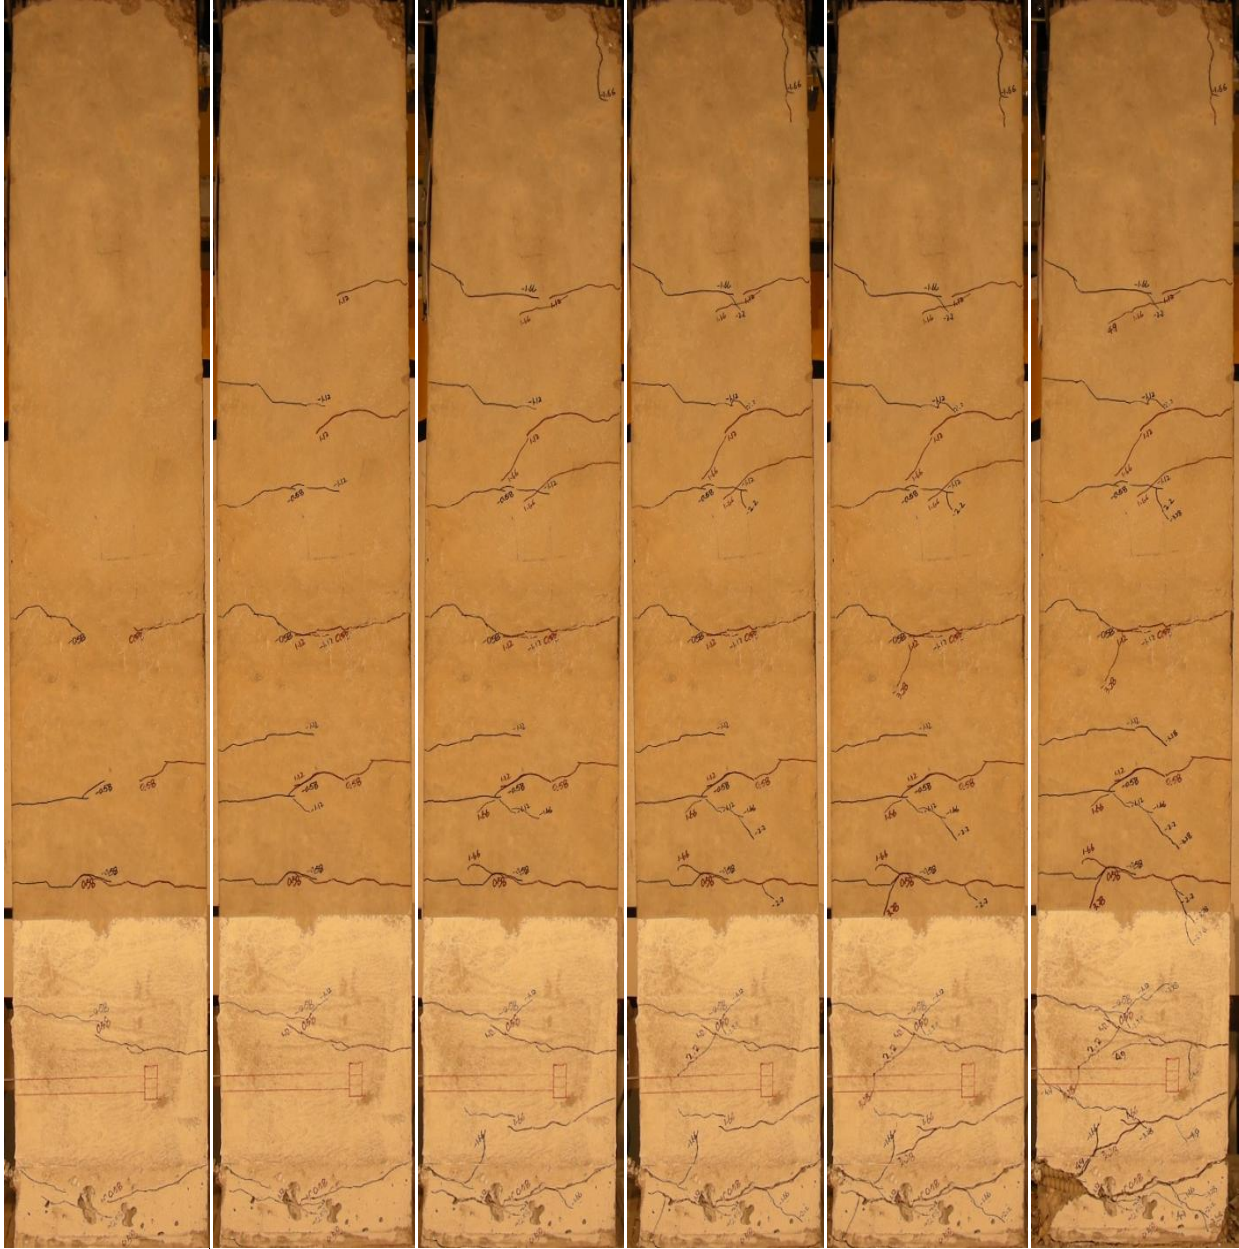
(a)  $\pm 0.58$  in. (b)  $\pm 1.12$  in. (c)  $\pm 1.66$  in. (d)  $\pm 2.20$  in. (e)  $\pm 3.28$  in. (f)  $\pm 4.9$  in.  
**Figure A.14-Crack map under various loading cycles (T3)**

Comparison of the crack growth and crack density under various cyclic loading levels was plotted in Figure A.14. Most cracks concentrated in the plastic hinge zone at the end of the last cyclic loading. The crack width at the base opened up to 9 mm while the major crack below the embedded anchor had a width of about 8 mm, as shown in Figure 4.12.

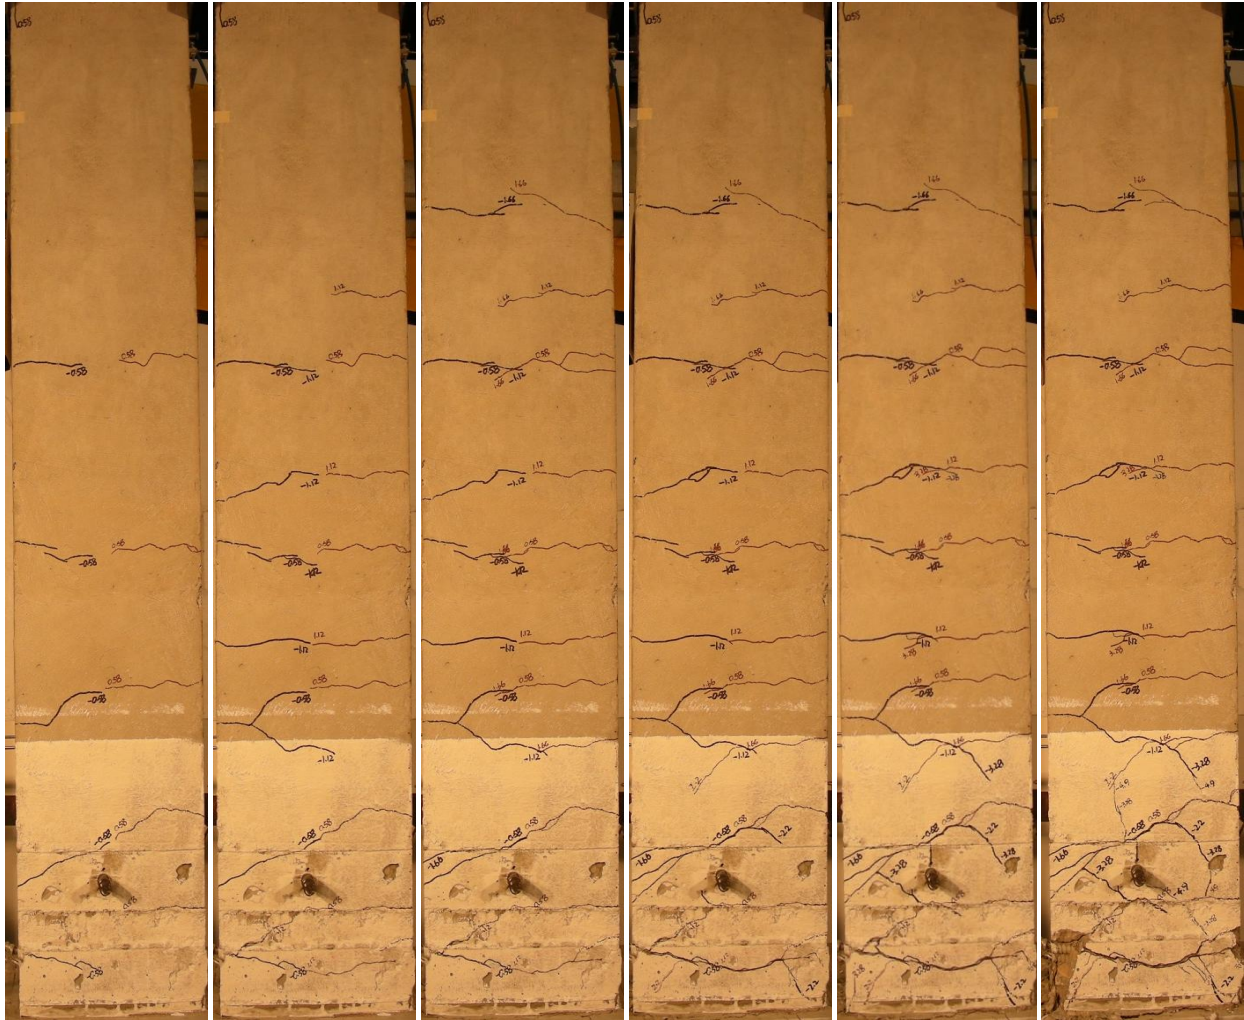
(a)  $\pm 0.58$  in. (b)  $\pm 1.12$  in. (c)  $\pm 1.66$  in. (d)  $\pm 2.20$  in. (e)  $\pm 3.28$  in. (f)  $\pm 4.8$  in.  
**Figure A.21-Crack map under various loading cycles (S1)**

Comparison of the crack growth and crack density under various cyclic loading levels was plotted in Figure A.21. The flexural cracks firstly developed at the base and within the plastic hinge zone. Small flexural cracks were then observed at higher location with the increase of the loading level. The cracks widened and propagated upon further loading, in particular, at the plastic hinge zone. Most cracks concentrated in the plastic hinge zone at the end of the last cyclic loading. The crack width at the base opened up to 8 mm while the major crack at 4 in. above the base had a width of about 7 mm, as shown in Figure 4.20. Outside the plastic hinge zone, the flexural cracks were evenly distributed and the maximum crack width, measured at the surface of concrete, was 0.4 mm.

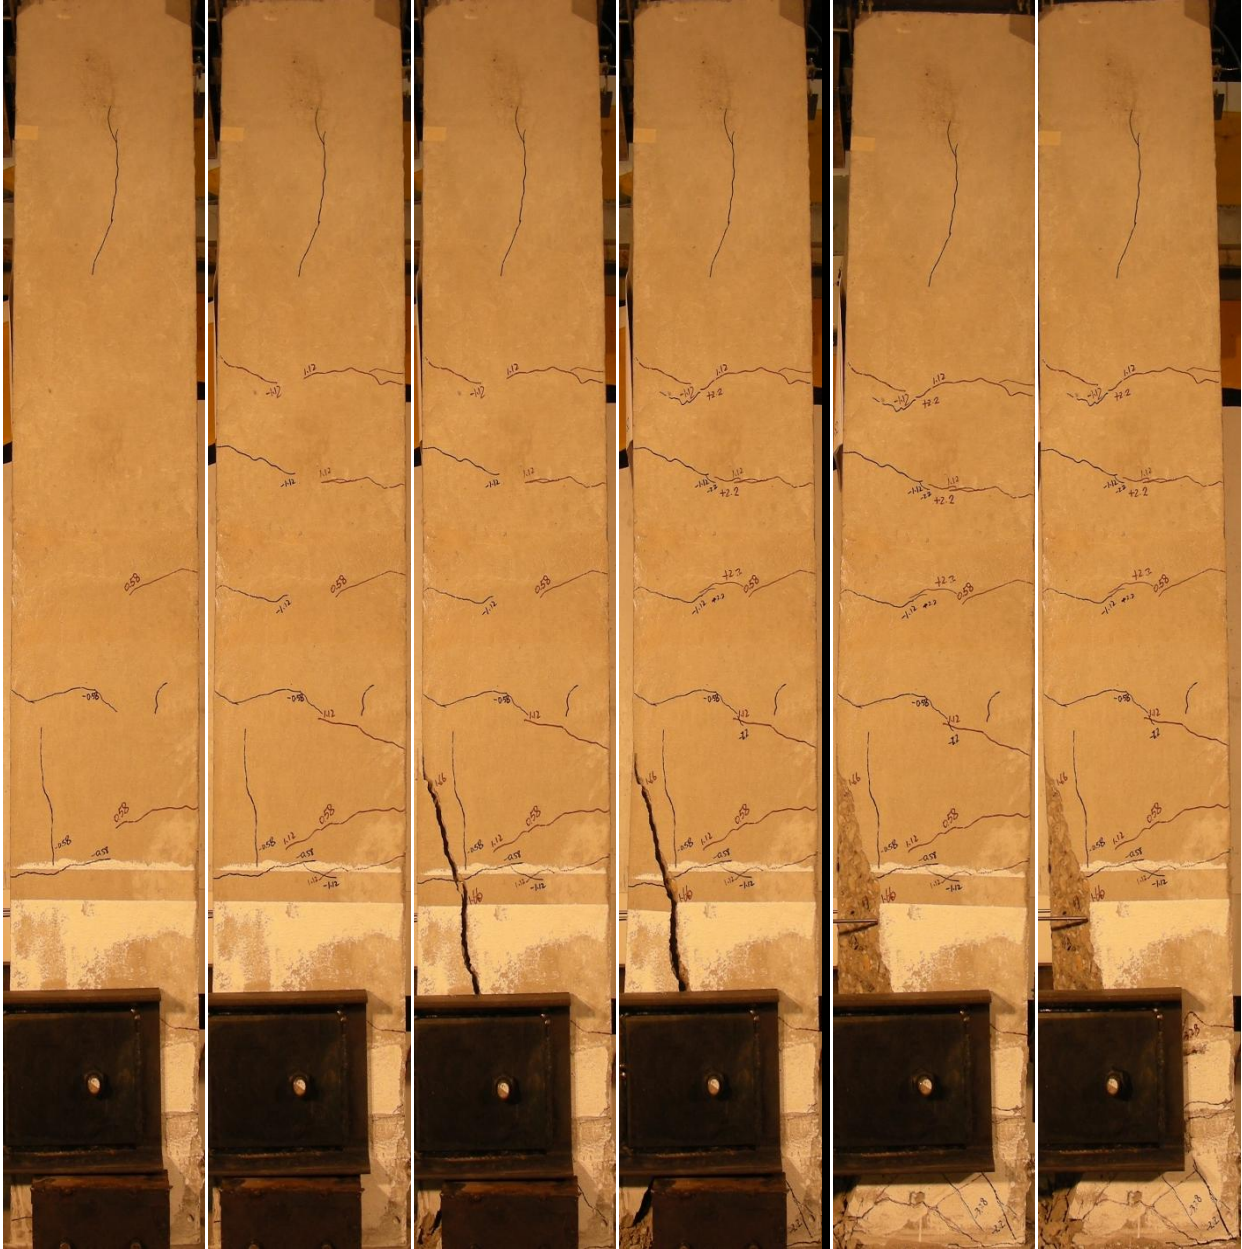
(a)  $\pm 0.58$  in. (b)  $\pm 1.12$  in. (c)  $\pm 1.66$  in. (d)  $\pm 2.20$  in. (e)  $\pm 3.28$  in. (f)  $\pm 4.9$  in.  
Figure A.28-Crack map of S2 under various loading cycles

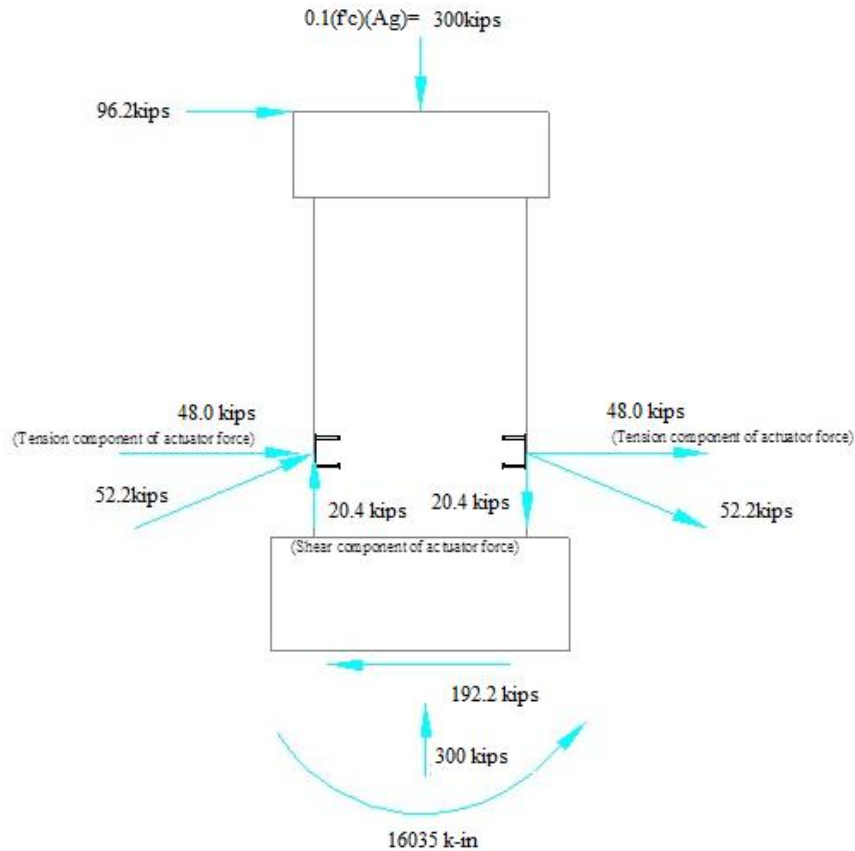
**Figure B.2-2: Free Body Diagram at Expected Wall Failure.**

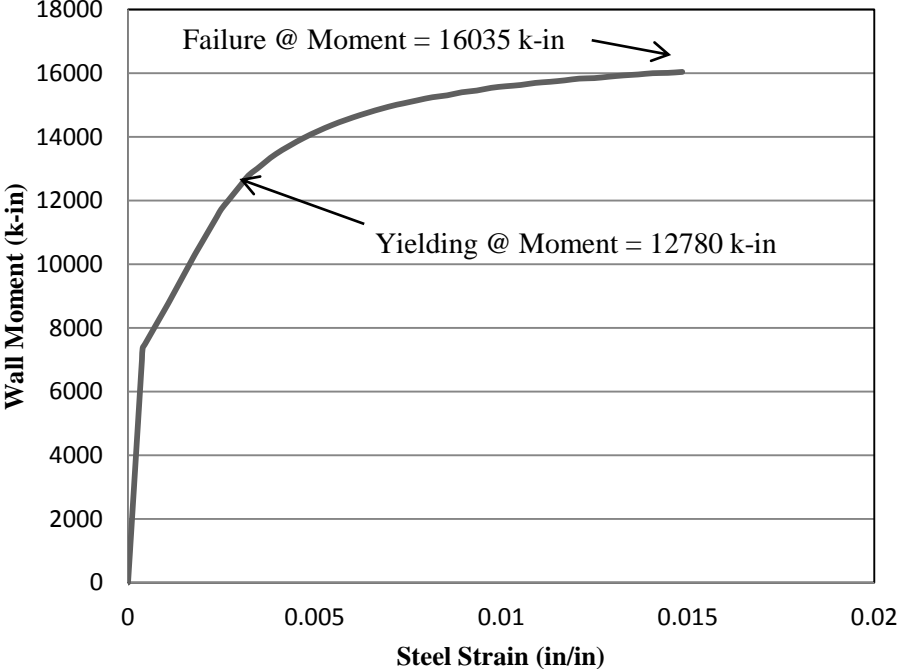
**Figure B.3-1: Expected Wall Moment vs. Steel Strain**
