# Behavior and Design of Cast-in-Place Anchors under Simulated Seismic Loading (NEES-Anchor)

Jian Zhao, University of Wisconsin, Milwaukee (UWM) Bahram Shahrooz, University of Cincinnati (UC) Xiangdong Tong, Jinhuan Manufacturing Group  
Derek Petersen (UWM graduate student); Zhibin Lin (UWM Post-doc); Luke Butler (UC graduate student)

## Unreinforced Single Anchors Subjected to Cyclic Tension, Shear, and Combined Loading

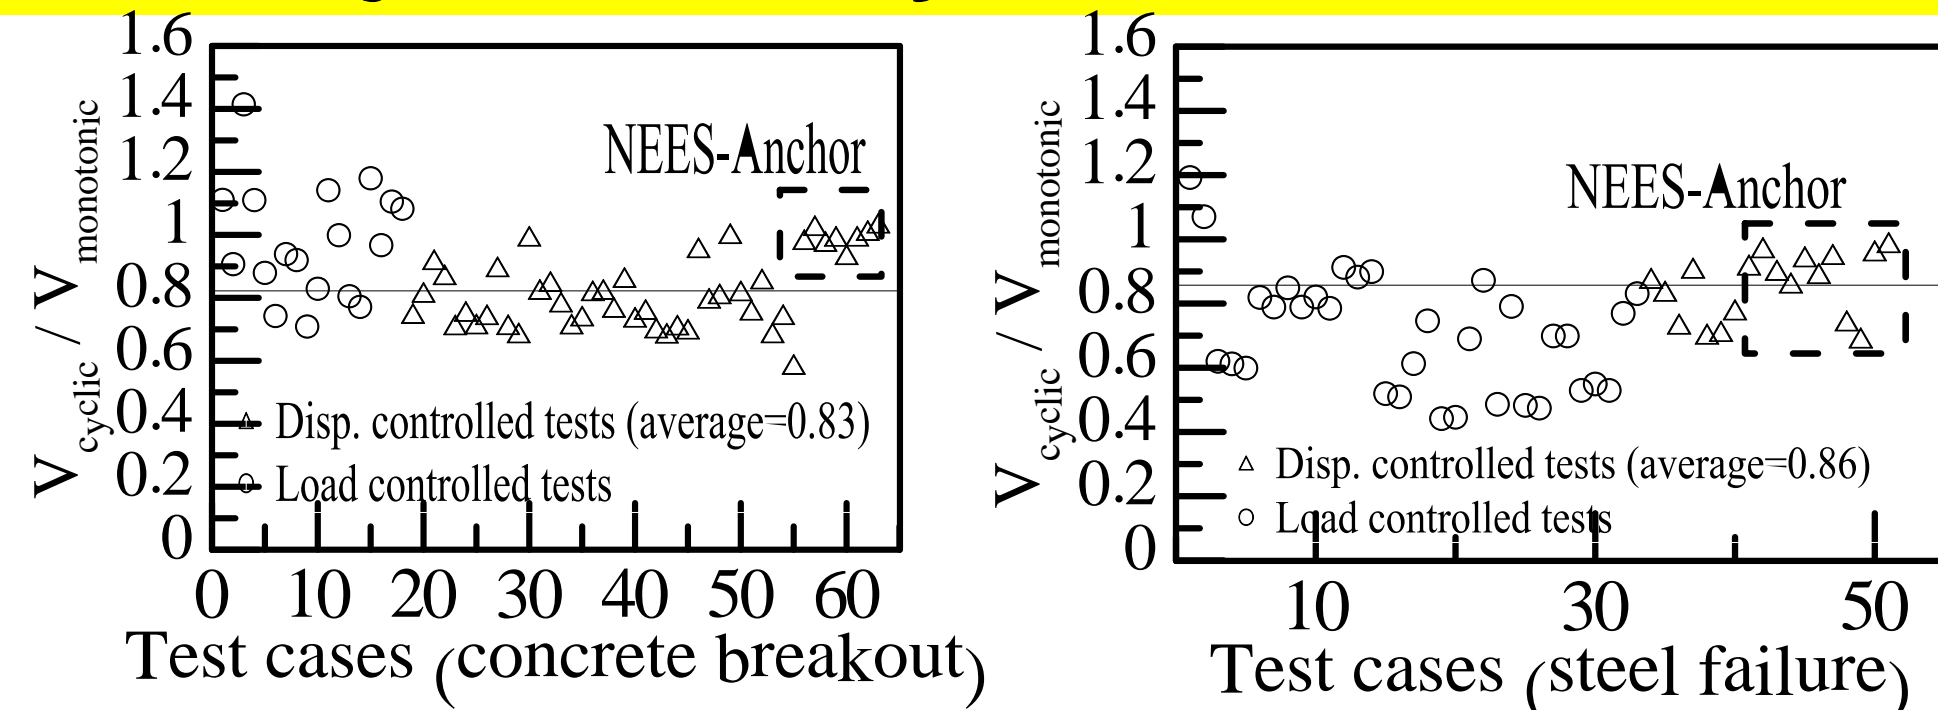
Quasi-static cycle tests were conducted.

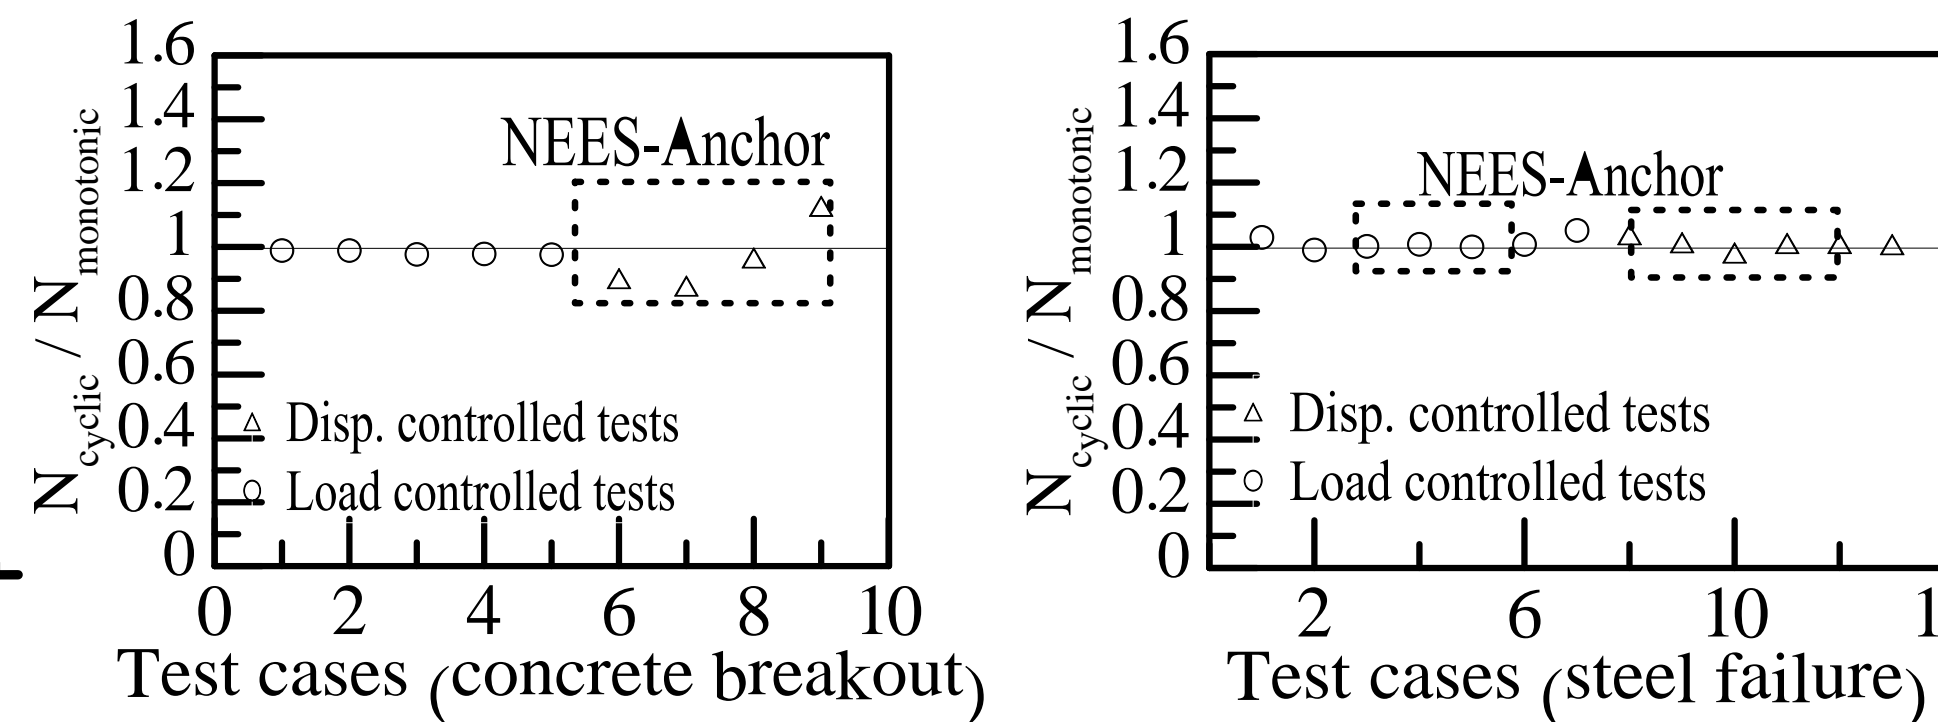
The observed anchor capacities under cyclic loads were lower than that of anchors subjected to monotonic loads, mostly due to accumulative/progressive damage in concrete.

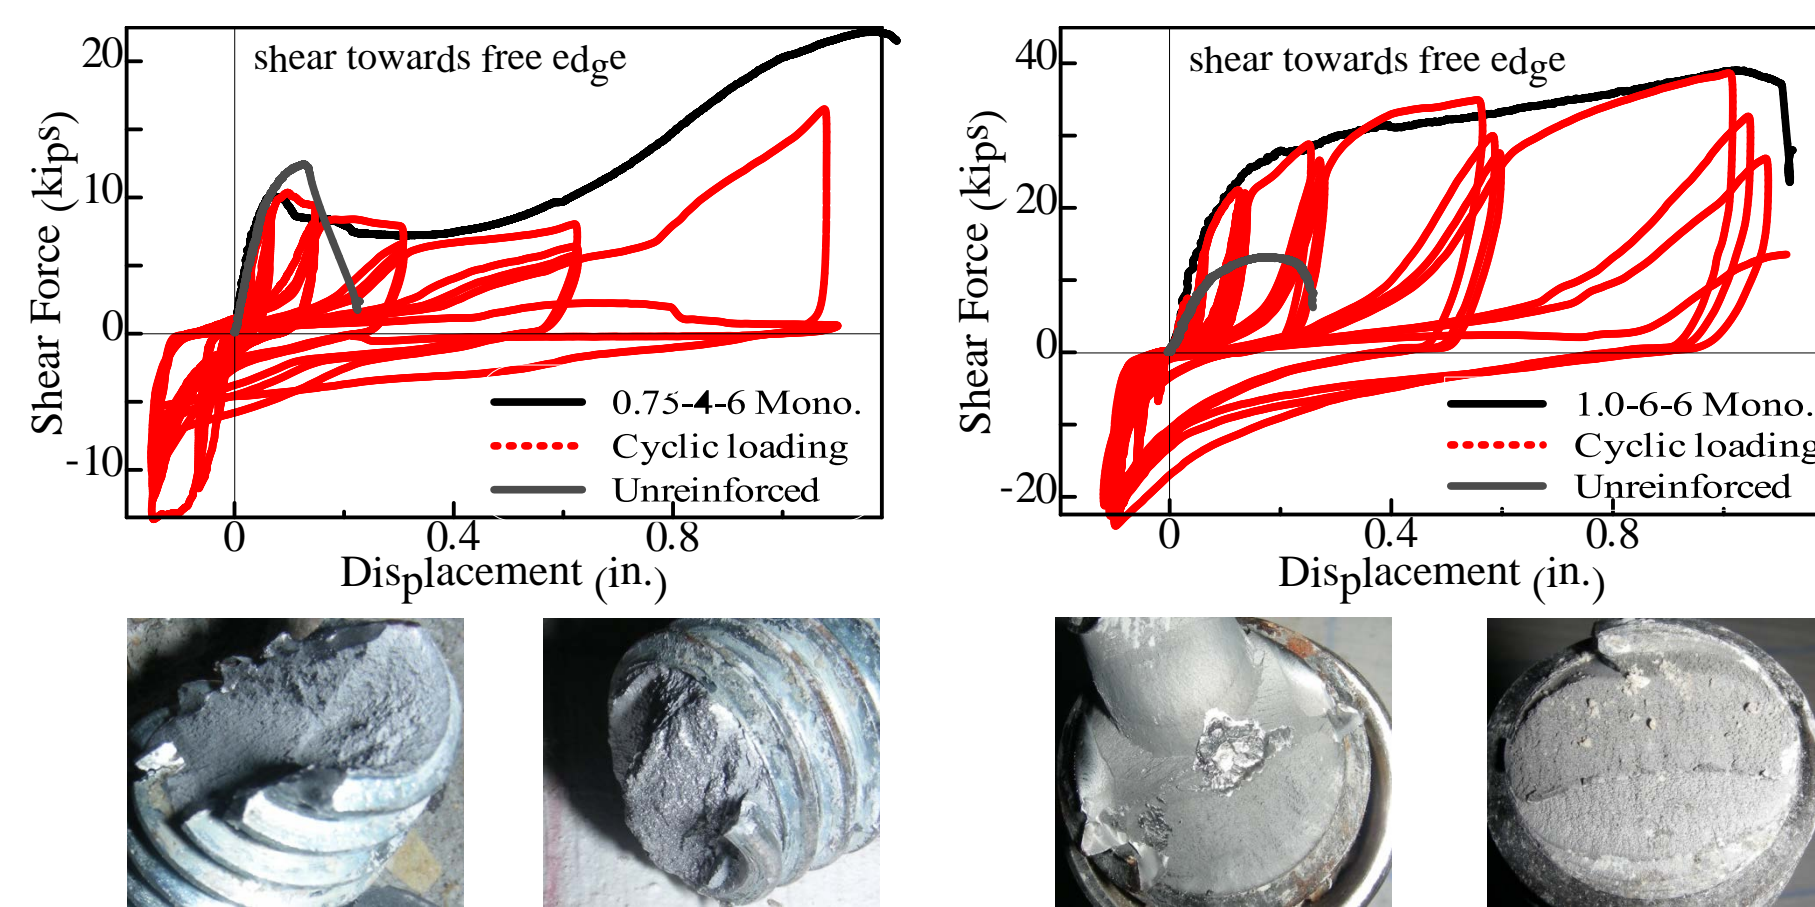
We proposed alternative designs and detailing for anchor reinforcement. The new reinforcement consists of a group of closed stirrups proportioned to resist the code-specified anchor steel capacity.

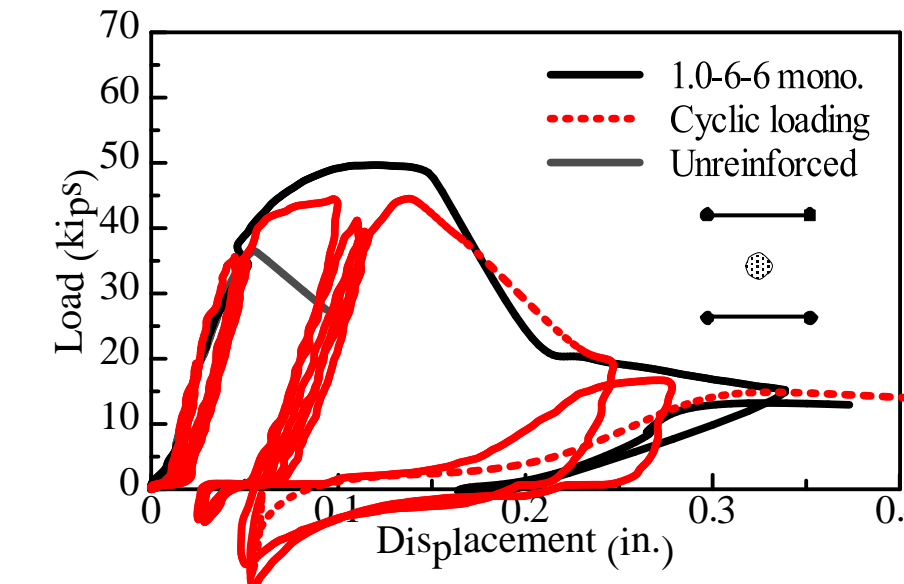
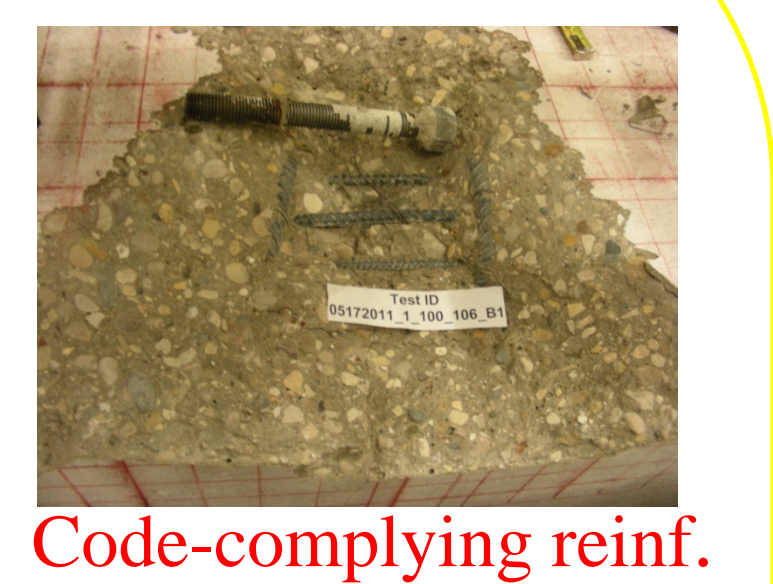
Code-complying reinf.

Steel fracture was achieved in all shear tests of 1.0 in. dia. reinforced anchors. Meanwhile, the observed anchor capacities were smaller than the code-specified anchor values because concrete spalling caused combined bending and shear action. Use a 0.75 factor, or  $V_{se} = f_{ya} A_{se,v} \sin \beta + \frac{f_{ya} \cos \beta}{0.9 A_{se,v} + 3.45}$

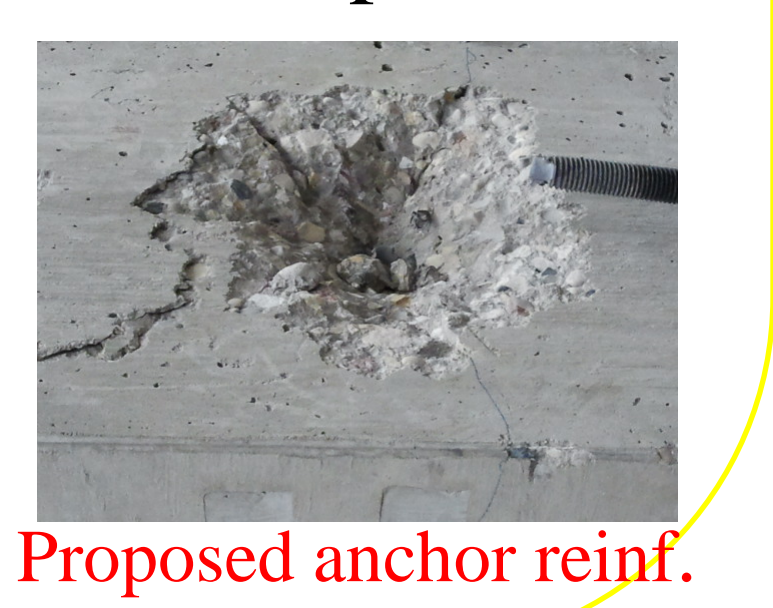
Proposed anchor reinf.

The expected steel tension fracture was not achieved mainly because the anchor reinforcement did not effectively prevent splitting cracks. Concrete around the anchor head thus lost its confinement and crushed prematurely. → Anchor pullout.

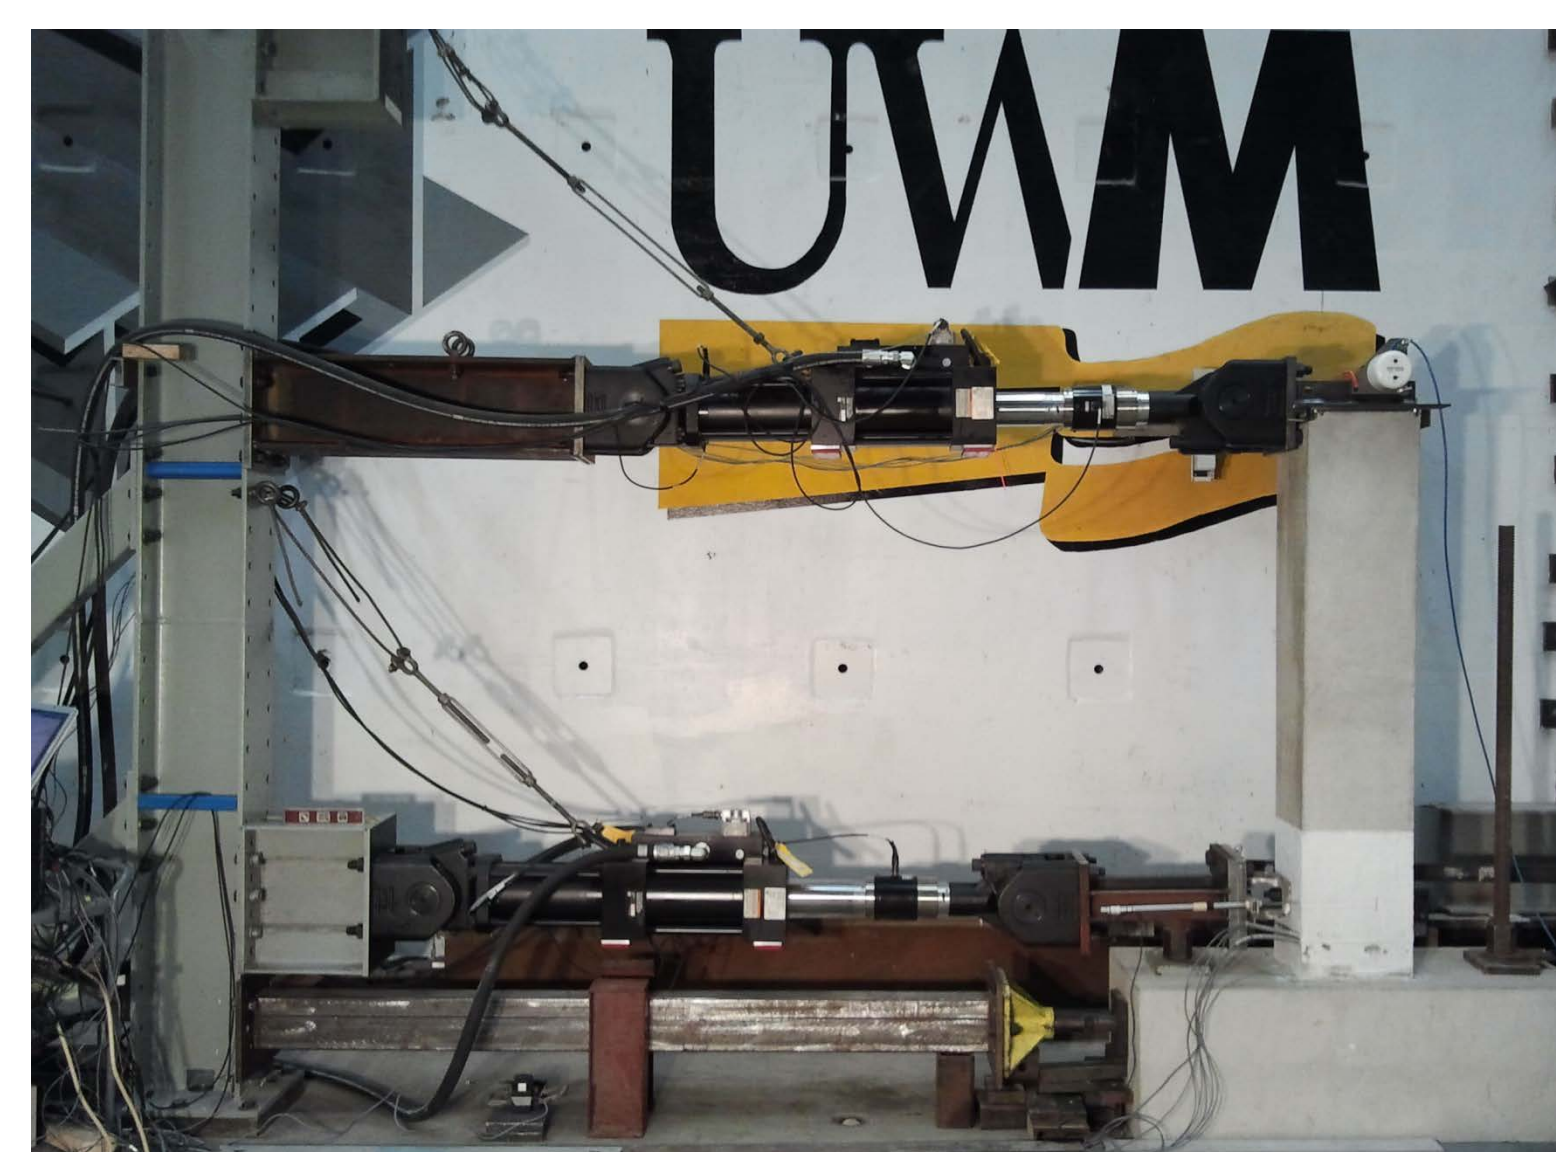
This group of tests was to investigate the feasibility of installing headed anchors in plastic hinge zones.

- 3 specimens w/ one anchor in tension
- 3 specimens w/ two anchors in shear

Well-confined core concrete can support headed anchors installed in plastic hinge zones of RC columns

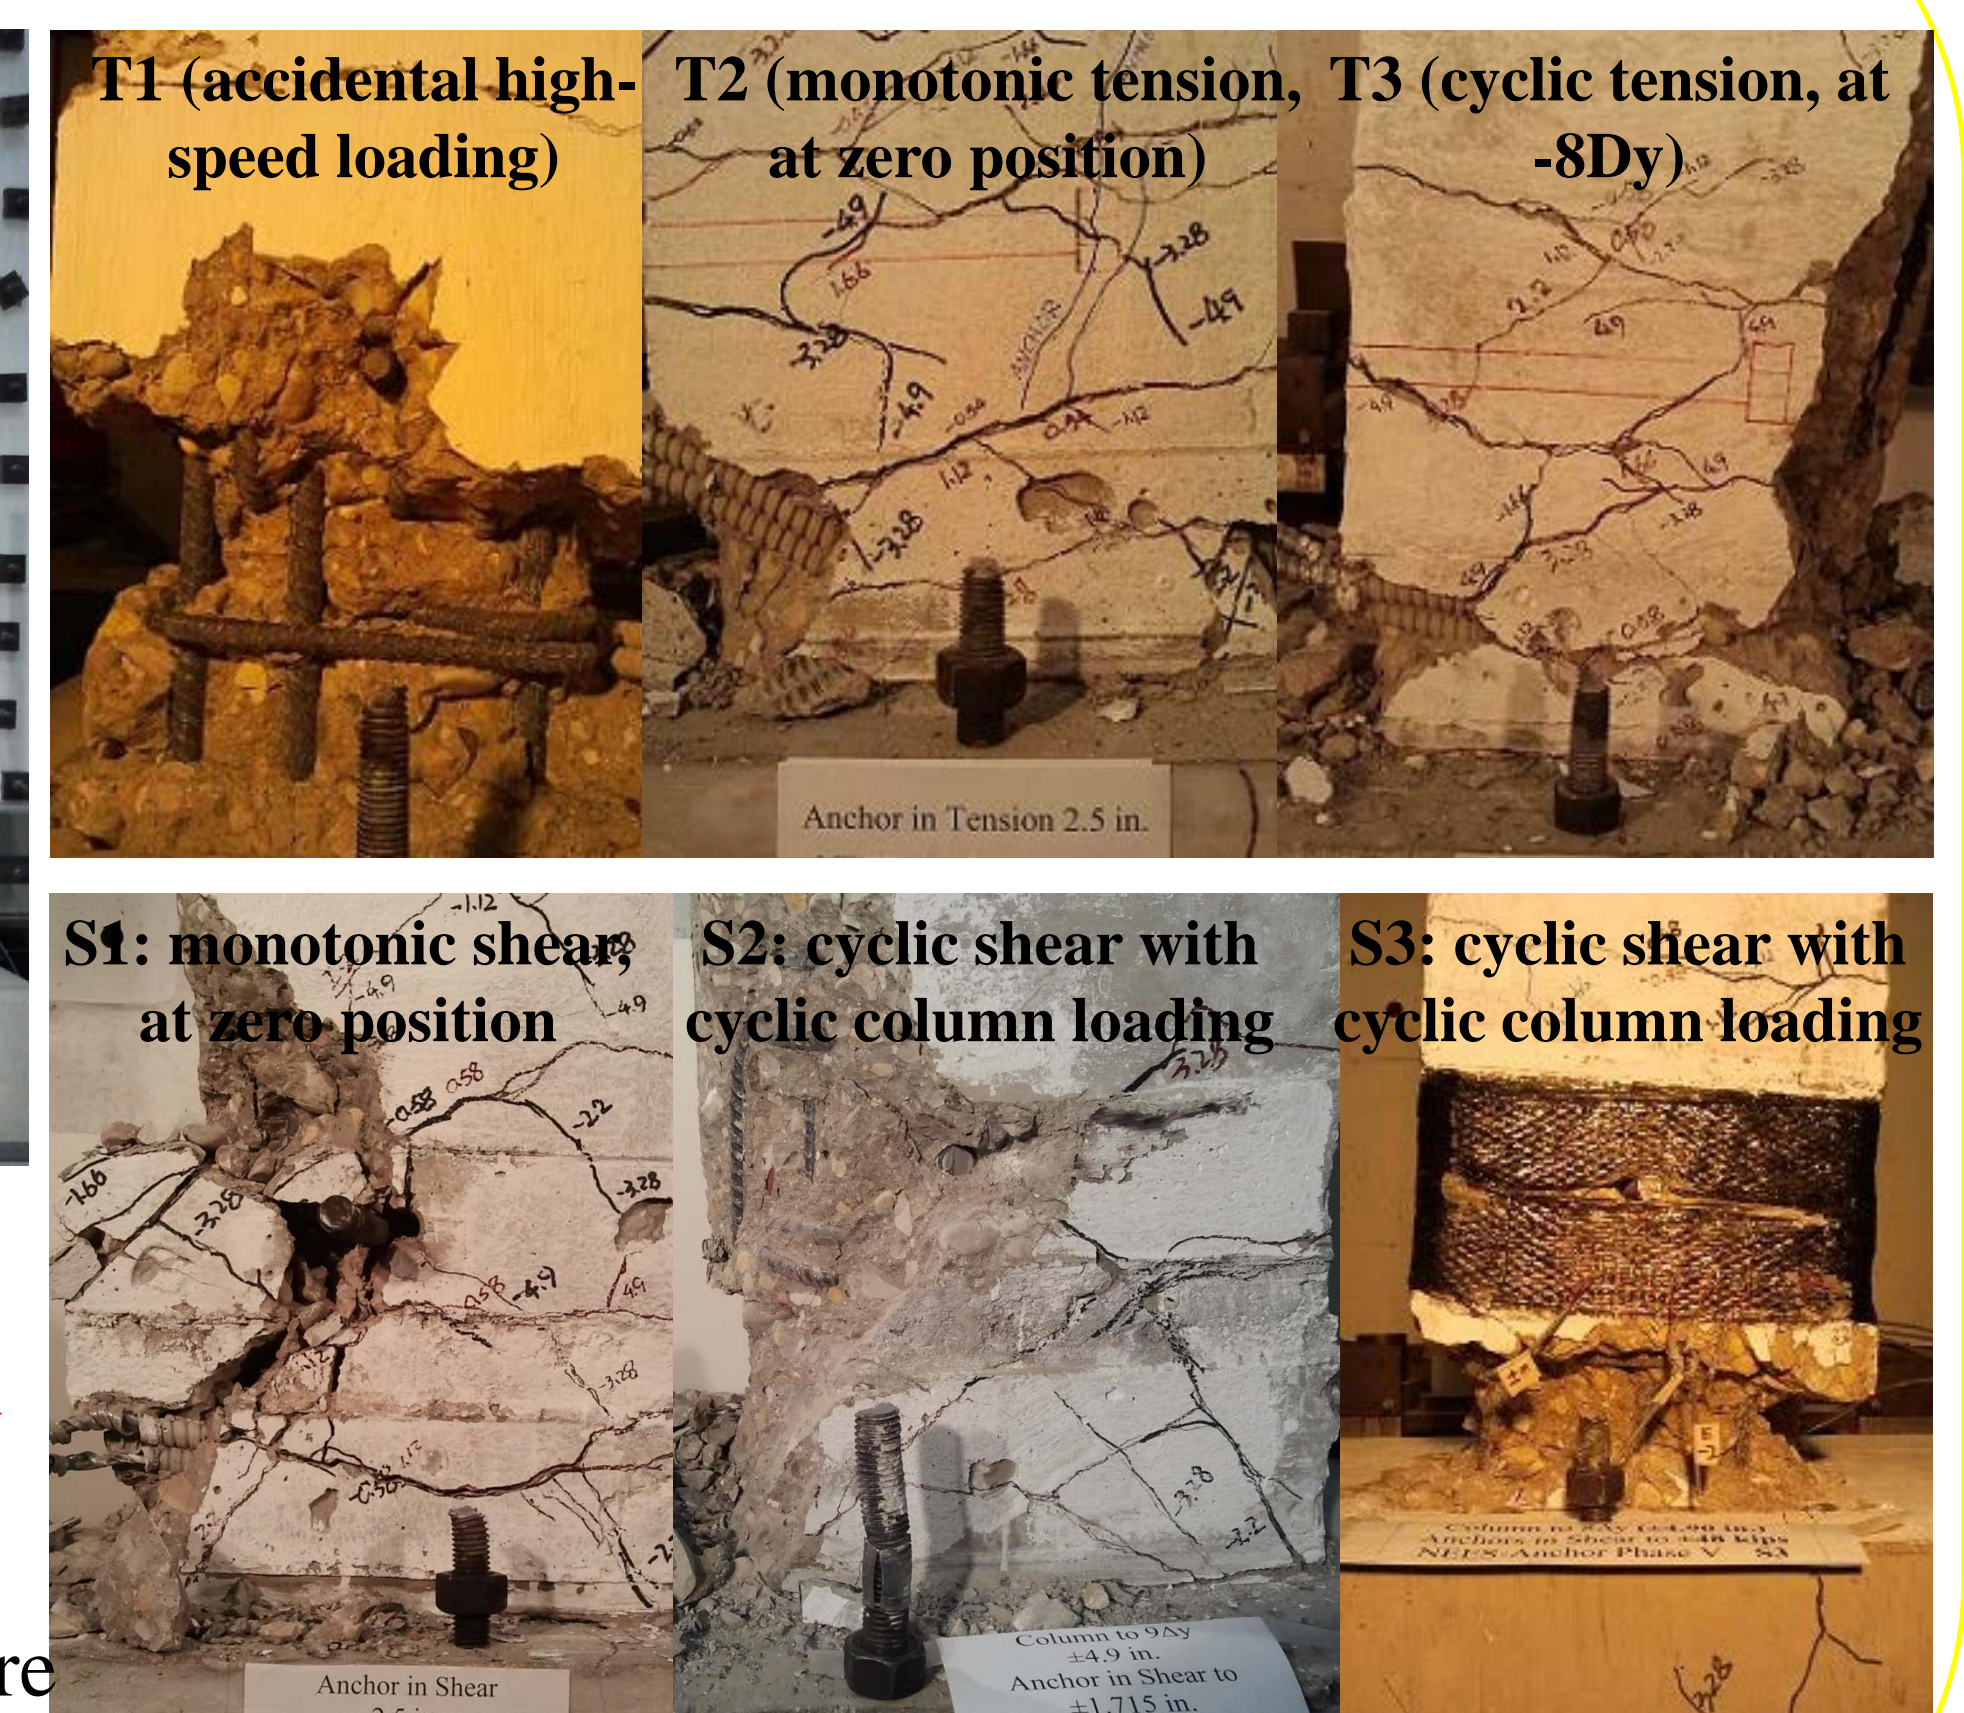
Anchor reinforcement should 1) Confine core concrete; 2) Restrain concrete splitting and blowout; and 3) Transfer loads from anchor heads; Cover spalling leads to exposed anchor shaft. Estimation of exposed length is key for capacity.
