Bradford Beach Standing Water Investigation

School of Freshwater Sciences
 Department of Civil Engineering and Mechanics UWM
 Geosciences Department UWM
 University of Wisconsin-Milwaukee
 Released: March 2012

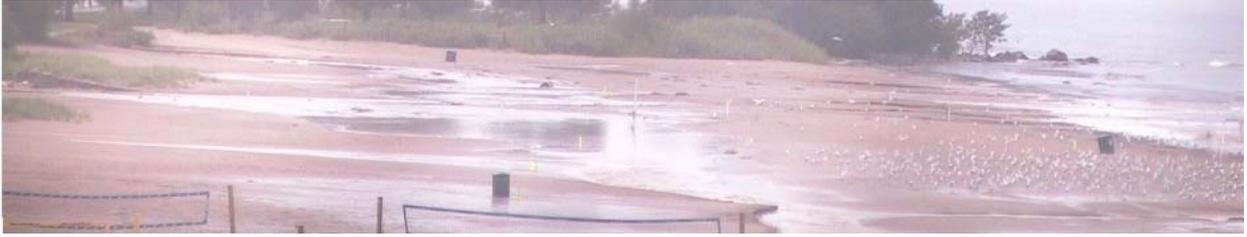
Figure ES- 1- Picture captured by a camera on the top of the beach house showing impact of heavy rainfall event on 7/22/10, such as beach erosion and accumulation of standing water at Bradford Beach.

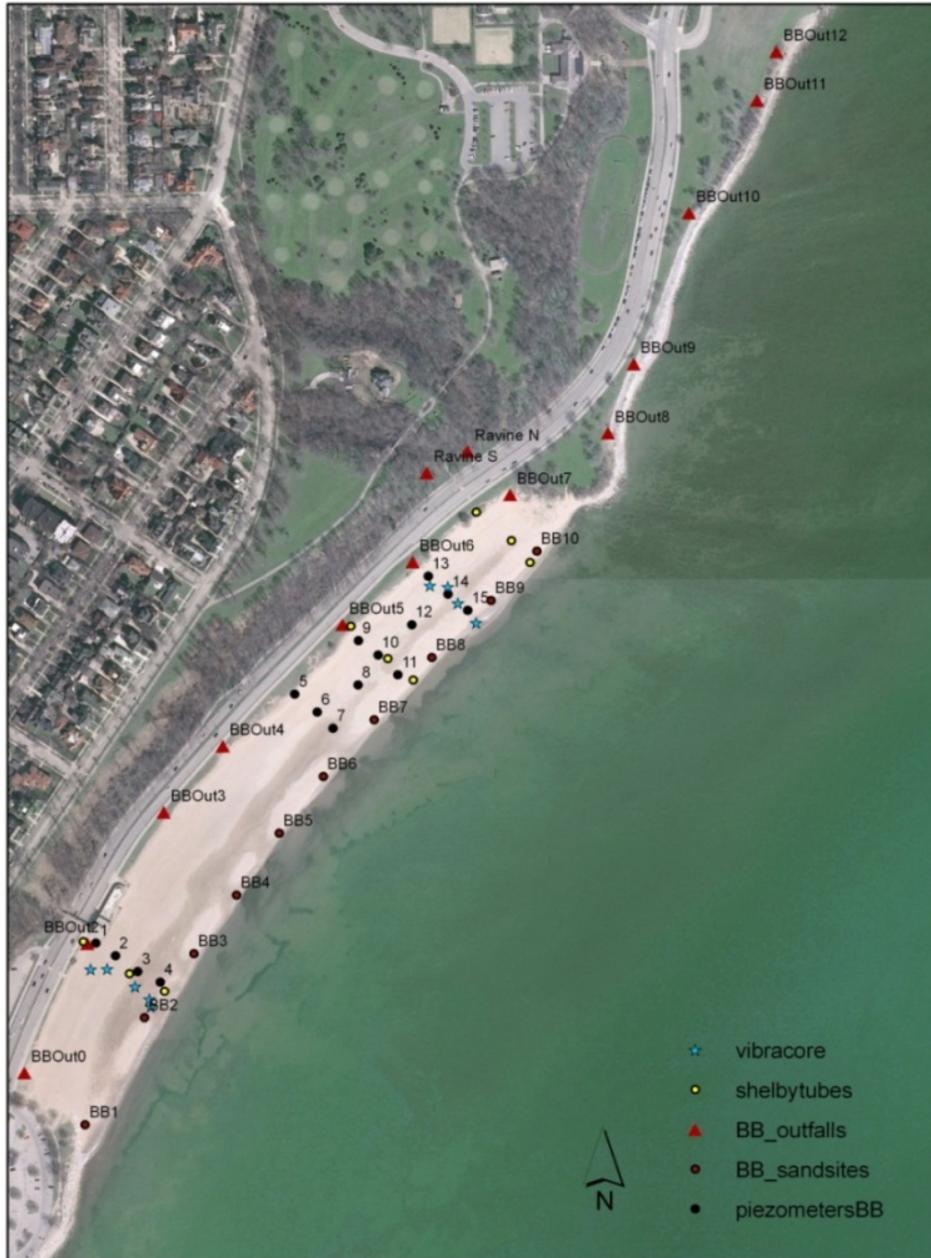
Figure ES- 2- Sampling sites. The yellow circles show the sites where sand cores were collected with Shelby tubes in 2007, the blue stars show the transects of sand cores collected in 2009 with a vibracore, the black circles show where piezometers were installed in October 2009, the red triangles show where the stormwater outfalls are located and the red circles show where the berm surface sand sites are located. Please note the region of wet sand along the beach.

2.1 *Beach erosion and deposition* - Beach erosion was observed mainly in the central part of the beach (cross-shore direction, where the wet sand can be observed on Figure ES- 2), with the deeper depressions located mostly on the northern part of the beach. Beach deposition produced a near shore sand berm after erosion lowered the beach elevation, allowing water to be caught shoreward of the berm. Three comprehensive topographical surveys were conducted at Bradford Beach in November 2009, April 2010, and July 2010. The main objectives of the topographic surveys were to provide a grading plan and to quantify the beach erosion due to the July 2010 storms. The accuracy parameters were predetermined with the intention of capturing the topographic relief of the site within 0.1 U.S. Survey Feet (3.048 cm). Topographical surveys show that there are regions with deeper depressions on the northern part of the beach, thereby contributing to concentration of standing water in that region.

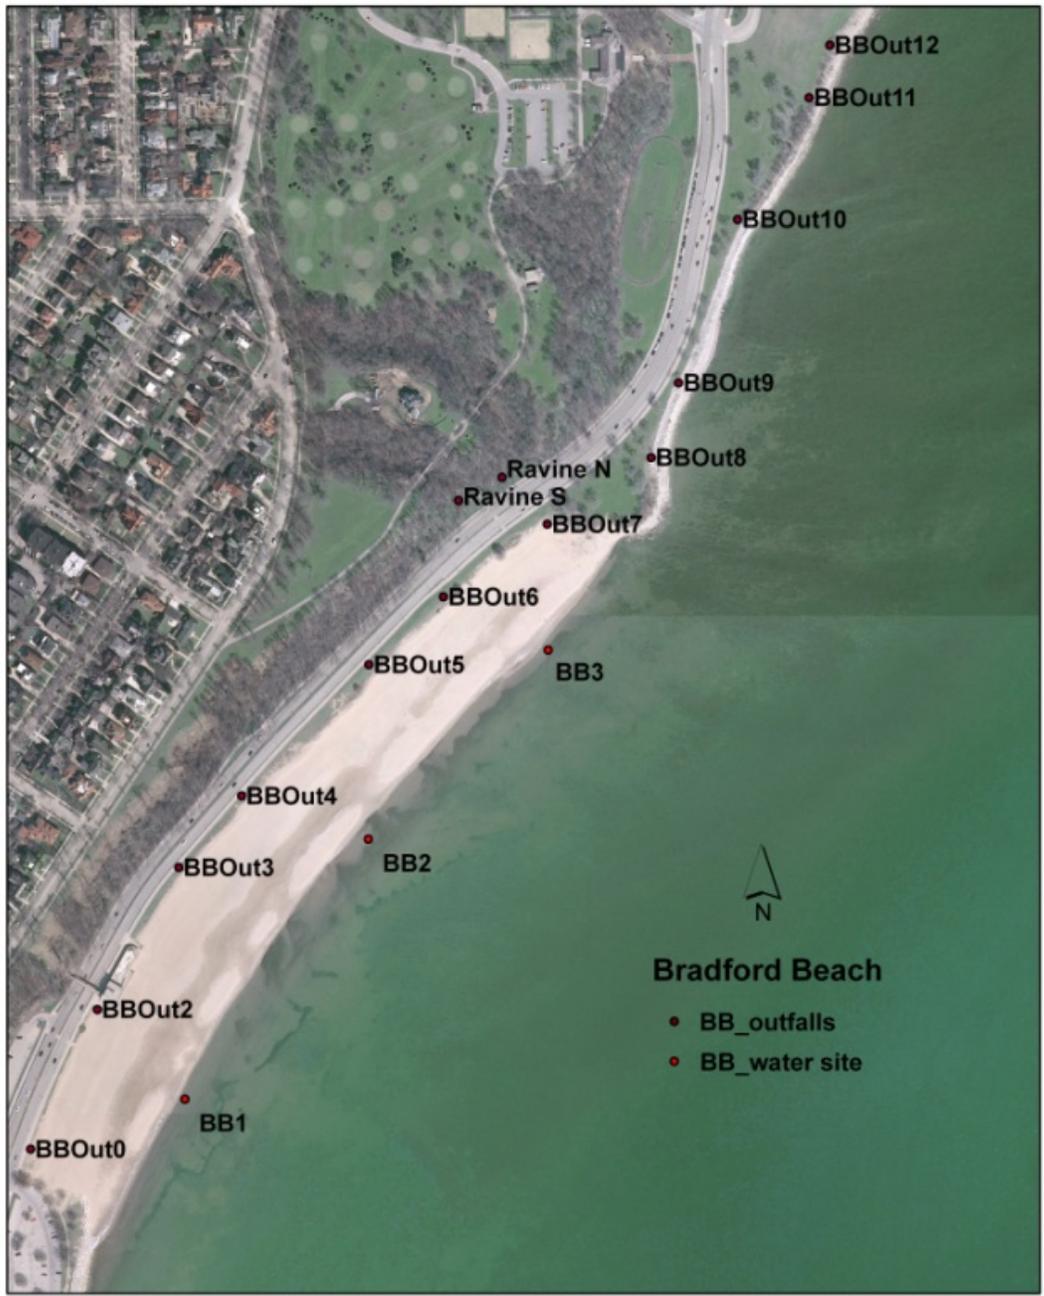
Water samples were collected 1-2 m from shore in knee-deep water using a grab sampler and transferred to 500-ml bottles, and stored on ice and in darkness until filtering in the lab. Grab samples were full-volume flushed at least three times with water from the sample site. Lake water samples are shown in Figure 2.

Figure 2-Sampling sites of beach water samples and outfalls

Previously eight stormwater outfalls (as shown in Figure 2) would discharge stormwater on the sand near the Lincoln Drive boundary. Stormwater runoff would run across the beach and reach lake water eventually. Stormwater outfalls were tested for human *Bacteroides*, which is a sewage indicator and they were found positive. This means that stormwater outfalls are contaminated with sanitary sewage (probably from leaking sewer lines exfiltrating into the stormwater system). This tells us that sewage is released at the beach, but it is very often below the limit of detection in the water. Therefore, it is important to control the sewage source directly.

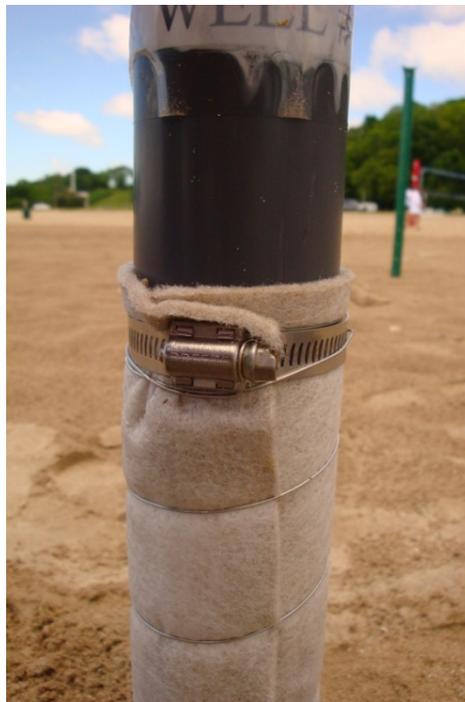
Figure 4-Piezometer at Bradford Beach

Piezometers were manufactured at the WATER Institute machine shop and they were made of 4-ft-long, 2-inches-ID-PVC pipe, with holes from 12 inches to 42 inches from top, and had two caps (one removable on the top and one sealed on the bottom). They were wrapped on a 100 μ m polyester filter felt. The filter was secured with stainless steel hose clamps and stainless steel wires, as can be seen in Figure 4.

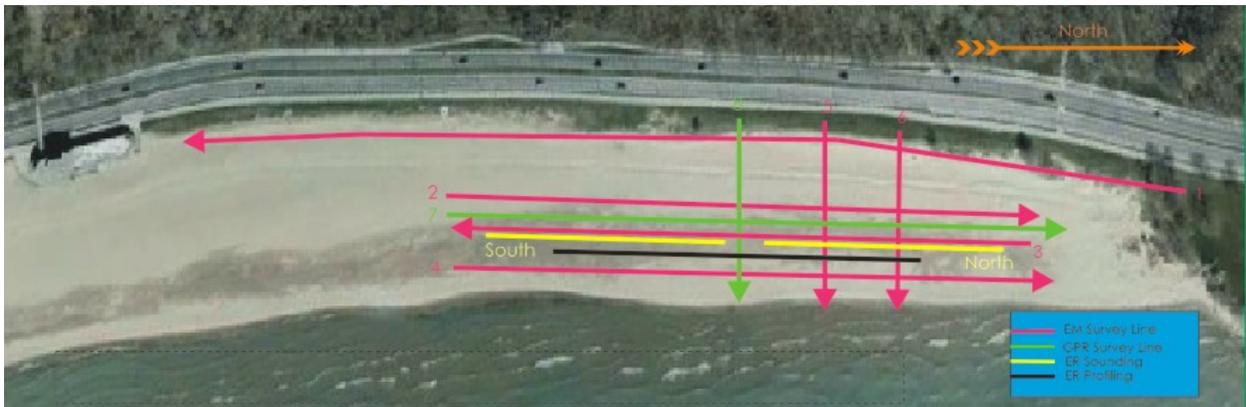
Figure 8-Electrical line locations.

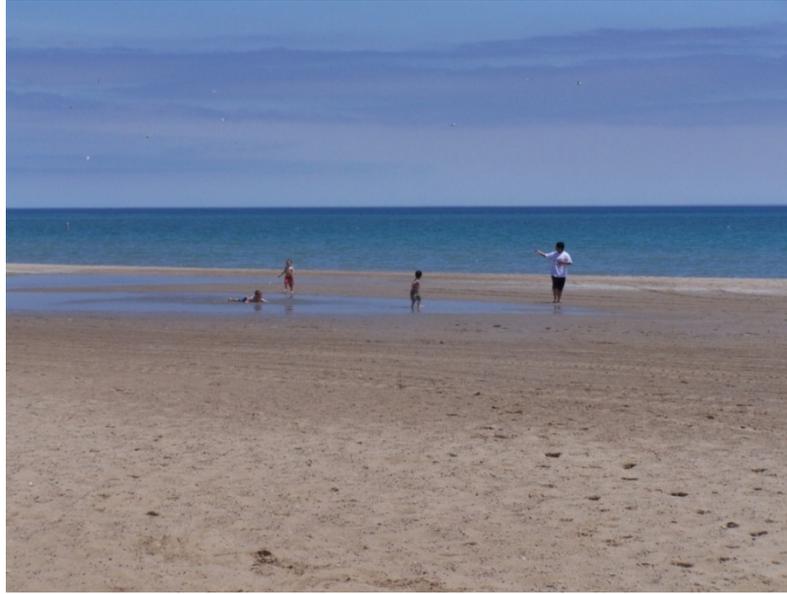
Figure 33- Children playing on standing water almost in front of the Beach House, at Bradford Beach. Picture was taken on June 8, 2009.
